Stator End-Winding Vibration in Two-Pole Machines

AVOIDING GENERATOR FAILURE

By John Letal, Bayu Satmoko,
Nixon Manik, and Greg Stone

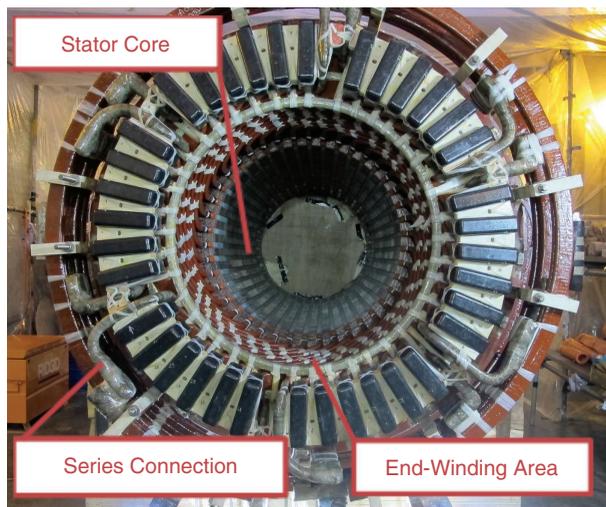
FIGURE 1. A turbine generator stator end winding.

Stator end windings, that is, the portion of the stator winding that extends beyond the stator core at each end (Figure 1), are one of the most critical locations in two- and four-pole rotating machines. Although the stator windings produce electricity (in generators) and torque (in motors) in the portion of the stator winding within the laminated stator core, the end windings are essential to make connections between the parts of coils in the different stator slots. As the speed of the machine grows higher, electromagnetic forces and spacing constraints require the end windings to be longer, that is, extend beyond the core for a greater distance. As described later, this longer end winding makes it more difficult to ensure that the end windings can fulfill their function without reducing the reliability of the motor or generator.

In 2013, after 13 years in operation, unit 2 (Figure 1) tripped when the generator relay (differential-phase current) was activated due to a phase B-to-phase C fault. This resulted in generator damage and the loss of production of more than US\$40 million. An incident investigation concluded that the probable cause was vibration occurring on the generator end winding, which abraded the insulation and led to cracking of the coil insulation just outside of the stator slot (Figure 3). As is known from similar failures elsewhere, in severe cases, this vibration may cause the copper conductors to fatigue crack. Once all the copper conductors in a coil had cracked, a high-arcing current occurred between the severed ends. The plasma melted the insulation in adjacent coils, leading to the phase-to-phase fault. The recommendation of the investigators was to install a generator stator end-winding vibration monitoring system.

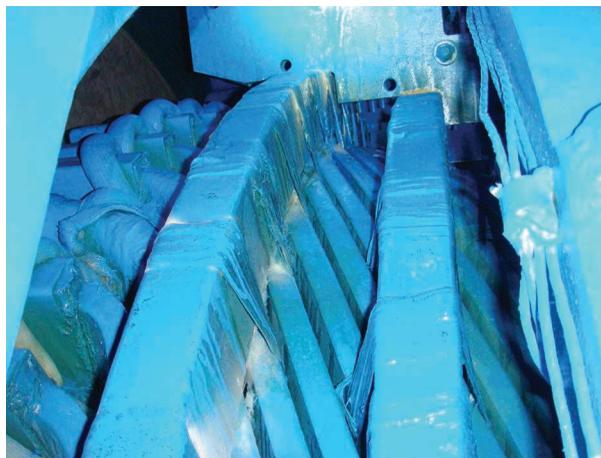
FIGURE 2. An example of insulation abrasion (the white powder caused by fretting) created by the relative movement between the coil, support ring, and support brace.

- 1) The vibration can lead to relative movement between end-winding components; for example, fiberglass rope affixing the coils to the support rings and braces abrading the coil insulation (Figure 2). Eventually, the abrasion can be severe enough to expose high-voltage copper conductors within the coil. If partly conductive contamination is present, it may result in a phase-to-ground fault.
- 2) End-winding vibration can loosen the stator wedges at the end of the stator core, which could eventually lead

Visual inspections of the end winding and surrounding support structure are generally considered the main way to detect evidence of excessive movement [12]. The dusting that results between components, which are supposed to be held tightly together, is an indication that they have loosened, are rubbing against each other, and causing the insulation to fret (Figure 2).

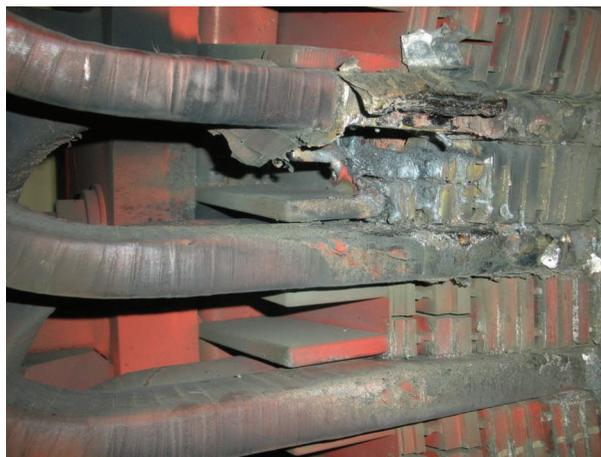
FIGURE 3. Collateral damage to the stator winding and core caused by fatigue cracking of the copper conductors due to severe end-winding vibration.

- 3) In the most extreme case, if the copper conductors within the coil vibrate enough, they will fatigue crack. If all conductors in a coil fatigue crack, the stator winding current will continue to flow through the coil by forming a plasma at the severed copper, which will cause extreme heating of the conductors, melt the copper and nearby components, and often completely destroy the stator winding (Figure 3).

In the early 2000s, reports of catastrophic stator end-winding failures similar to that shown in Figure 3 were discussed at utility conferences by several operators of air-cooled turbine generators rated up to a few hundred megawatts. The end-winding failures were apparently occurring on several different brands of machines, often after only a few years of service. In addition, many cases of fretting (Figure 2) were being found in modern air-cooled, two-pole generators and greasing in hydrogen-cooled, two-pole generators. This led the Electric Power Research Institute (EPRI) to commission a report to educate end users on the design of two- and four-pole generator end windings as well as possible failure mechanisms [4]. Various researchers also published papers on the recent increase in end-winding vibration issues [5]–[10]. In 2010, FM Global, a large insurance company used by generating stations, presented data indicating that, for the period from 2000 to 2010, it paid out more in claims for generator failures caused by end-winding vibration than any other failure mechanism [11]. About the same time, machine manufacturers decided that an IEC standard was needed to educate end users about the end-winding vibration issue and ways to determine if a problem exists. This resulted in the 2016 publication of IEC TS 60034-32 [1].

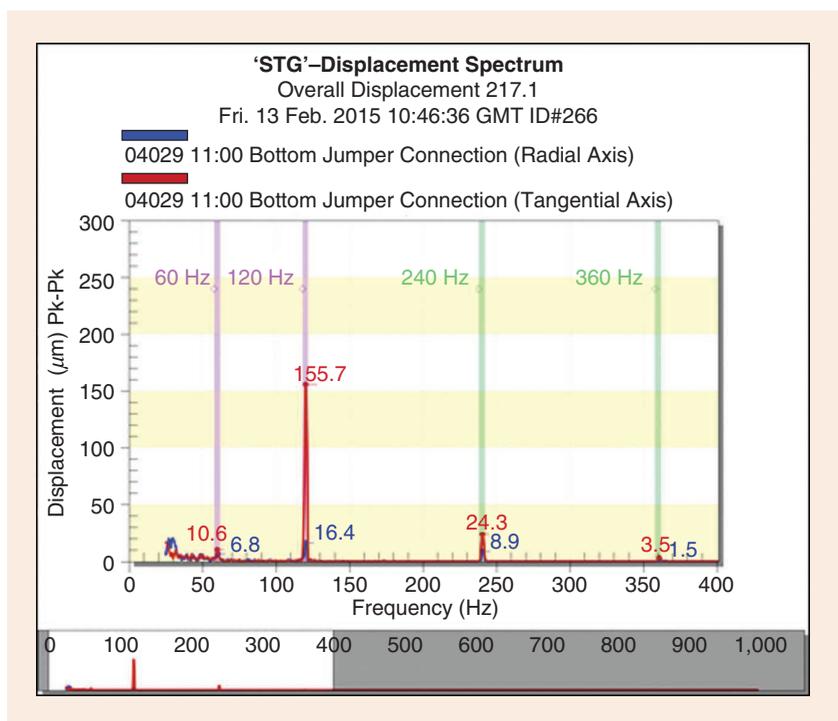
FIGURE 4. Displacement spectra at the onset of looseness. Pk: peak.

[1] often amplified by one or more resonances, so it can sometimes be advantageous to view the data as acceleration or integrated just once to velocity. Velocity has a smoothing effect over a wider range of frequencies to more readily identify harmonics possibly associated with mechanical looseness. The excitation force is still 1x or 2F, and the looseness allows the component to vibrate more freely than if there was a tight bond due to a reduction of stiffness in the support structure. It is this condition that can result in rattling and the production of harmonics in the frequency spectrum. For comparison, we provide displacement and velocity spectra at the onset (Figures 4 and 5) and leading up to (Figures 6 and 7) end-winding support structure looseness identified during a visual inspection (Figure 8) [9]. Not only is the dominant frequency at 2F (120 Hz

for 60-Hz machine), which is considered a typical end-winding vibration, but the harmonics present are indicative of mechanical looseness. When comparing the relative amplitudes at 240 and 360 Hz to the fundamental 120 Hz, they are more easily identified when viewing the velocity.

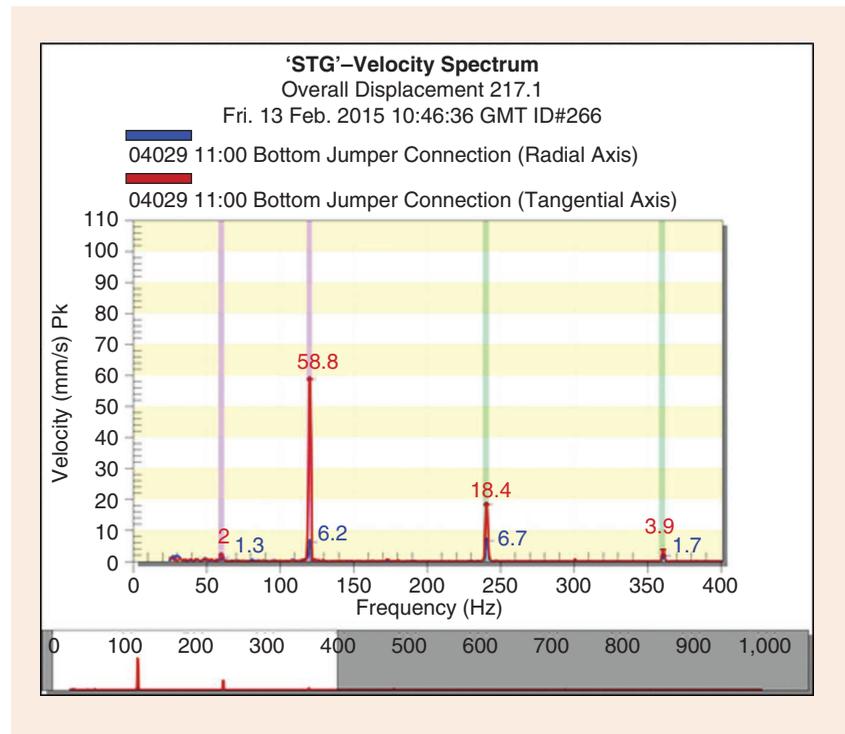
FIGURE 5. Velocity spectra at the onset of looseness.

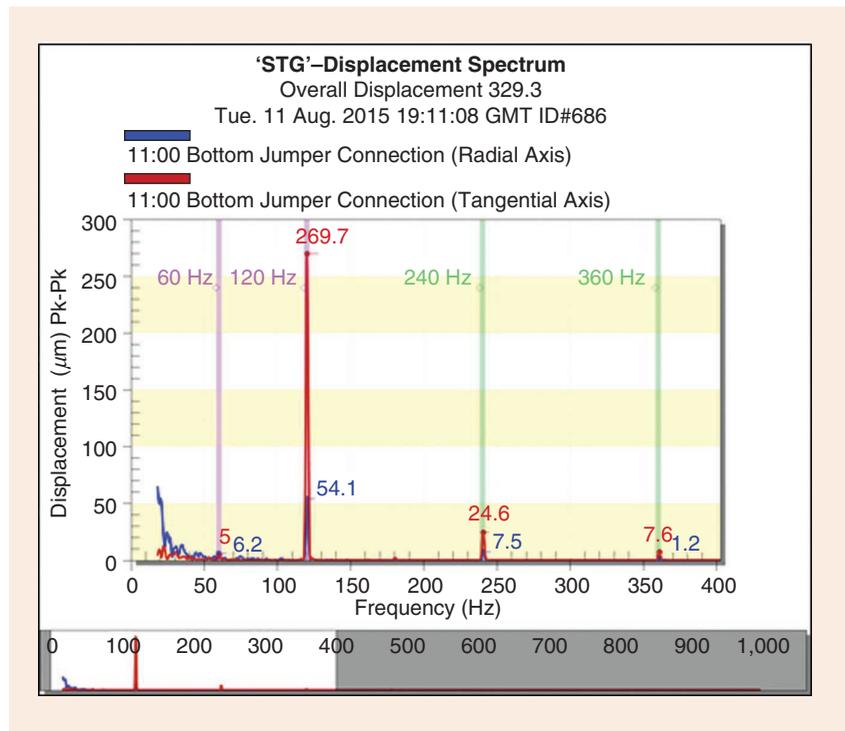
FIGURE 6. Displacement spectra just prior to visual inspection confirming looseness.

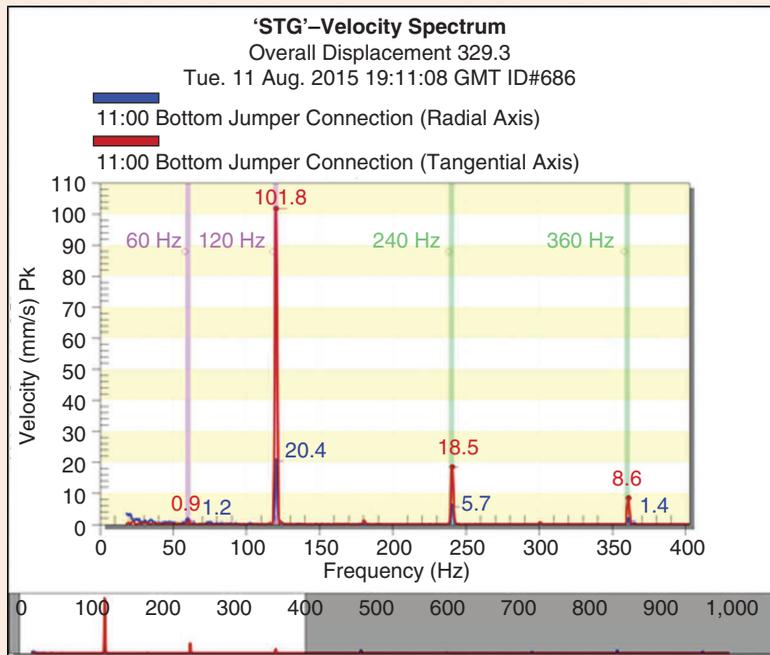
FIGURE 7. Velocity spectra just prior to visual inspection confirming looseness.

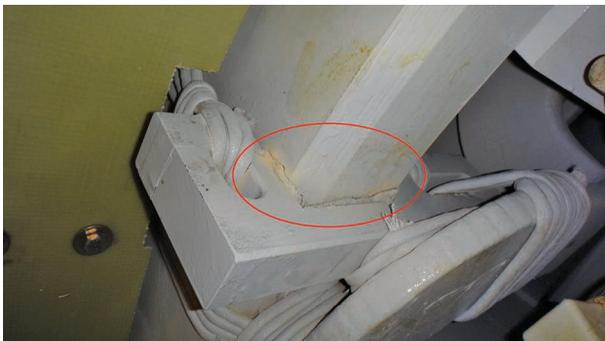
FIGURE 8. Visual inspection showing looseness between the support block, circumferential support ring, and connection between the winding and circuit ring [9].

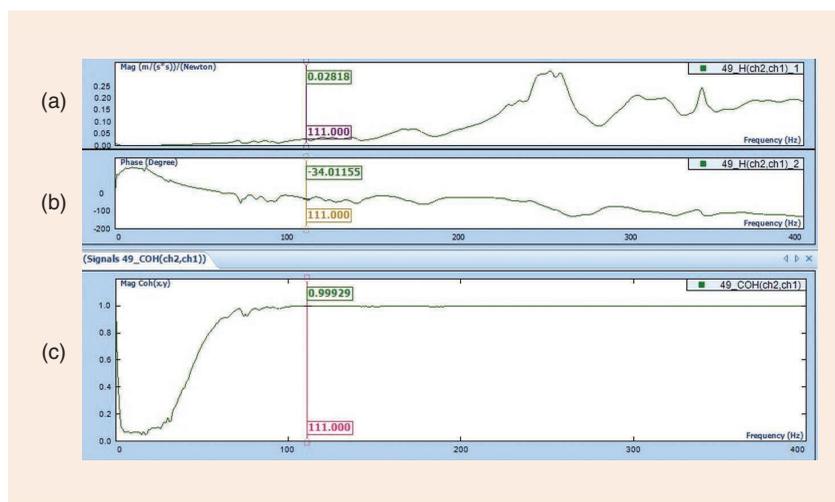
FIGURE 9. A typical frequency response function depicting 0.028 $(\text{m/s}^2)/\text{N}$ (or 0.013 g/lb-F) at (a) 111 Hz with (b) phase and (c) coherence. g/lb-F : acceleration (gravity) per unit of force (pounds).

Bump testing was used to determine the most responsive areas where the potential for vibration was greatest to locate where to install the accelerometers. The maximum acceleration responses [in $(\text{m/s}^2)/\text{N}$] were recorded in the critical frequency band of 90–120 Hz for this 50-Hz machine (Figure 9).

The failure criteria used for the bump test were an accelerance response of greater than 0.055 (m/s²)/N (or 0.025 g/lb-F) within 5 Hz of 50 and 100 Hz and greater than 0.110 (m/s²)/N (or 0.050 g/lb-F)

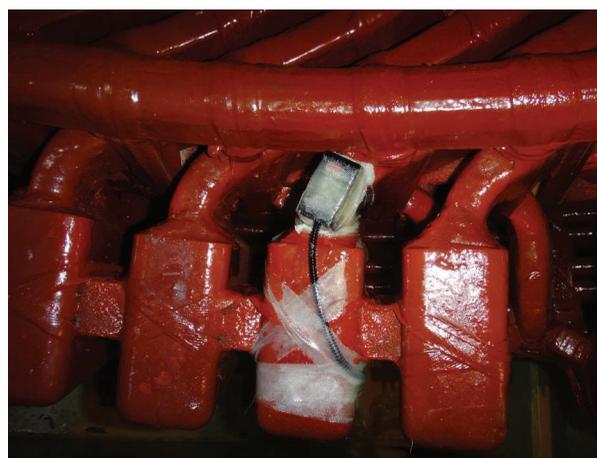
FIGURE 10. An example of a sensor installed on a winding near the end cap, which insulates the connection between two coils.

An effort was made to distribute the accelerometers sufficiently to maximize coverage for monitoring the generator stator end-winding vibration. Dual-axis sensors were installed to measure the radial and tangential directions at six locations on the connection end of the generator. Various components were selected to generalize the vibration behavior of the stator end winding, including two sensors' online end connections from the windings to the circuit rings, one on a jumper connection, one on a winding near the series

connection end cap (Figure 10), and two on the circuit rings. Additionally, a single-axis sensor was installed on the stator core as a reference. The instrumentation used to continuously monitor the end-winding maximum overall displacement vibration data online was commissioned to store the raw maximum overall displacement vibration levels once daily on all sensors for the data set.

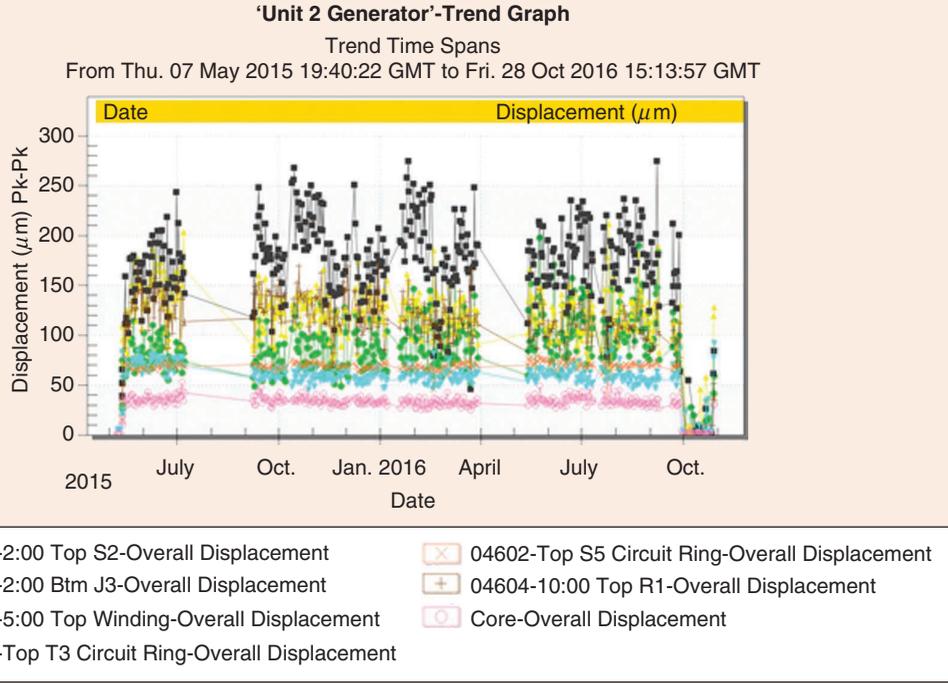
Vibration levels greater than 250 μm (or 10 mil) peak-to-peak (broadband) on the connection end led to a shut down in October 2016 (Figure 11). The predominant frequency was subsynchronous (below turning speed). This peak was present on all sensors at varying amplitudes, including the core. It is likely that the source was external to the end windings (Figure 12). Viewing the data as velocity demonstrated some higher frequency response unrelated to the 2F (Figure 13), which was totally suppressed when viewing the displacement spectra. It is likely that

FIGURE 11. The overall broadband (25–1,000 Hz) displacement trend before and after the October 2016 repair.

Wedge replacement on the connection end appears to have affected the end-winding vibration response. After the outage, the unfiltered vibration levels were reduced to 200 μm (or 8 mil) peak to peak for the remainder of the year (Figures 11 and 16). Tightening the coils in the slot seems to have limited the end-winding vibration response from the subsynchronous external source. The 100-Hz vibration remained unchanged.

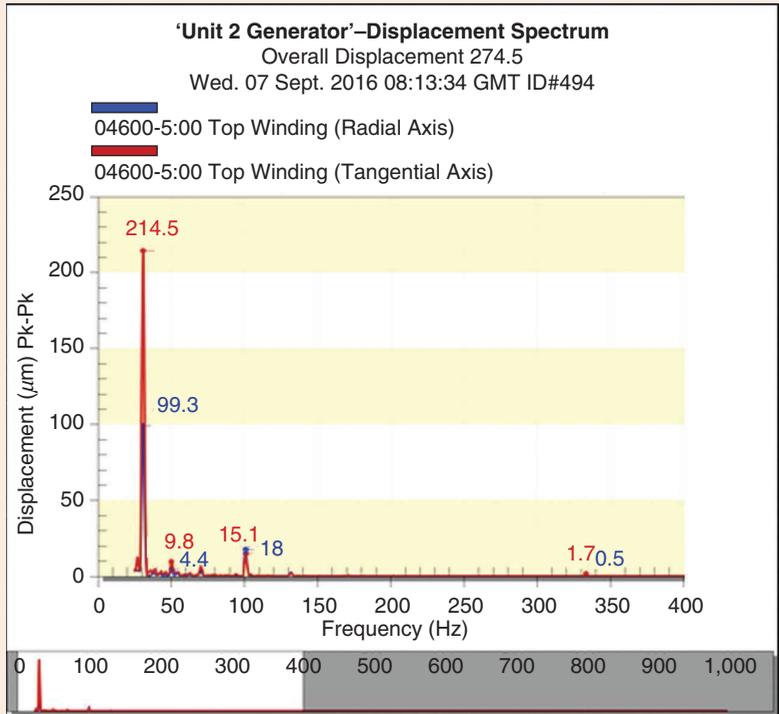
the 333-Hz vibration amplitude was being amplified by a natural frequency. The vibration amplitude from the electromagnetic force at 100 Hz was acceptable at fewer than 75 µm (or 3 mil) peak to peak (Figures 12 and 14).

FIGURE 12. Displacement spectra before repair.

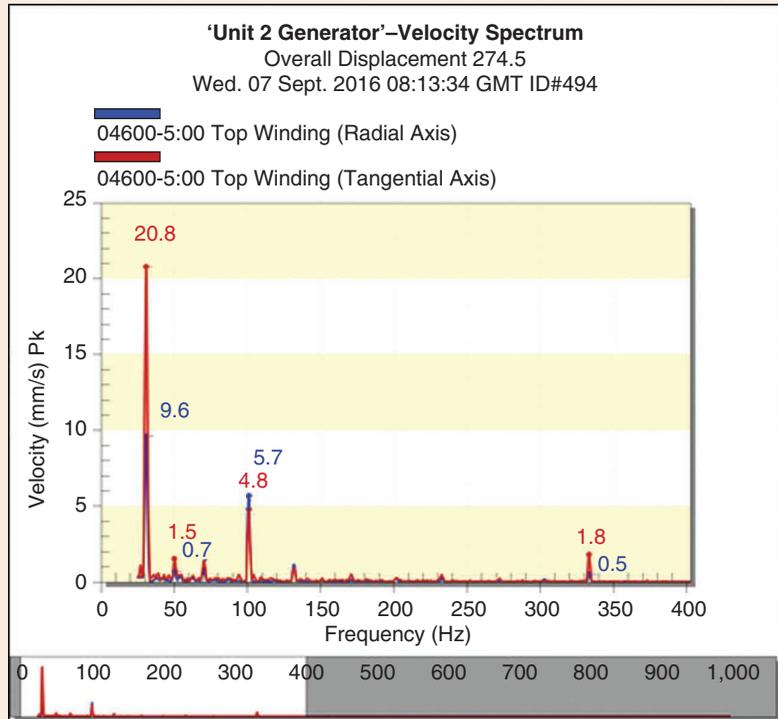
FIGURE 13. Velocity spectra before repair.

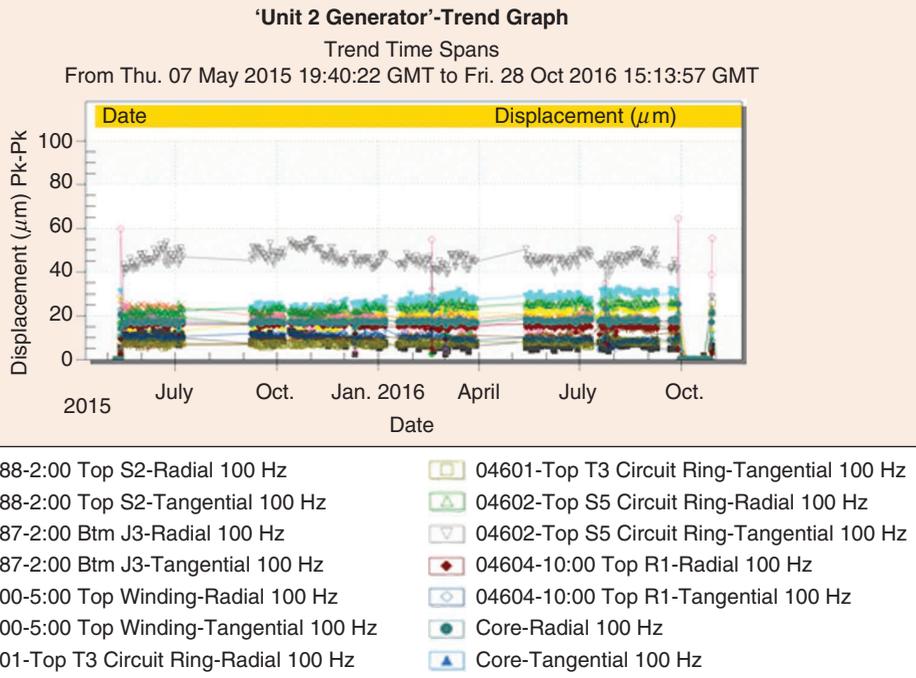
FIGURE 14. The 100-Hz displacement trend before and after repair.

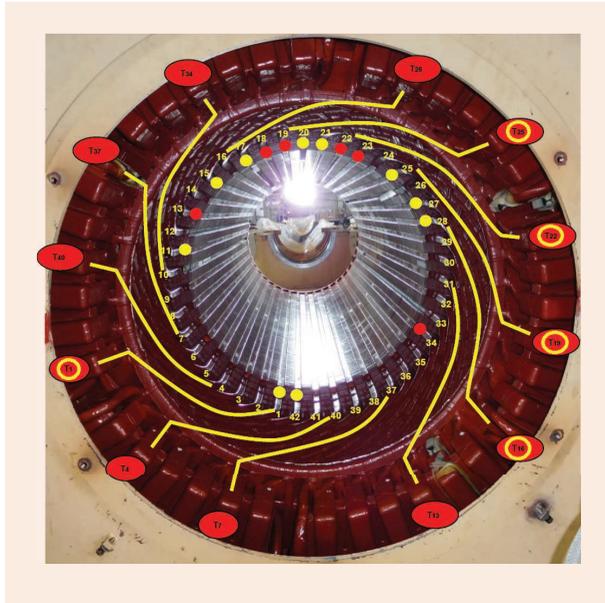
During the outage, a manual tap test of the stator slot wedges showed that many were loose and needed to be replaced. A bump test on the end windings was also performed, and there seemed to be some correlation between five of the loose wedges with end turns that had high responses in the bump test on the turbine end. The loose wedges numbered 1, 19, 22, 25, and 28 correspond with T1, T25, T22, T19, and T16 locations that experienced high bump test levels (Figure 15).

FIGURE 15. The unit 2 generator with wedges and bump test locations identified.

within 10 Hz. The results from the bump test also led to the decision to install additional sensors on the turbine end of the generator stator end winding. The stator slot wedges that were loose were also replaced.

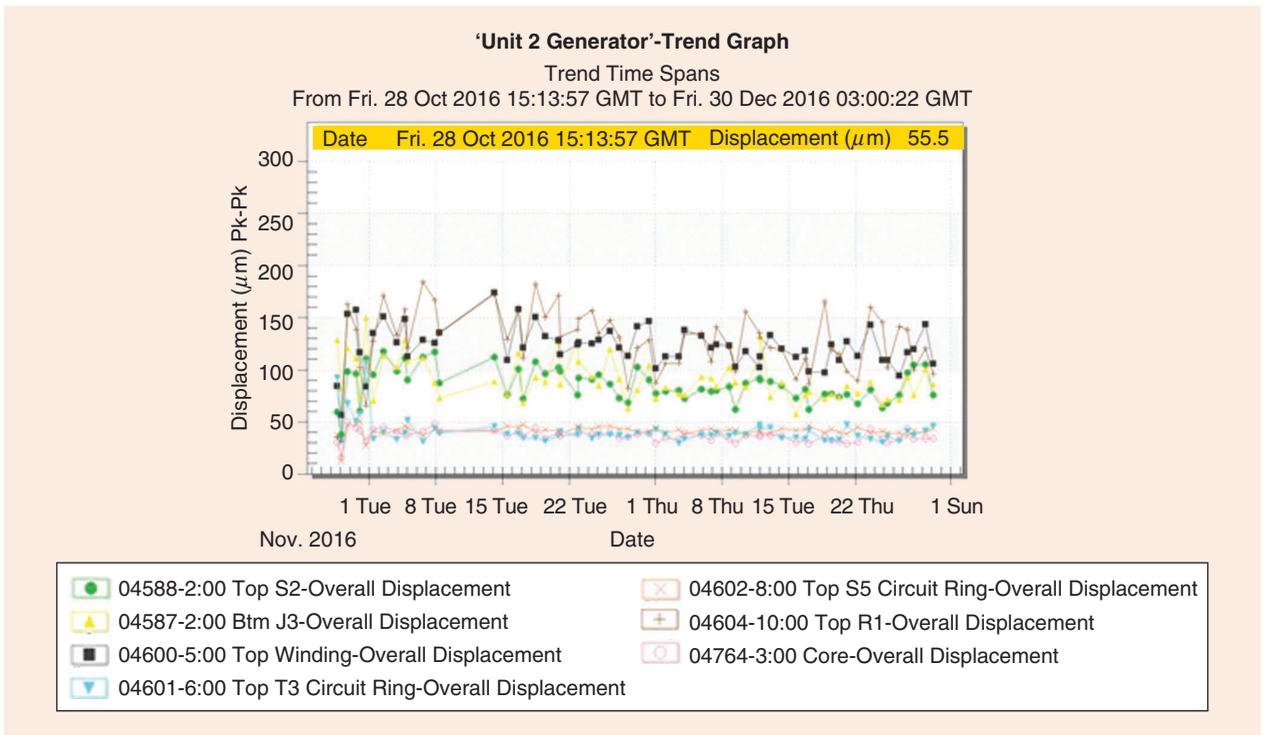
FIGURE 16. The overall broadband (25–1,000 Hz) displacement trend after repair.

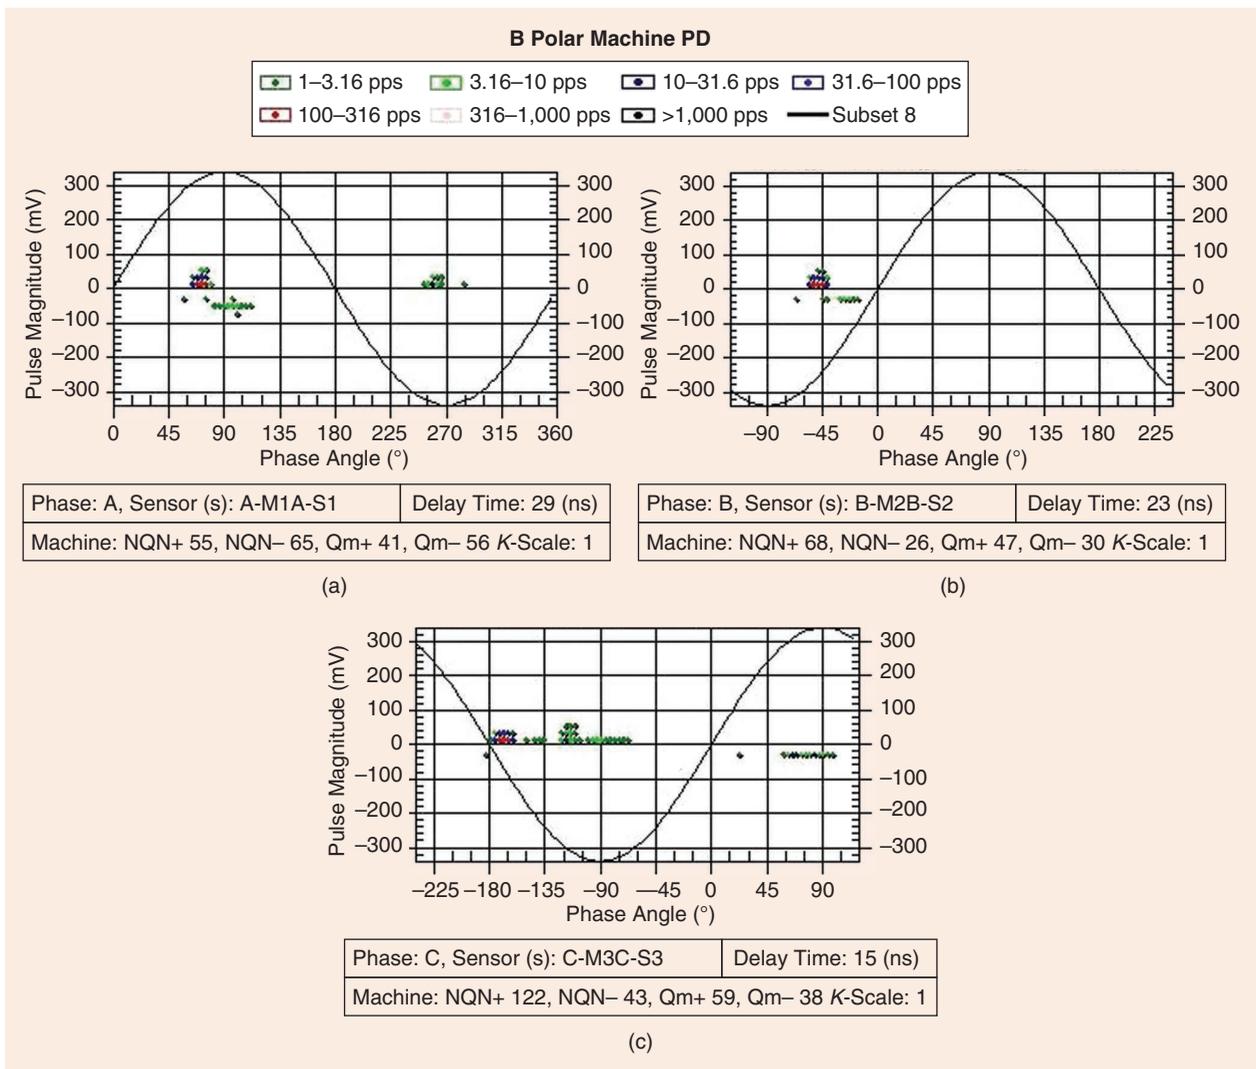
Partial discharge levels were recorded prior to the August 2016 outage. The maximum peak PD magnitude (Qm) value was 59 mV (Figure 17). For air-cooled stators equipped with 80-pF sensors on their terminals, these magnitudes are considered low when compared to

FIGURE 17. The machine PD at a sensitivity range of 20–340 mV. (a) Phase A; (b) phase B; (c) phase C.

other similar machines [15]. Even though the wedges were loose, the coils were not vibrating sufficiently to degrade the semiconductive surface coating.
