Virtual IRIS Rotation Machine Conference

Overview of Various Machine Online Condition Monitoring Techniques based on On-site Testing and Inspection

GE Power Conversion

June 23, 2021

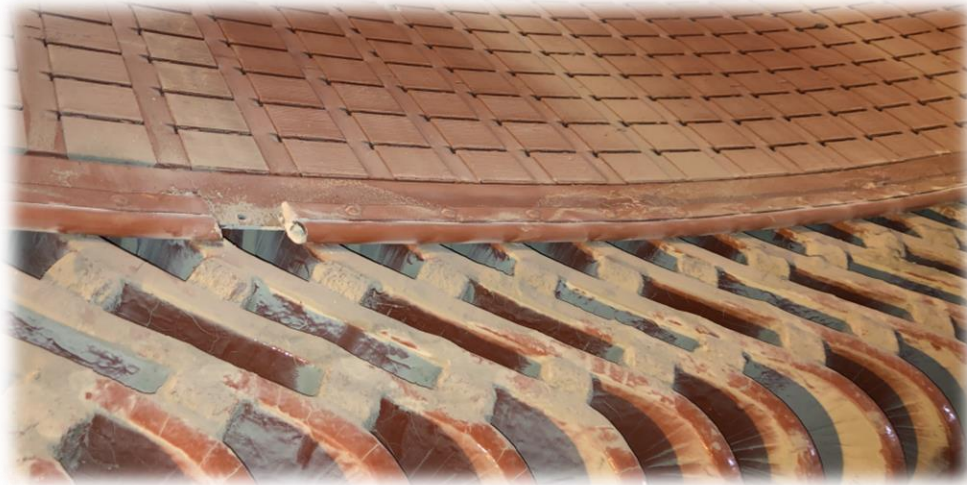
A. Thermal, B. Electrical

C. Ambient, D. Mechanical

- ***Thermal:*** *The operating temperature of motors can impose thermal stresses due to losses in the copper conductors and by generating heat.*
- ***Electrical:*** *During the service life PD can cause slow degradation and weakness in the insulation leading to failure, especially if an over-voltage or a lightning impulse occurs.*
- ***Ambient or Environmental:*** *Moisture or surface contamination if present in the environment can affect the rotor and stator insulation when combined with other stresses.*
- ***Mechanical:*** *In rotating machines, rotor insulation is exposed to high centrifugal force which can distort the insulation during service life.*

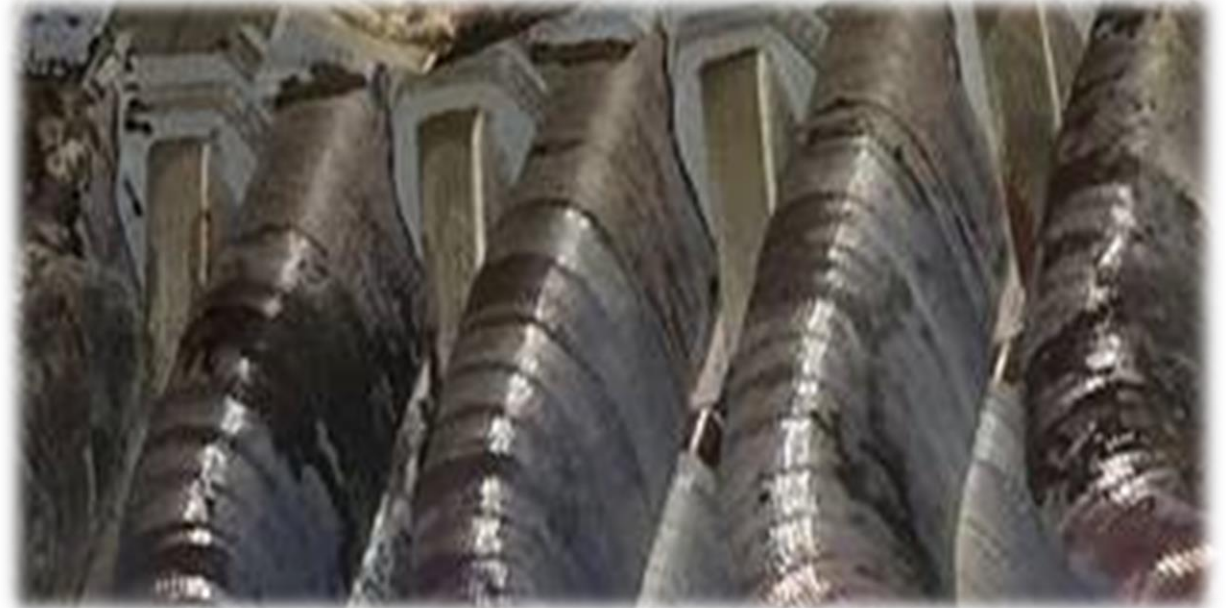
Case Study 1: RTDs Data Comparison

- ▶ Stator winding inspection of a generator rated at 28750 kVA/23000 kW revealed signs of insulation degradation mainly due to thermal aging.
 - ▶ It was established that the overheating was likely due to insufficient circulation of cooling air inside the machine.
 - ▶ Inspection of the generator enclosure revealed that the cooling air may have been restricted through the cooler air passages due to contamination.
 - ▶ Clogged pipes in the water cooler further increased the temperature of the cooling air entering the stator which increased the temperature of the stator winding.
- *The comparison of the operational data received from 2007 and 2014 indicated that the stator RTDs temperature had increased up to 18°C when the machine ran at full load.*

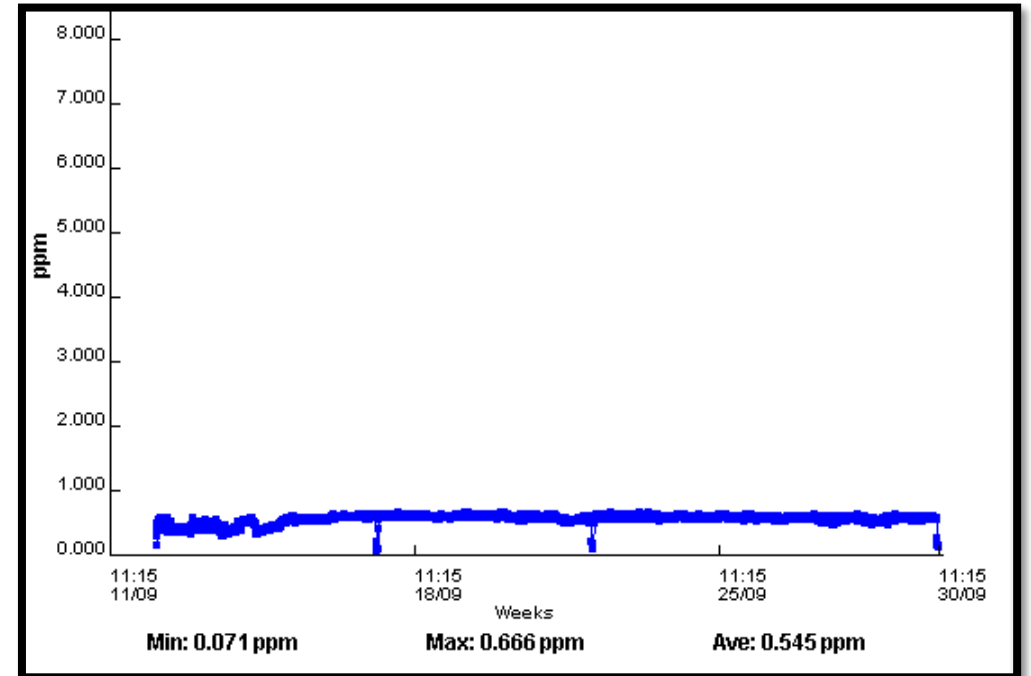
Case Study 3: Ozone Monitoring

- ▶ Ozone monitoring and trending was performed on four 13800 V synchronous machines that were installed at the same location within one building.
 - ▶ Ozone monitoring performed at the customer site revealed levels around 0.2 ppm, with time weight average (TWA) values around 0.06-0.07 ppm. Overall, highest levels of ozone found near vicinity of machines were 0.6-0.7 ppm.
 - ▶ As a preventative action, it was recommended to improve ventilation where the machines are installed to better remove ozone from the environment and bring it to a safe level.
- *A better and continuous use of ventilation showed significant improvements in bringing ozone levels to acceptable limits.*

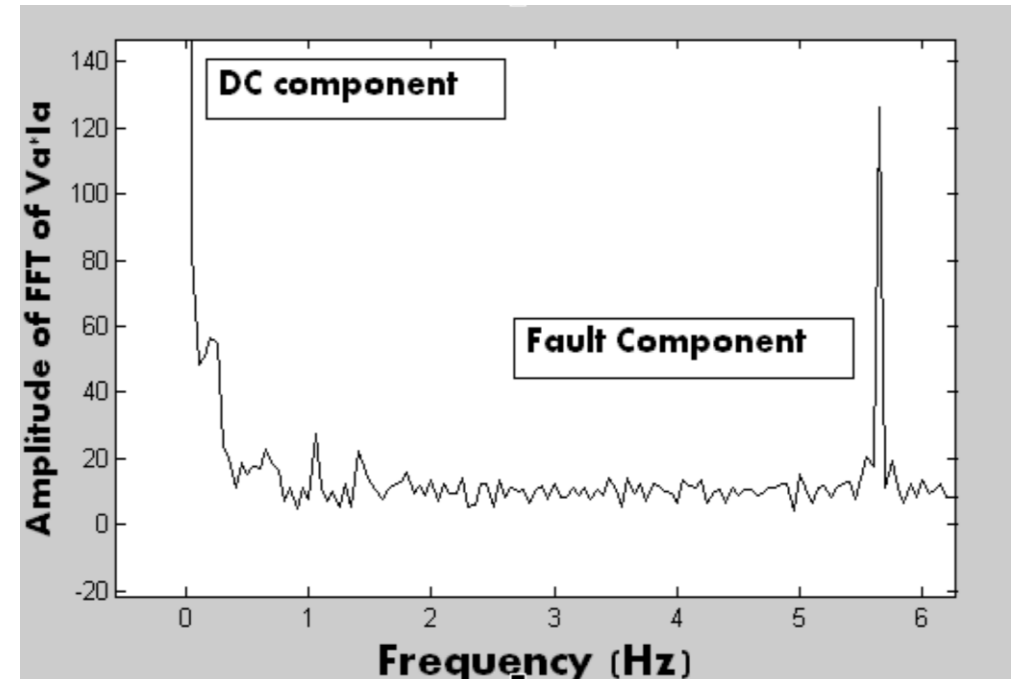
Case Study 5: Broken Rotor Bar Detection

- ▶ A defect in an induction motor rotor bar causes the modulation of the stator current.
 - ▶ The impact of broken rotor bars to the stator current can be determined by analyzing in the frequency domain to detect rotor bar failures and the approach is typically called a Motor Current Signature Analysis (MCSA).
 - ▶ Advanced protection relays are now available to provide FFT analysis in order to detect failure of the rotor bars.
 - ▶ The combination of a voltage and current signature provides a more accurate detection compared to the typical current based algorithm.
- *Fault component as shown in figure was successfully captured suggesting broken rotor bar detection which was later confirmed during visual inspection.*
