Preventing Failures in Isolated Phase Bus

**2021 Virtual IRMC
June 22, 23, 24, 2021**

James E Timperley

J E Timperley Consulting.LLC

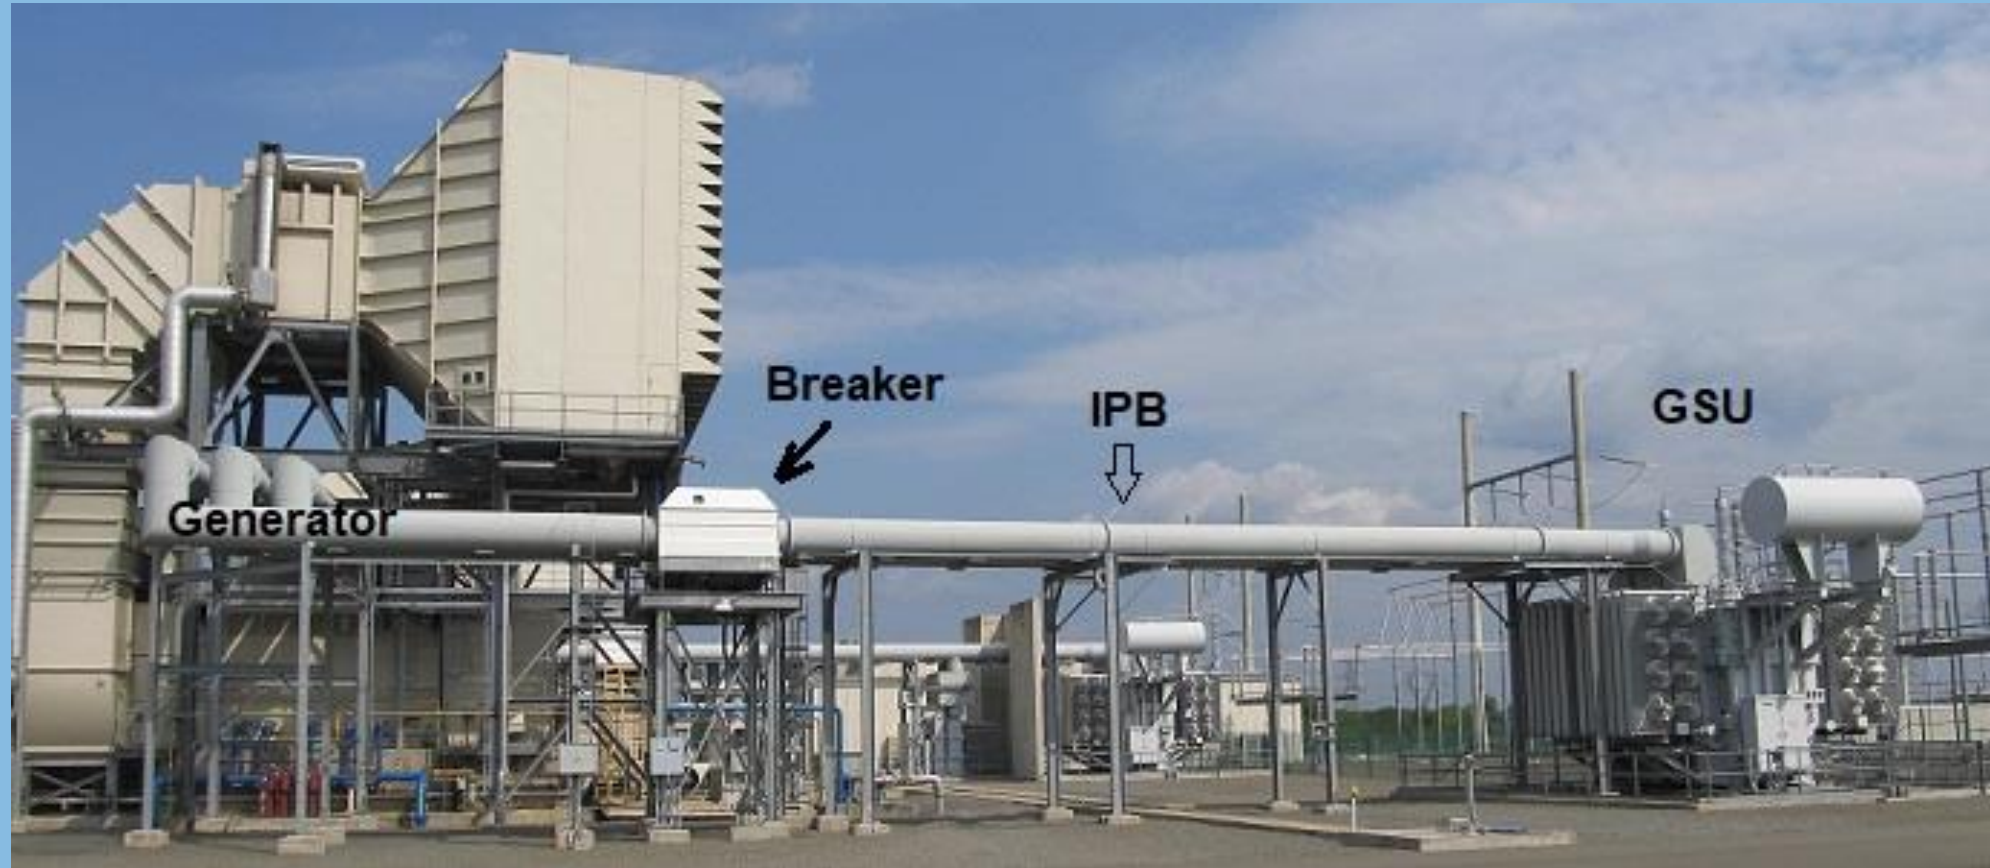
Typical modern isolated phase bus connecting a generator to the system. Perhaps 1000 like this have been installed.

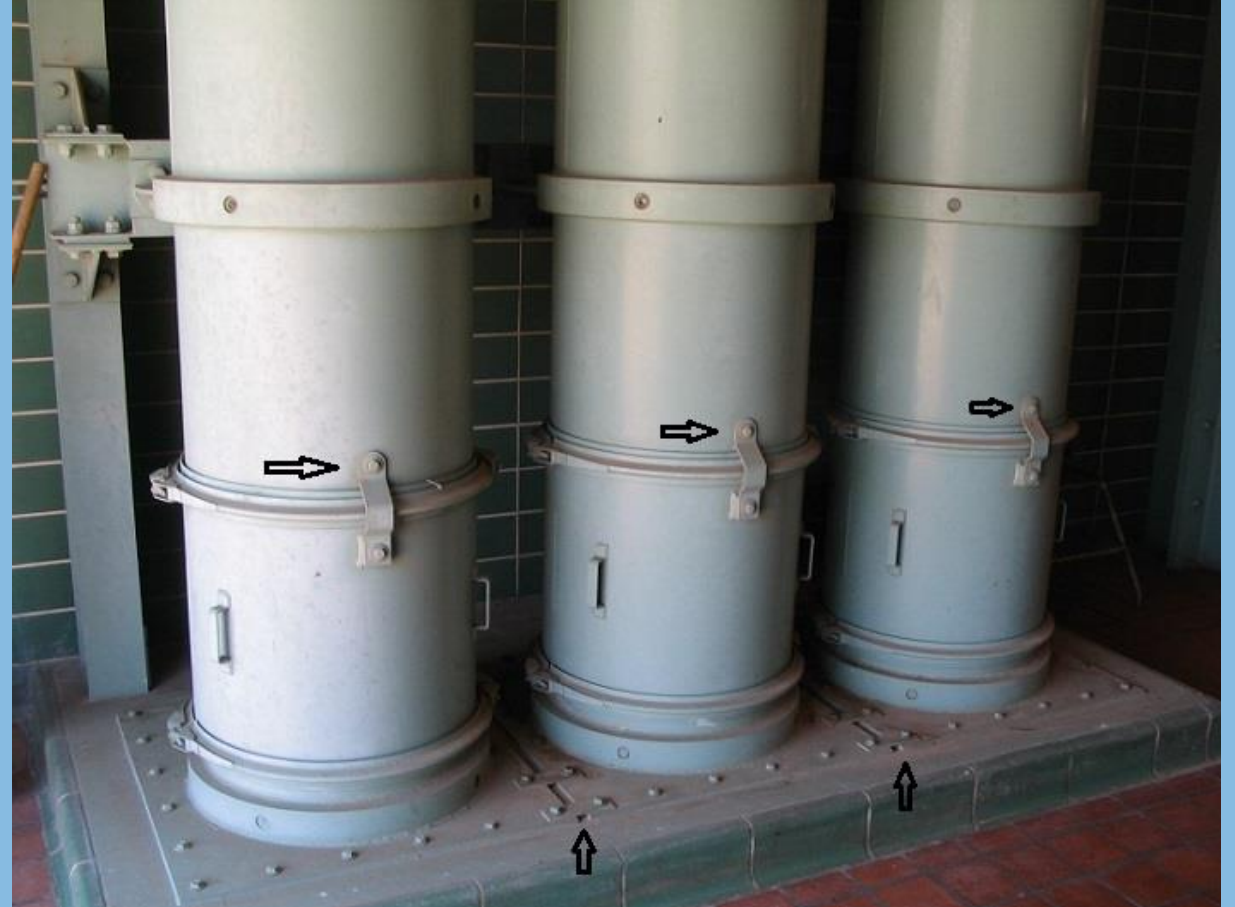
The non-continuous bus enclosures are insulated from each other and then grounded at one location.

A large strap bonding adjacent enclosures is a feature of this design.

Note the straps connecting penetrations at the floor.

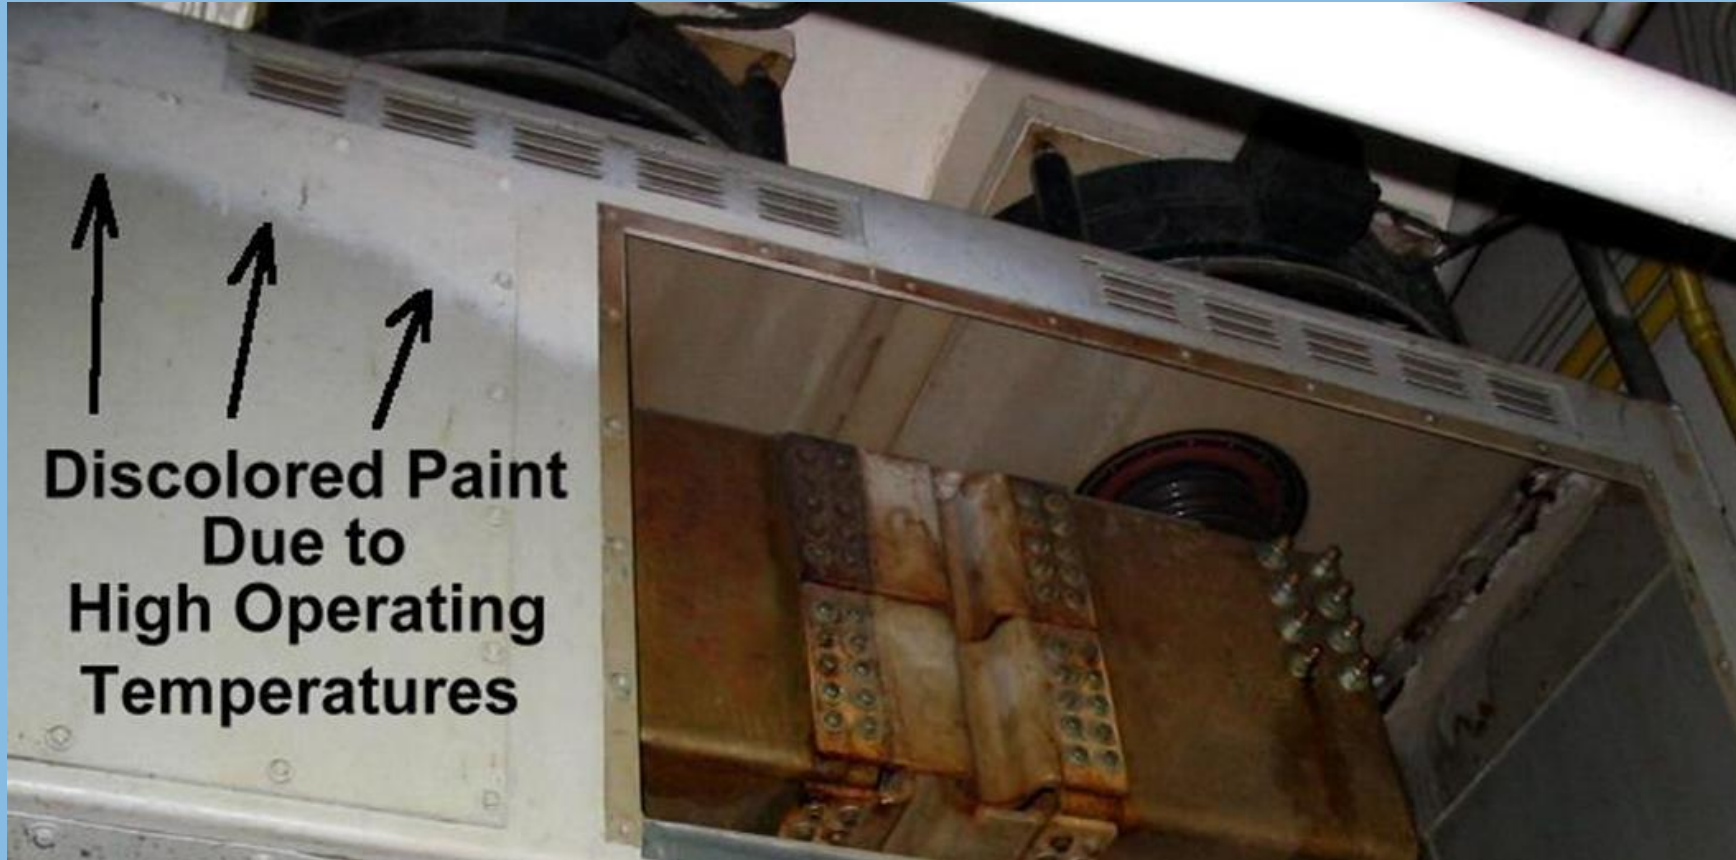
There may be deficiencies in the original design. Below is a 30,000 amp neutral bus that needed more cooling. Note the severe paint oxidation. This extra heat will severely age the generator bushing current transformers.

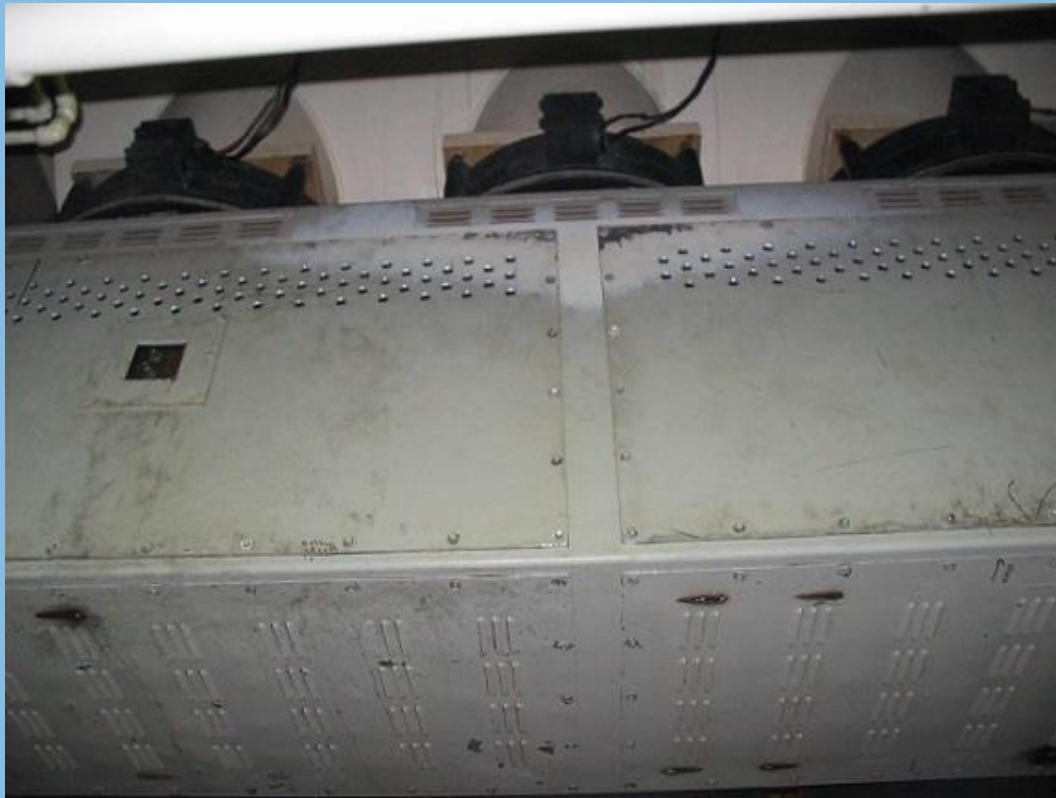
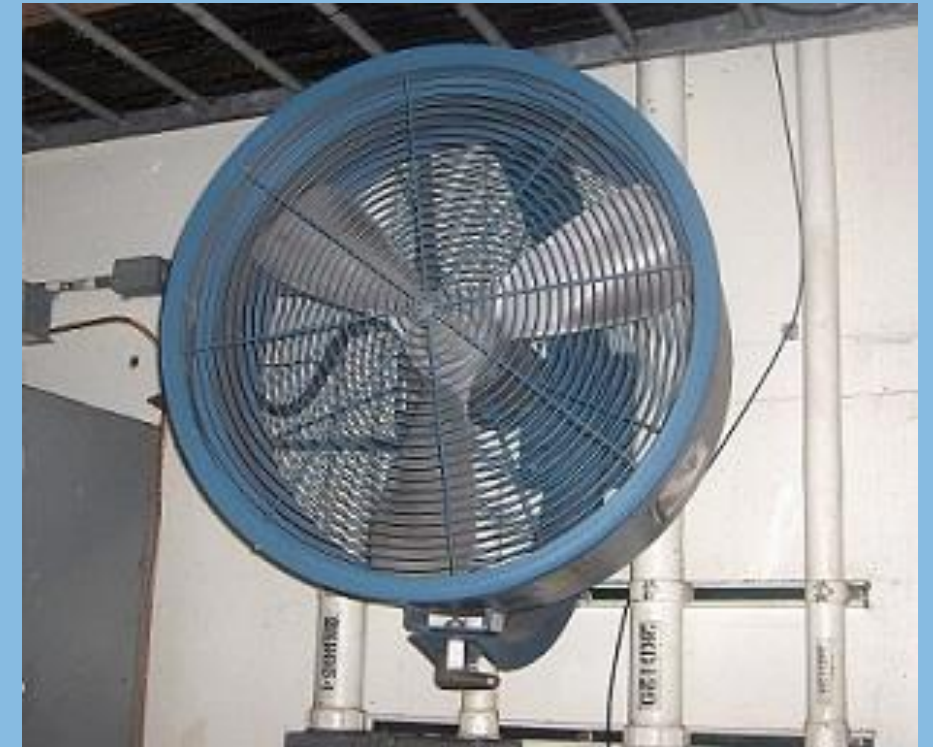
The solution was to add new top ventilation holes. At some locations a fan to move air was found necessary. Free air movement under the generator is often restricted. A small increase in air movement can greatly reduce temperatures.

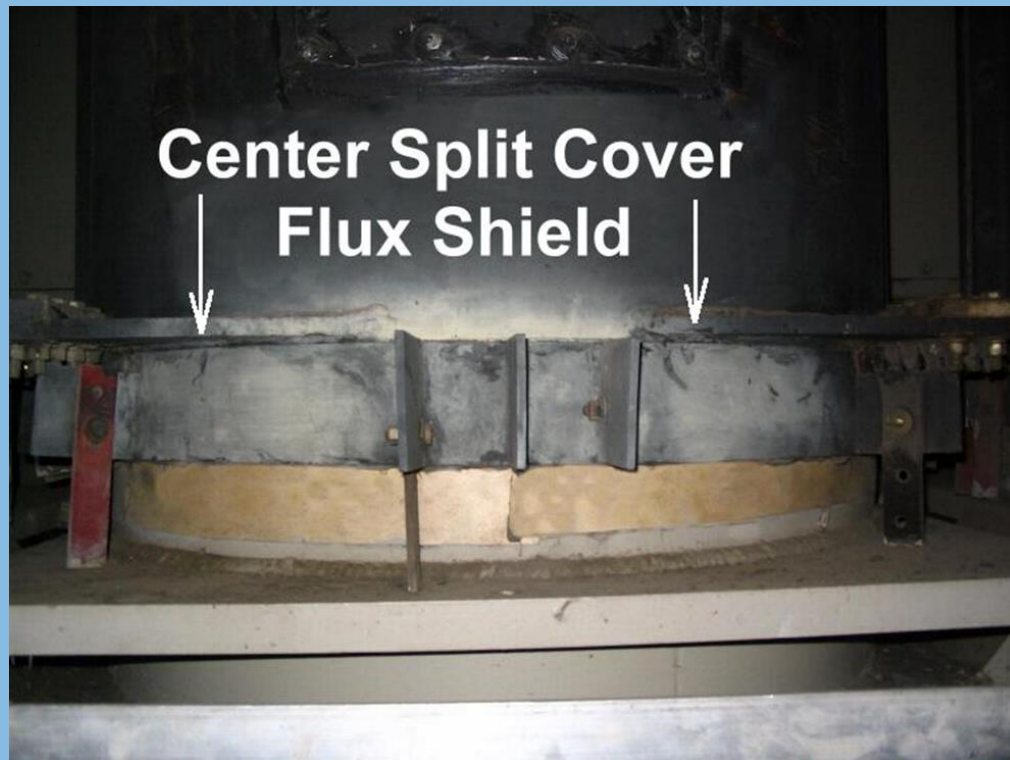
The center enclosure develops 50% of the total bus loss. Forced cooling is often required. Sometimes a flux shield is required.

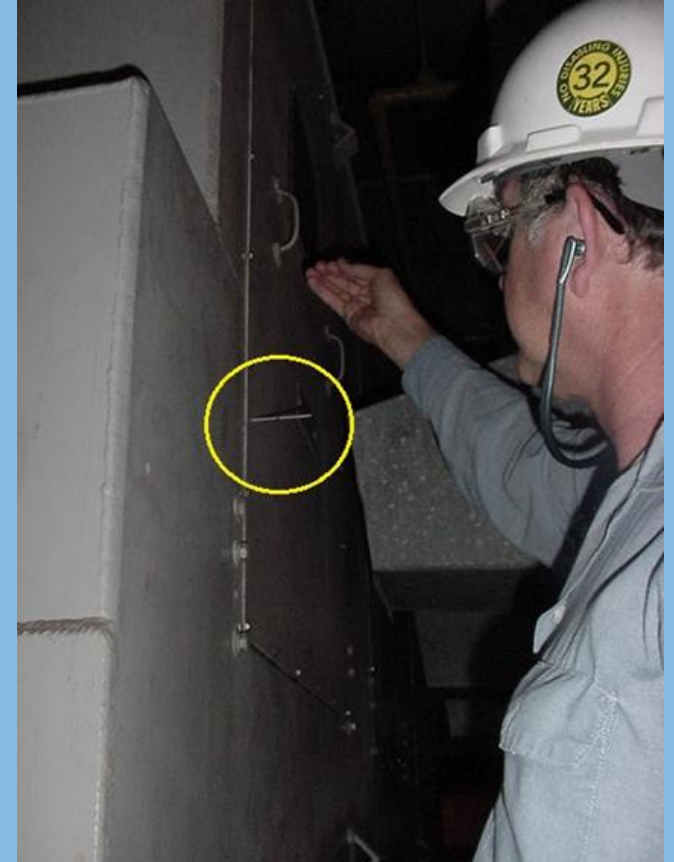
Measuring the flux direction will determine the source of heating and point to a solution.

At this neutral cabinet, flux is perpendicular to the metal. A flux shield is needed, thicker metal, or improved cooling.

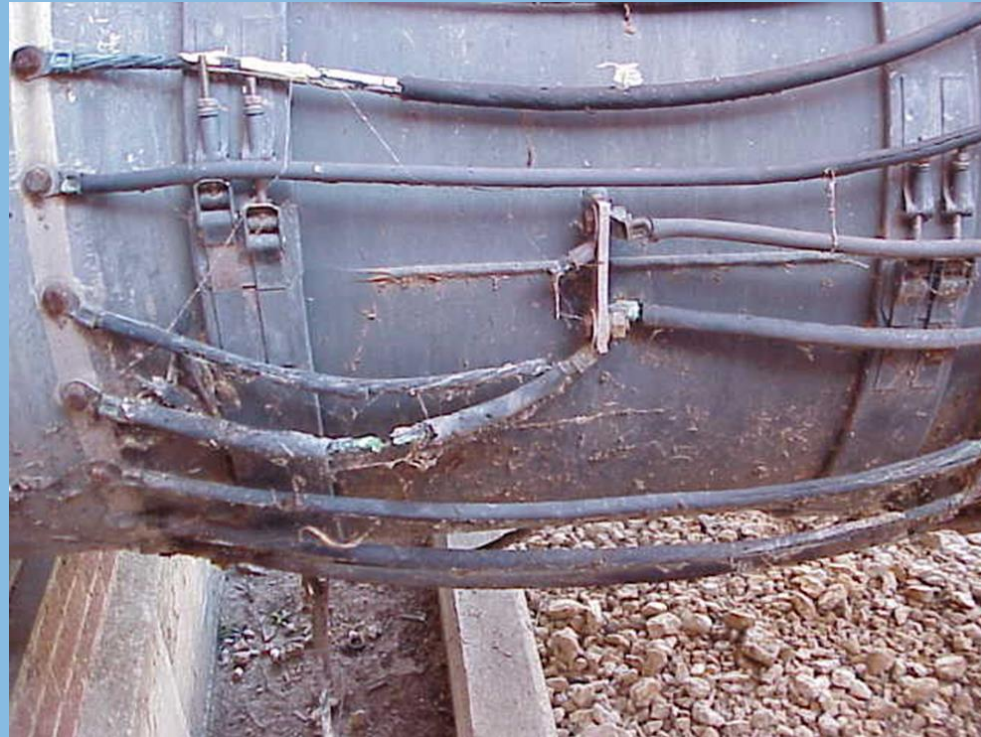
A visual inspection is critical for continued failure free operation. Infrared, (IR), confirmed one jumper was carrying most of the enclosure current, the cold ones were floating. To solve the problem on the right a new jumper design was developed. Note the ones working had melted.

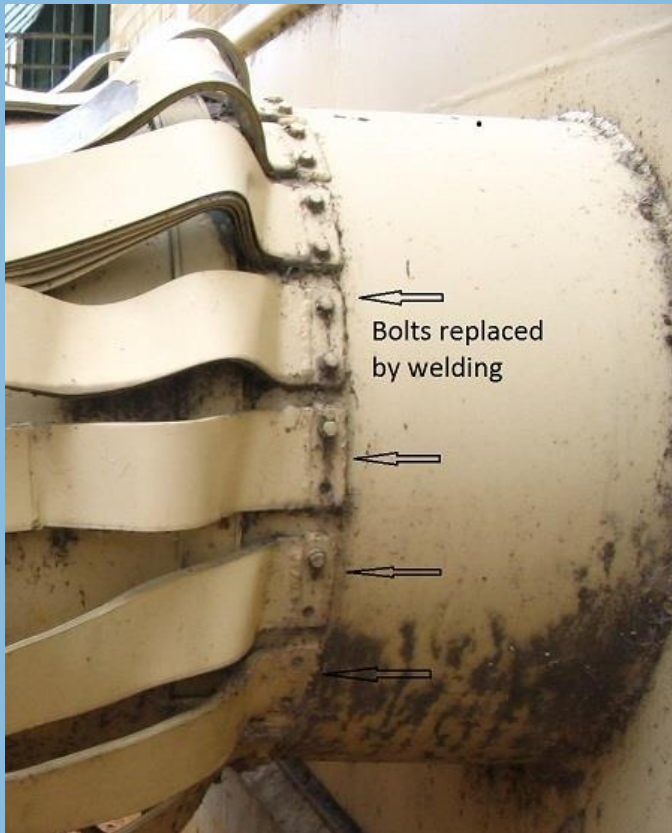
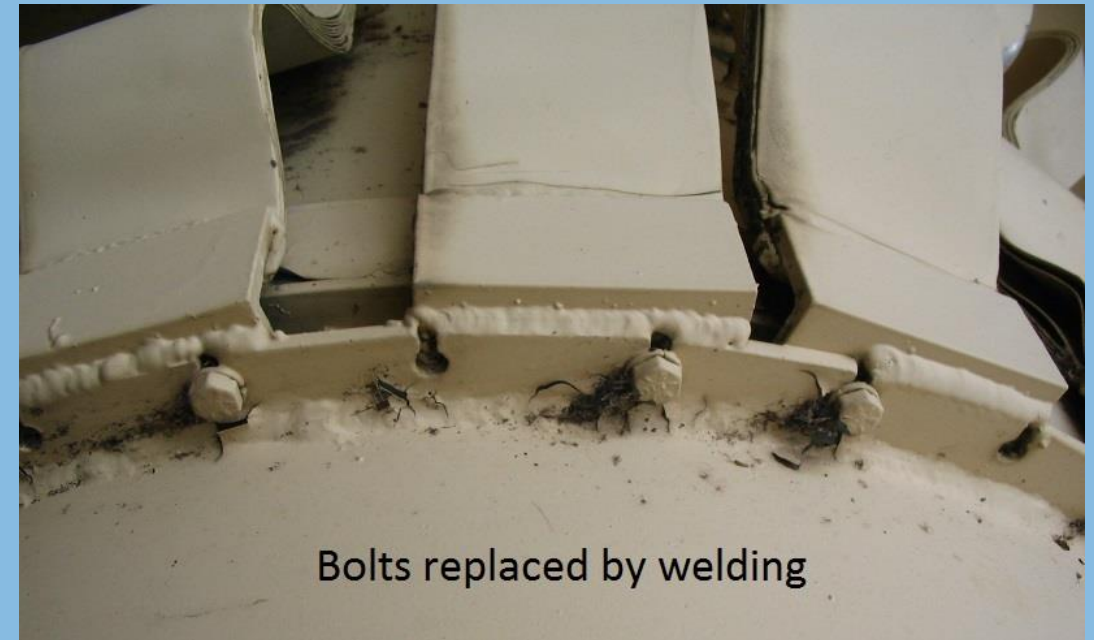
Some enclosure designs are difficult to maintain. Here the owner had to weld the enclosure shunts. The bolted surfaces were inadequate for both. Proper bolting will be discussed later. It is amazing how few understand how to design a bolted joint.

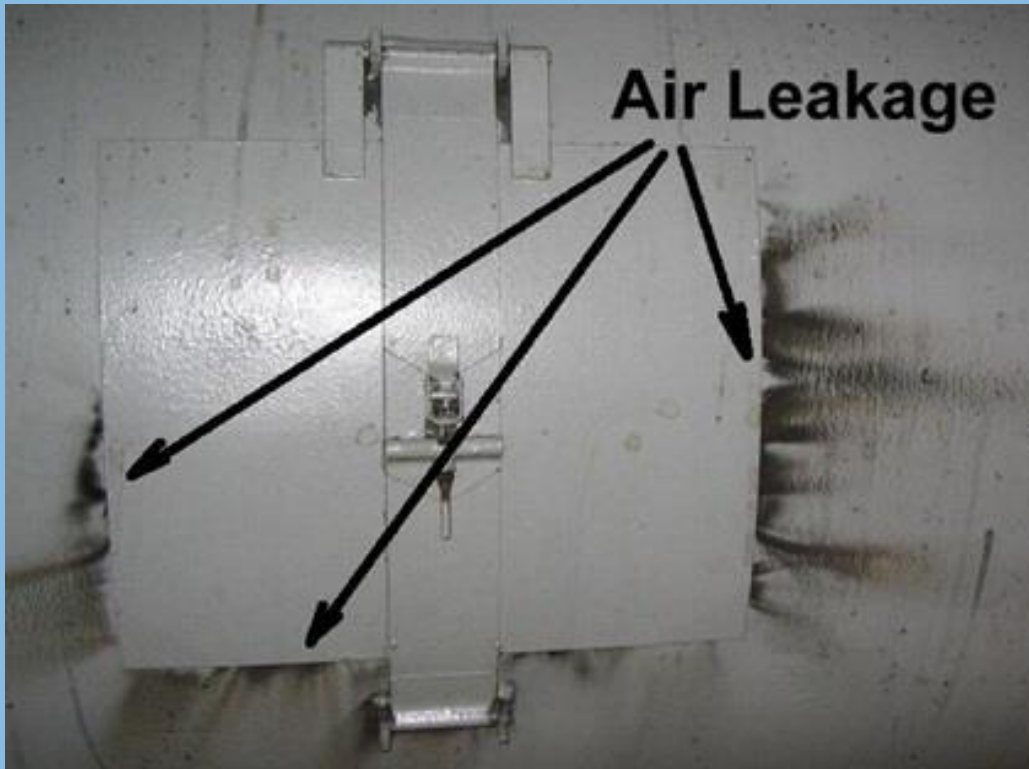
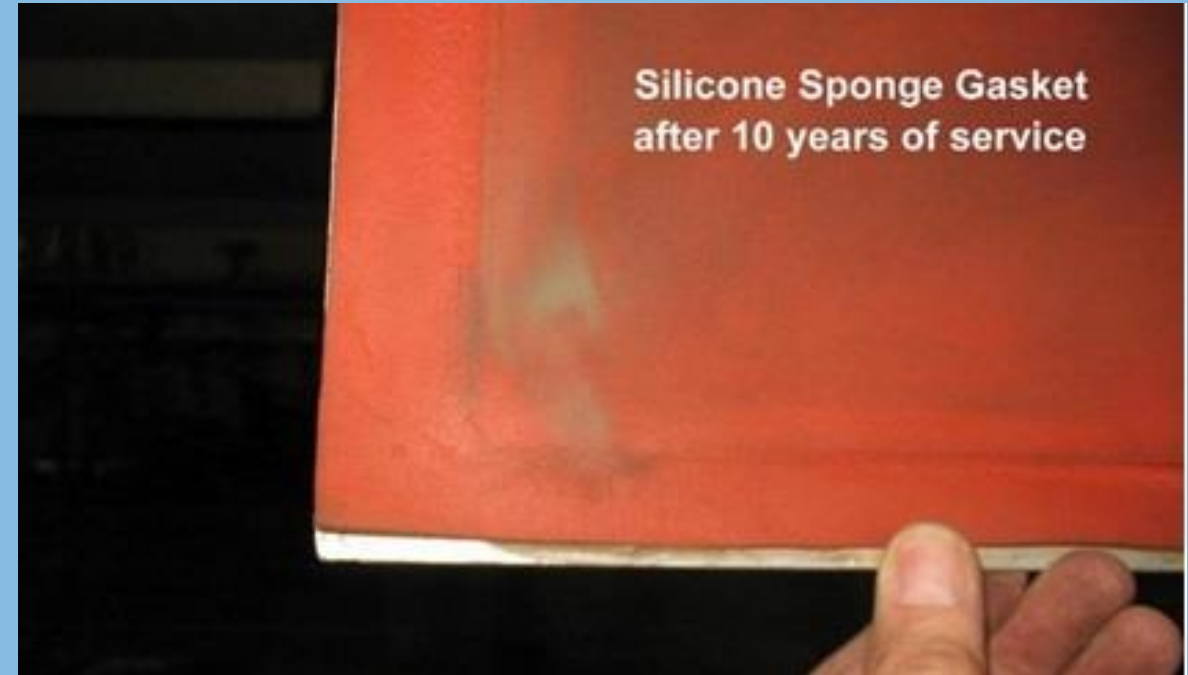
Enclosure gaskets will harden and leak air or allow water to enter. The materials available to designers 30 years ago were limited. Replacement with new materials is necessary. Closed cell silicone rubber sponge is a lifetime replacement material.

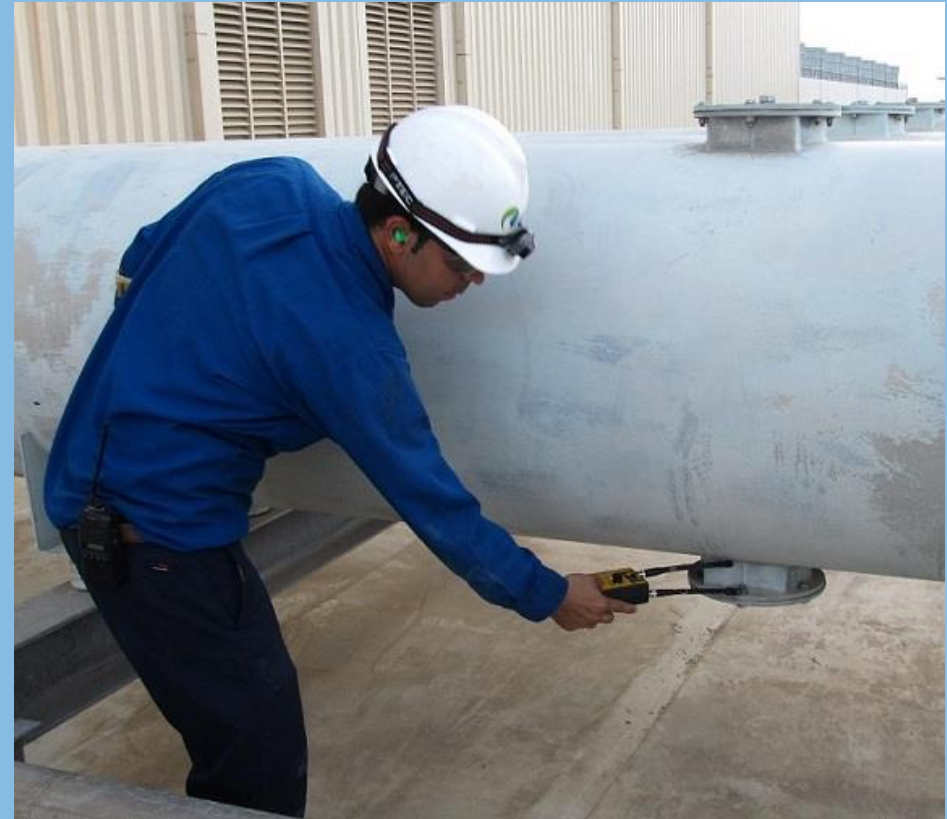
Detecting problems inside the enclosures is difficult. Infrared has very limited application in detecting center conductor problems. Partial Discharges, (PD) and electromagnetic (EMSA), techniques do have the ability to detect internal problems with both the insulators and the center conductor. Here a bus is scanned for radiated EMI.

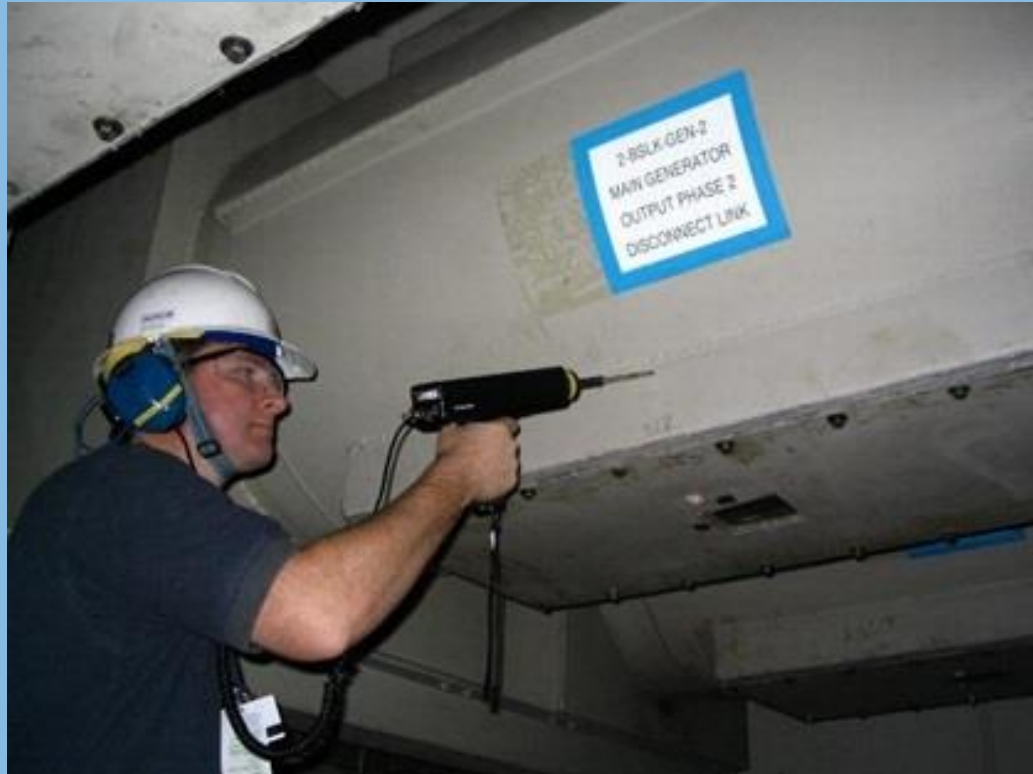
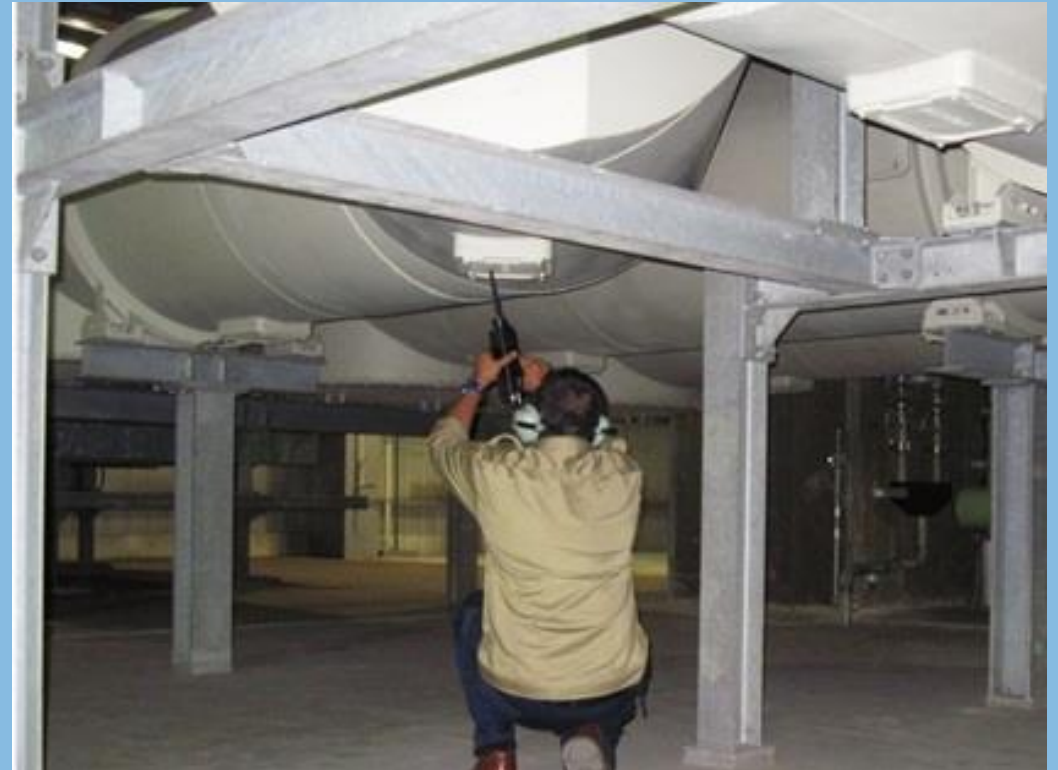
Ultrasound can be used but internal reflections and attenuation with distance, from the source, can be serious limitations.

Visual inspection remains the best method.

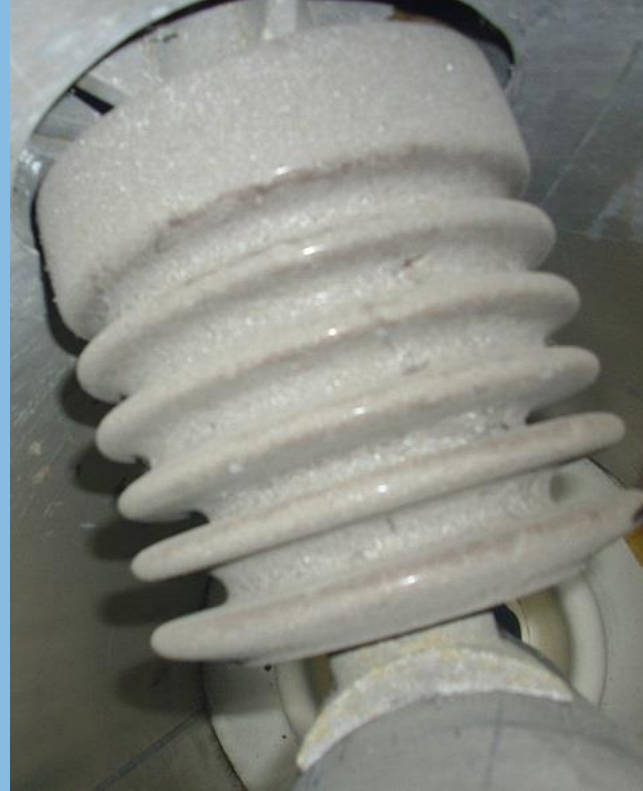
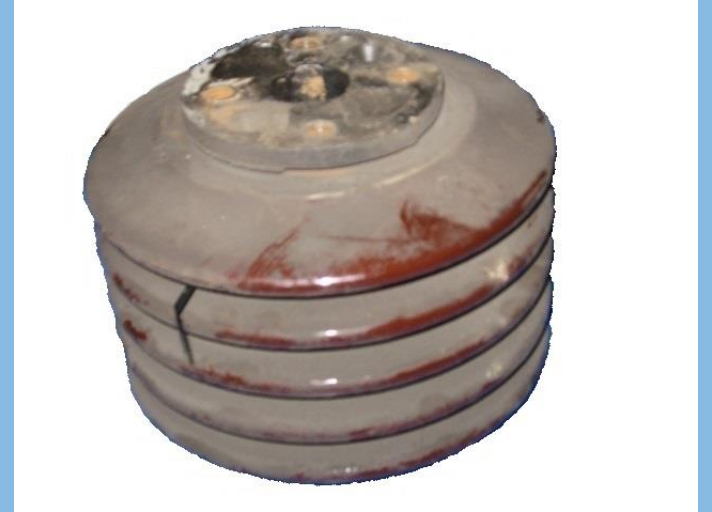
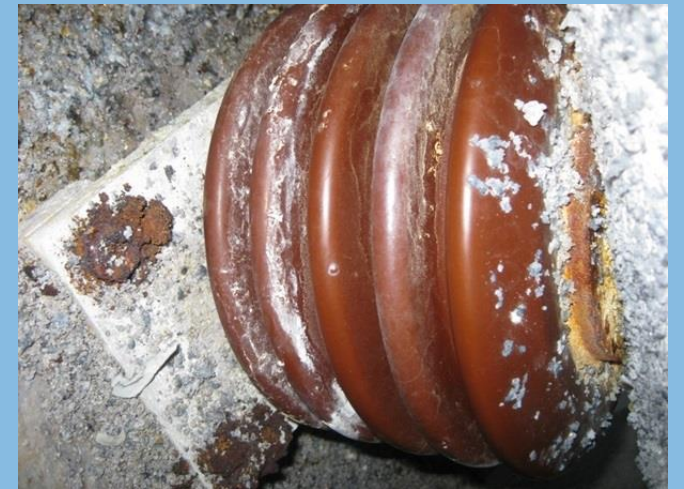
Insulators do collect dirt over time. Cleaning is necessary to prevent flashover. Many insulators are difficult to reach making this a multi-outage or continuous project. Some designs make removal for cleaning simple, others do not. Failure is more common when moisture is present and/or the dirty surface.

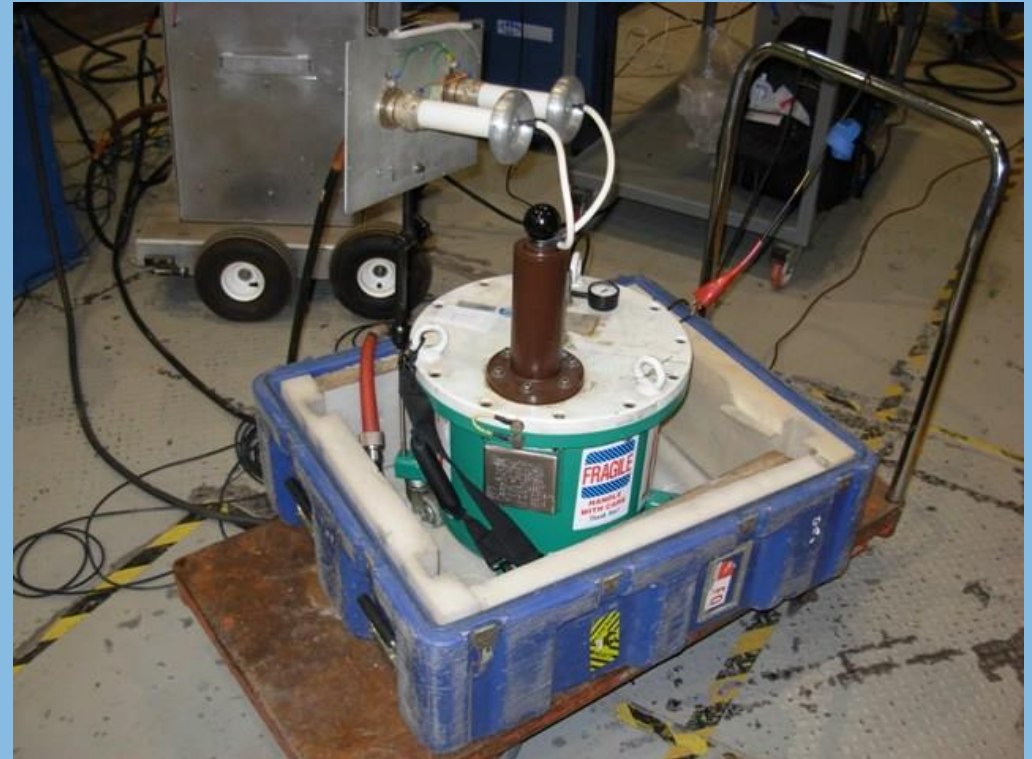
An insulation resistance test @ 5,000 or 10,000 volts DC will detect wet or contaminated insulators.

A minimum of 1 meg ohm/ kV can be used. Much higher can be expected on short, dry bus. A DC or AC over-potential test is the only suitable test to confirm continued insulation operation. Values

should be higher than rated operating voltage. Most prefer the DC test due to the smaller test equipment size. A variety of values are used (75%) of the 100% test of twice rated voltage + 1000 volts, AC.

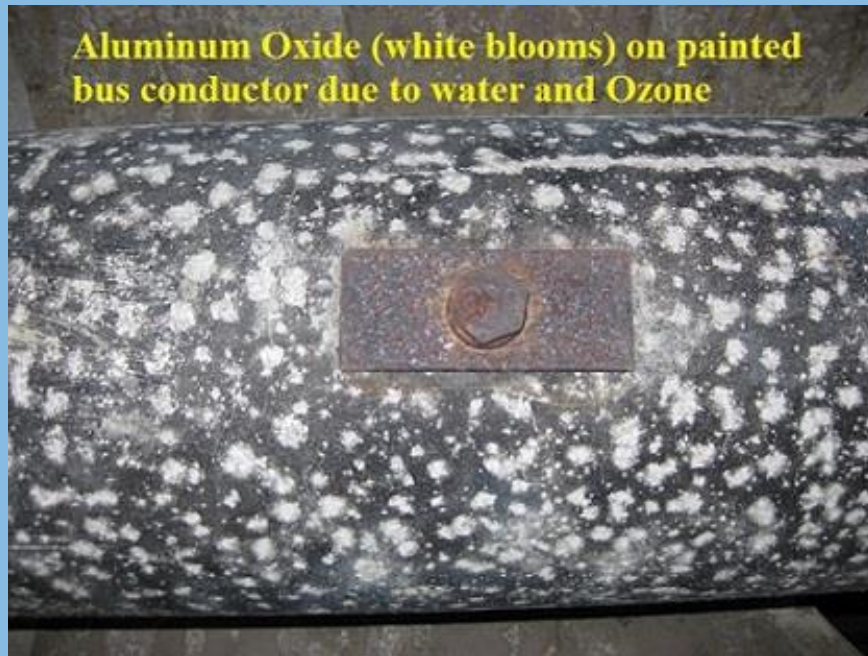
I define a “sealed system” as one that water enters but can not escape. IPB must be kept dry. Ozone and moisture form nitric acid which attacks all metal. Some systems are sealed and have a slight positive pressure of dry air. If maintained this works fine.

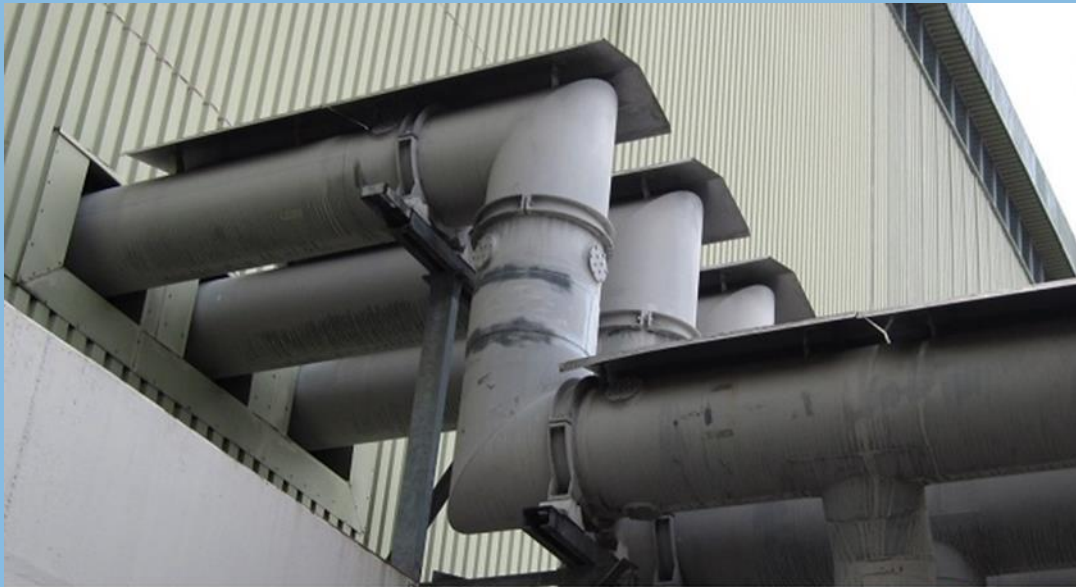
In very wet environments a roof over the bus or various components has been necessary to keep out rain. This also lowers operating temperatures by blocking direct solar heating. The examples below are from Malaysia, left and Texas, right.

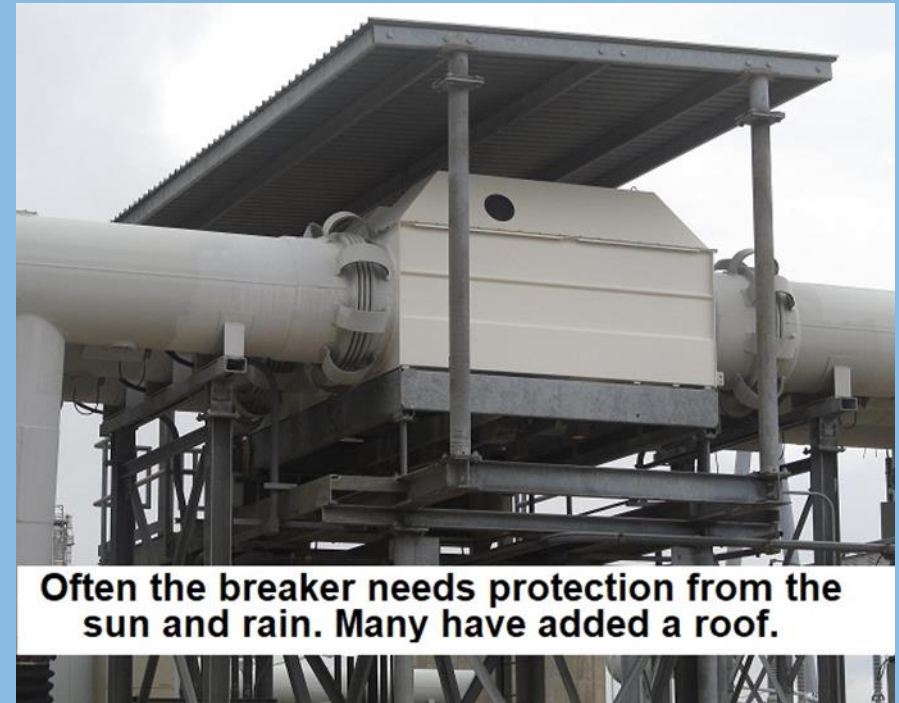
Here the main bus is fitted with a roof for weather protection.

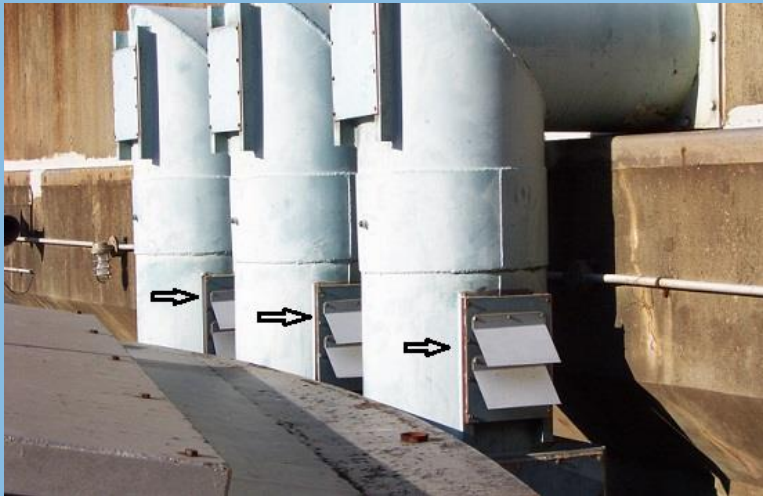
Bus vent for protected location

Non forced cooled IPB must have vents to reduce accumulation of fog and free standing water. Simple to install, and very effective in clearing moisture. Most bus have only water drains which will plug. The examples below are in Virginia and Malaysia. A screen to keep out birds and insects is mandatory.

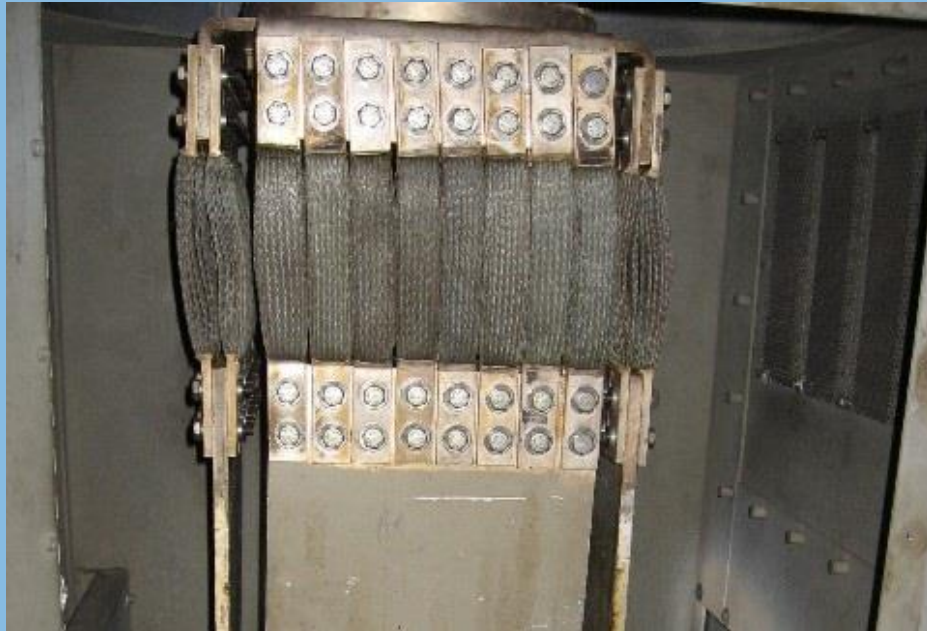
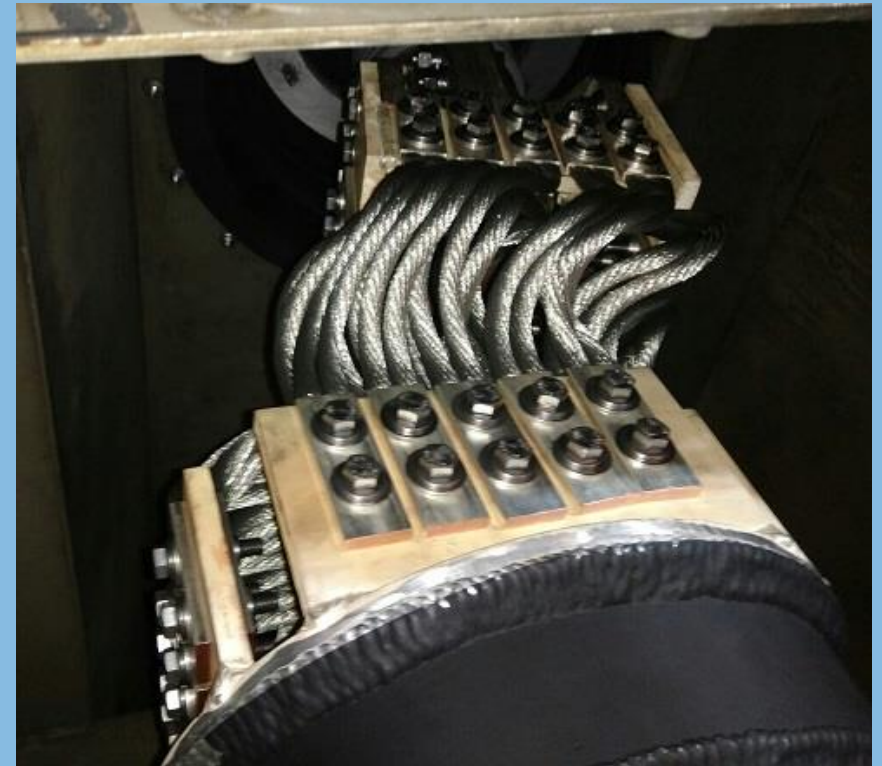
Thin metal shunts should be replaced with copper braids or ropes when possible. They are more resistant to vibration and flexing damage.

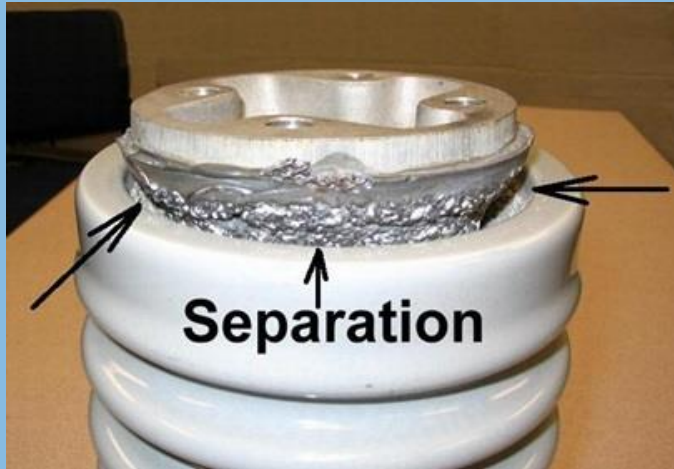
Broken and cracked insulators generate high levels of PD that is easily detected.

Several designs are prone to this deterioration. Try a different design.

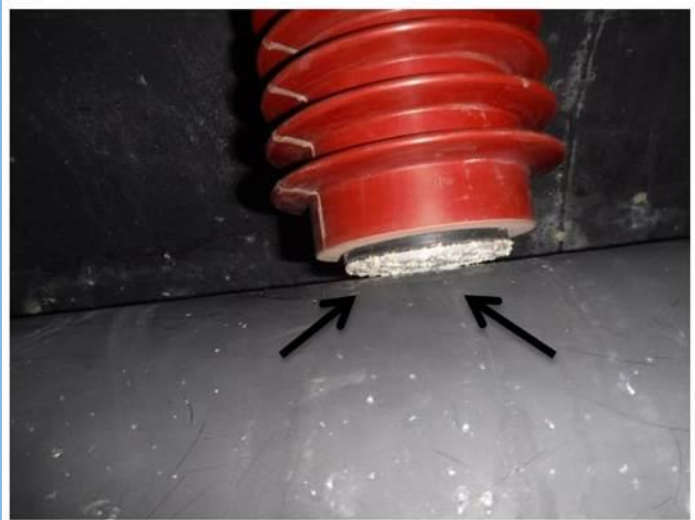
Insulators that are not in good contact with the center conductor generate high levels of PD. Many designs are prone to this condition. High PD results in high ozone levels.

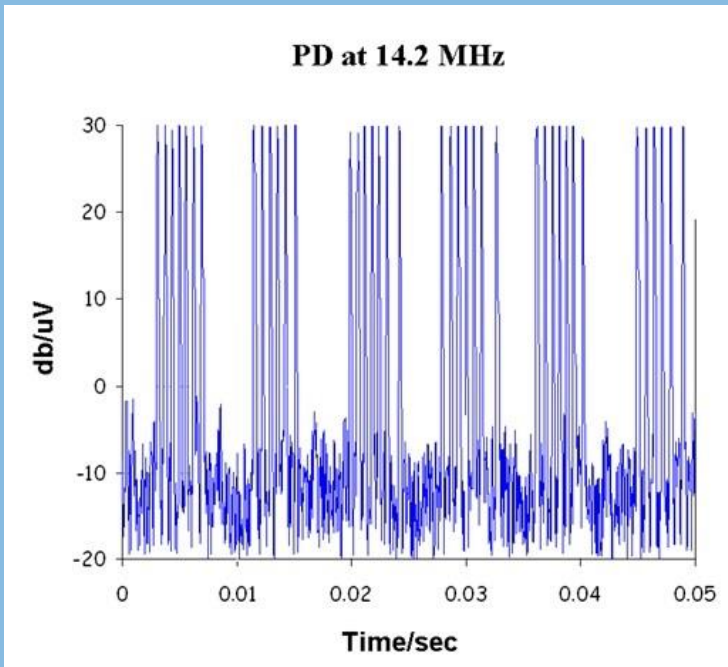
Insulator bolts can vibrate loose. Here is an example of the frequency domain EMI signature for this condition, the time domain PD pattern and the condition found.

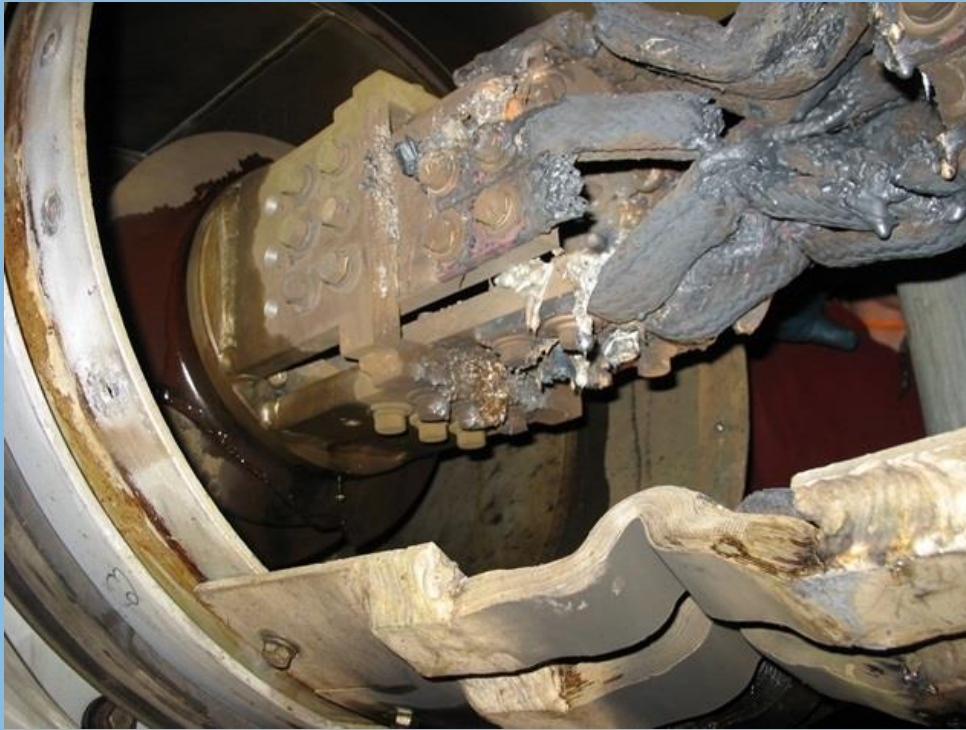
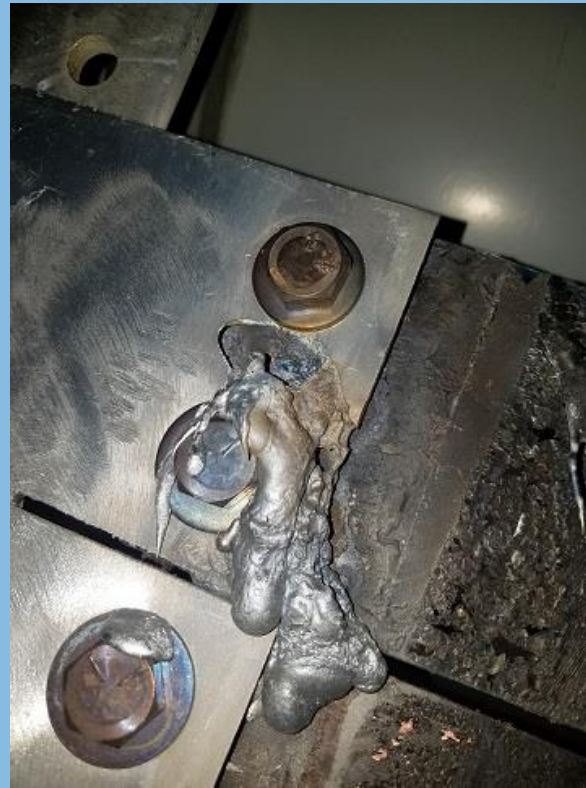
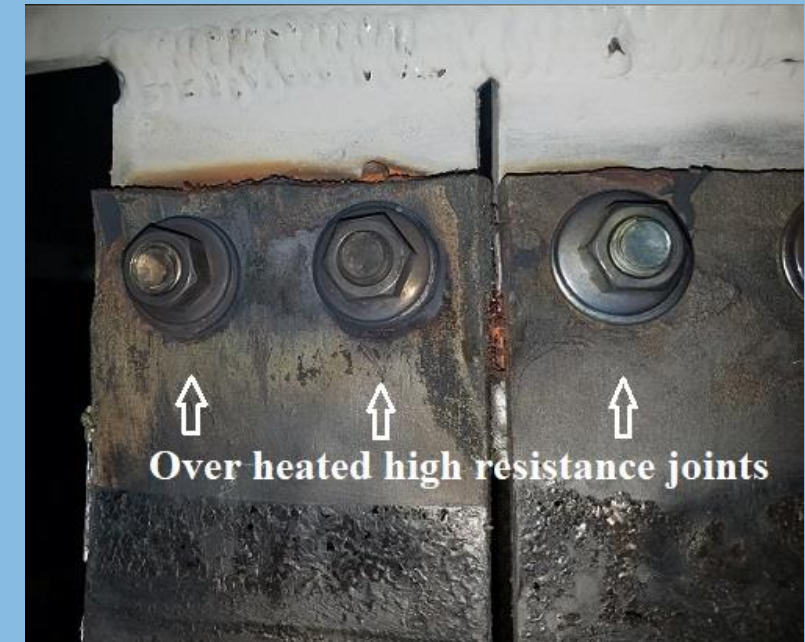
Lack of proper center conductor bolting is the #1 reason for bus failures. There is no excuse for not torqueing bolts correctly. There must be a written procedure to follow.

The procedure for torqueing should include torque specifications for the bolts and washers used, visual inspection of hardware, replacing Belleville washers after each use, second checking of these torques and hardware makeup by independent person (not on the job site when the first crew was doing their checks/torques).
