Preventing Failures in Isolated Phase Bus

**2021 Virtual IRMC
June 22, 23, 24, 2021**

James E Timperley

J E Timperley Consulting.LLC

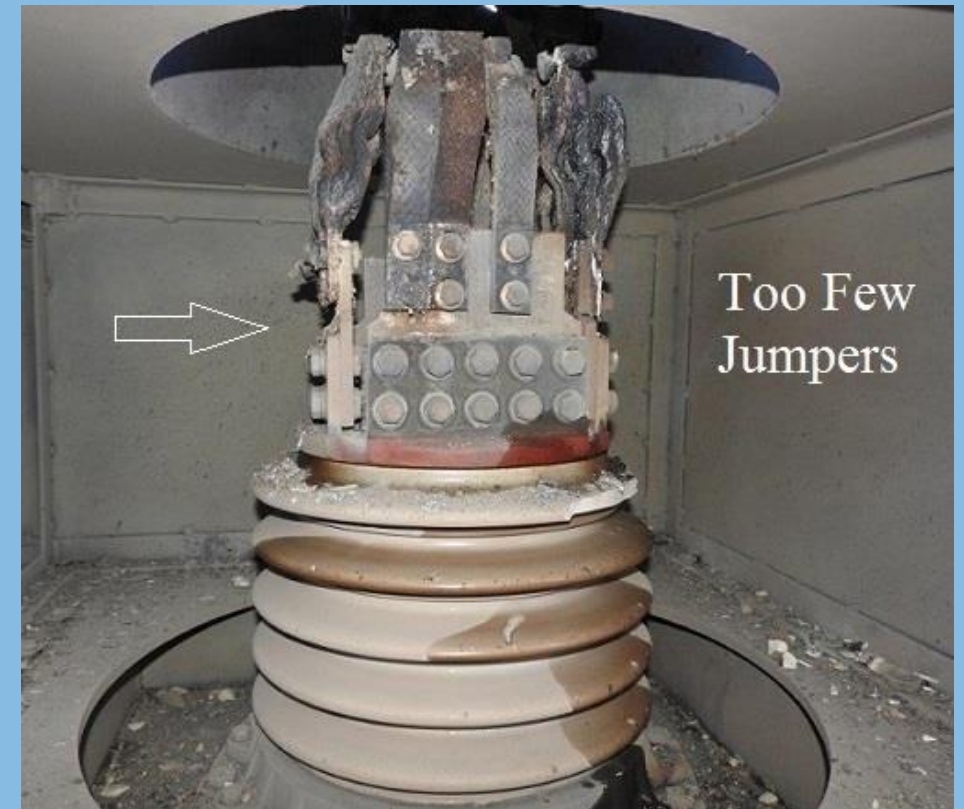
Be very careful when there is a change in the bus. Some mistakes are obvious. In the cases below too few jumpers were installed. The number of bolt pairs should be the same.

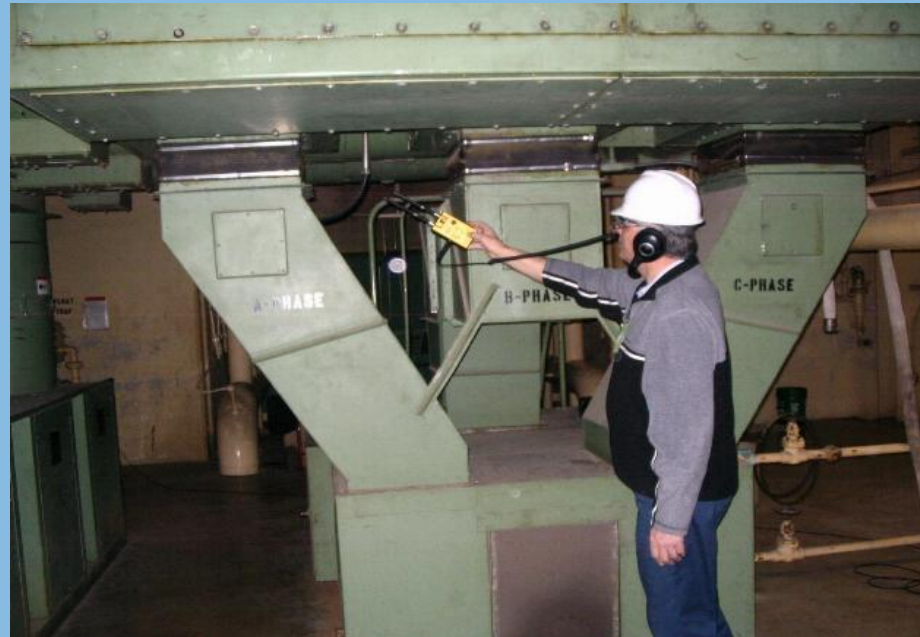
In most cases this poor bolting will result in very high levels of radiated radio noise or EMI. Metal objects left inside a bus will also result in high EMI levels. A scan for radiated EMI located the Foreign Materials problems shown below.

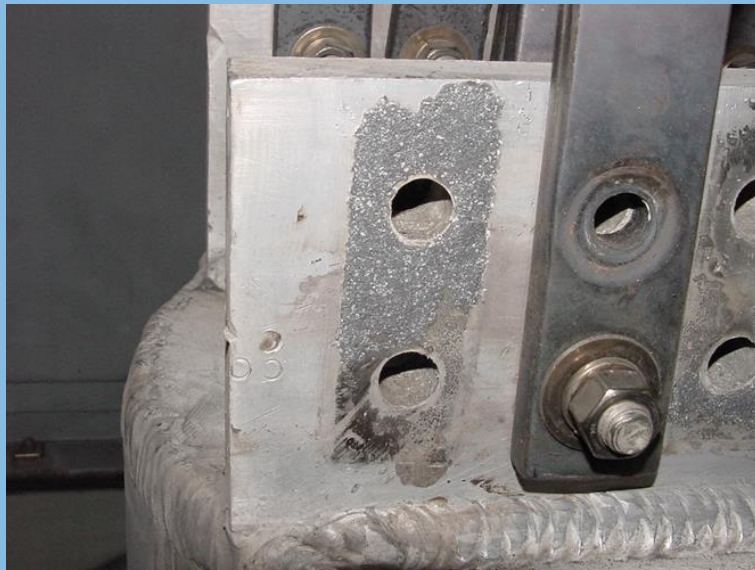
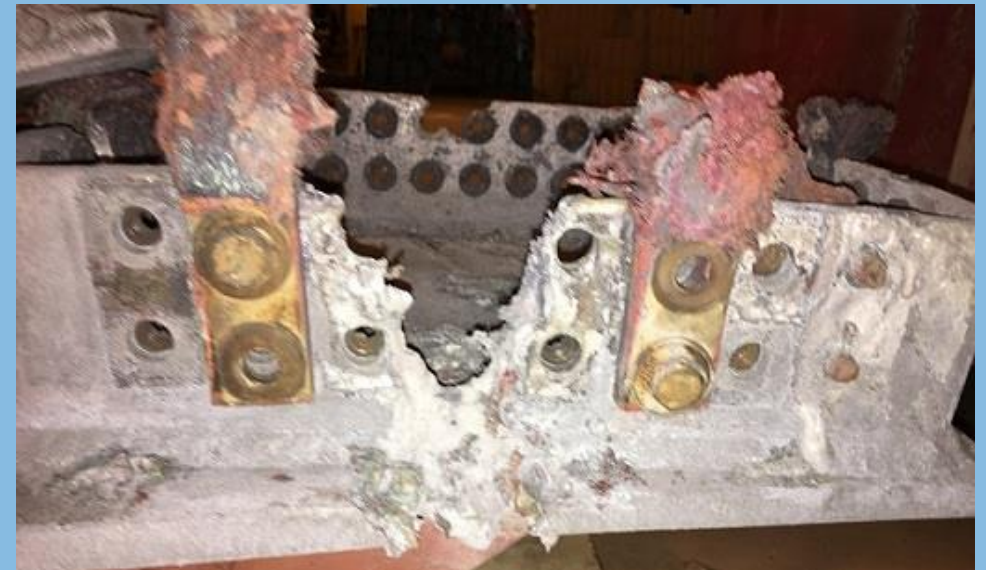
Poor contact will result in a cascade of increased temperatures, higher resistance and more heating until the joints melt. This is difficult to detect with IR, easy to detect with radiated EMI. IR will not see through the enclosure.

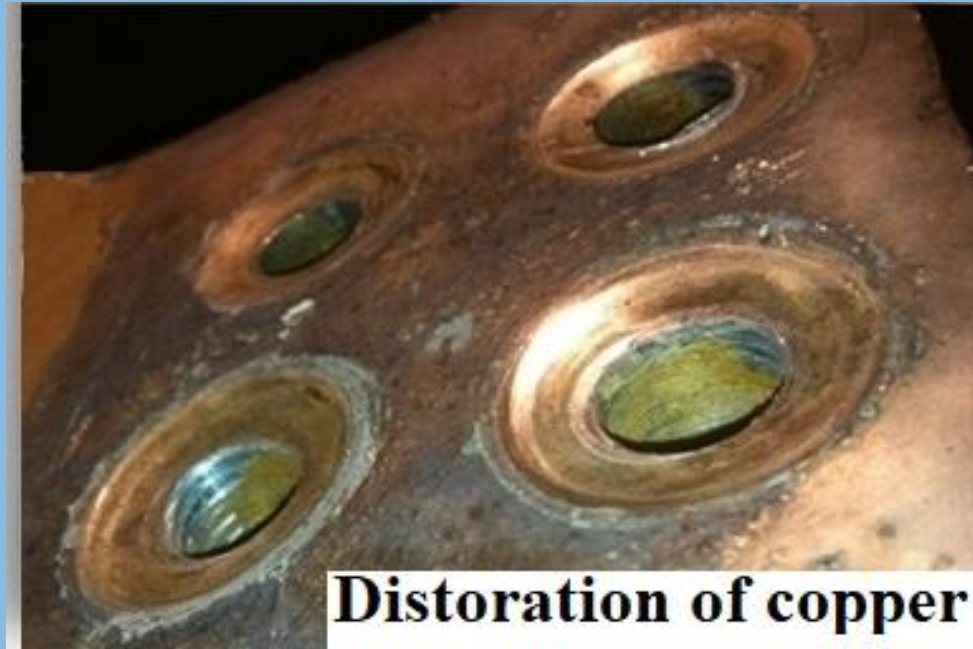
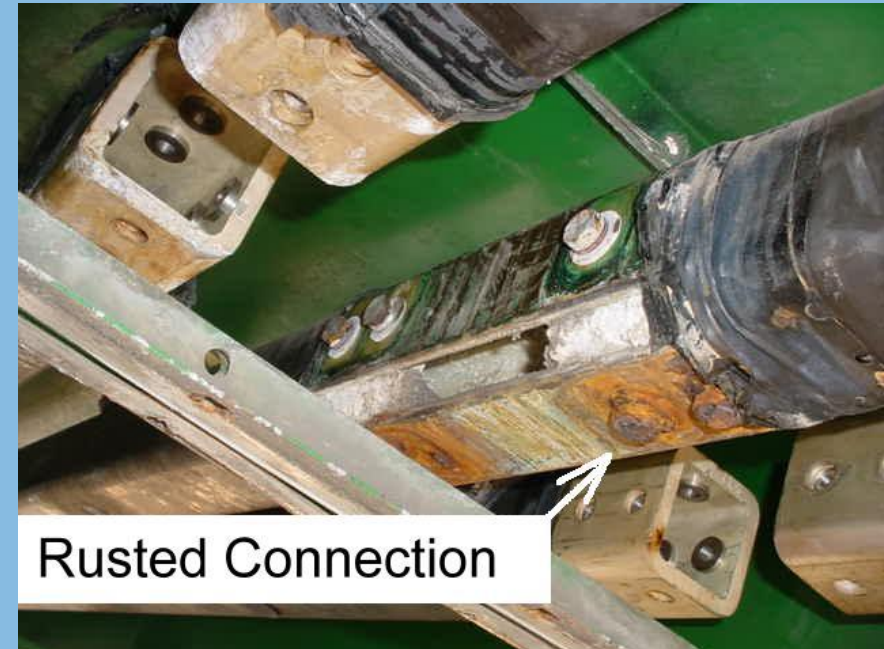
After almost 150 years it is amazing how few understand bolted electrical connections. The example below, left, shows damage to a copper conductor when incorrect bolting was used. Often lock washers and iron bolts are used to save money. Note the rusting below, right. The author has disassembled copper to copper joints with phosphor bronze bolts, still tight after 50 years service.

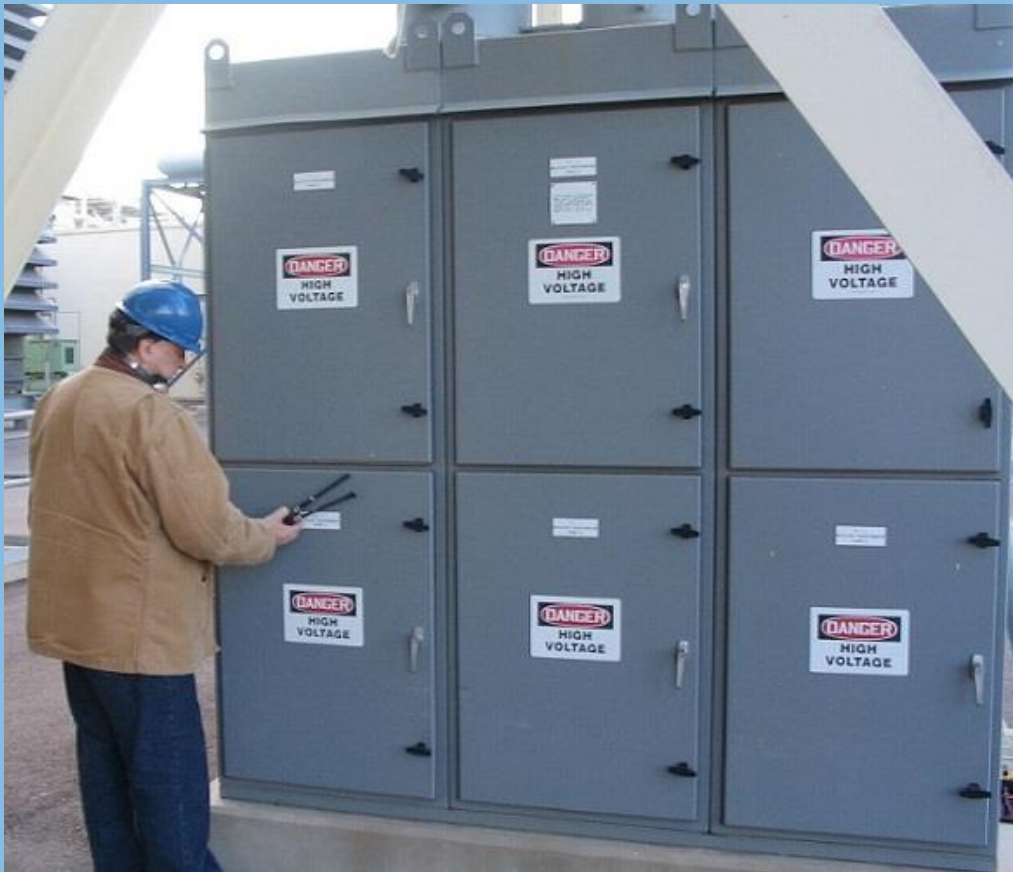
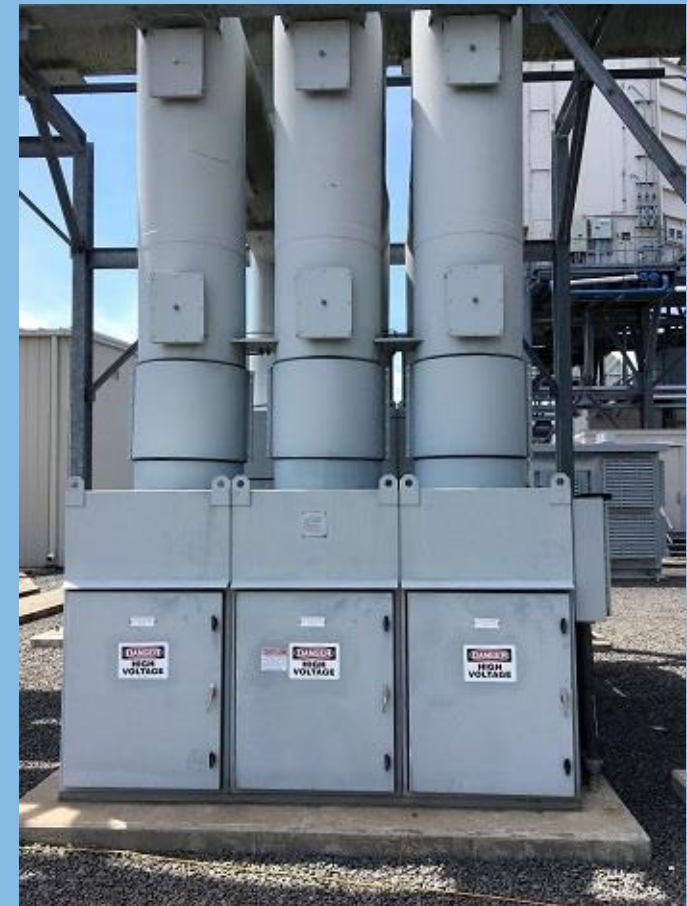
A location prone to deterioration is the potential transformer cabinets. Several problems are common to most systems. A scan for radiated EMI is an efficient method to determine if an inspection is warranted.

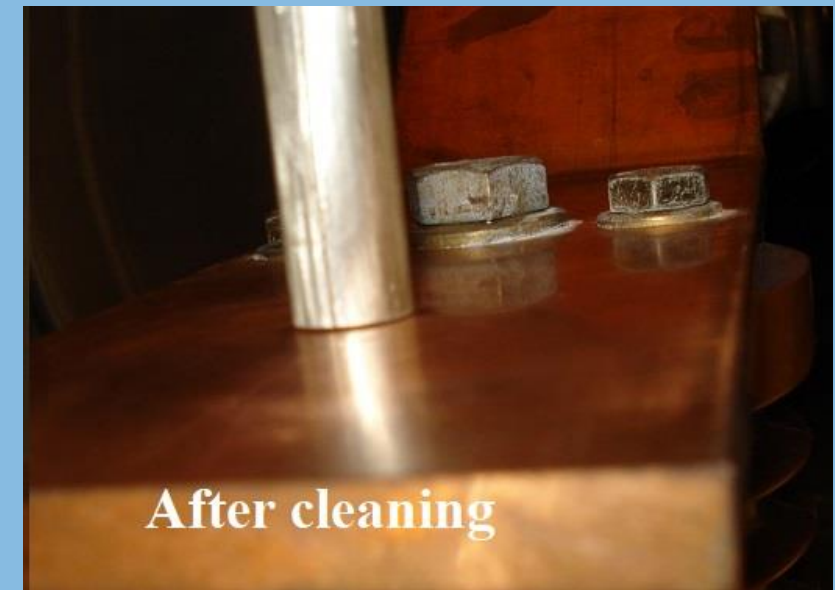
The design of potential transformer connections may not follow good practice. This one has no self cleaning wiping action. A high resistance contact results and arcing develops.

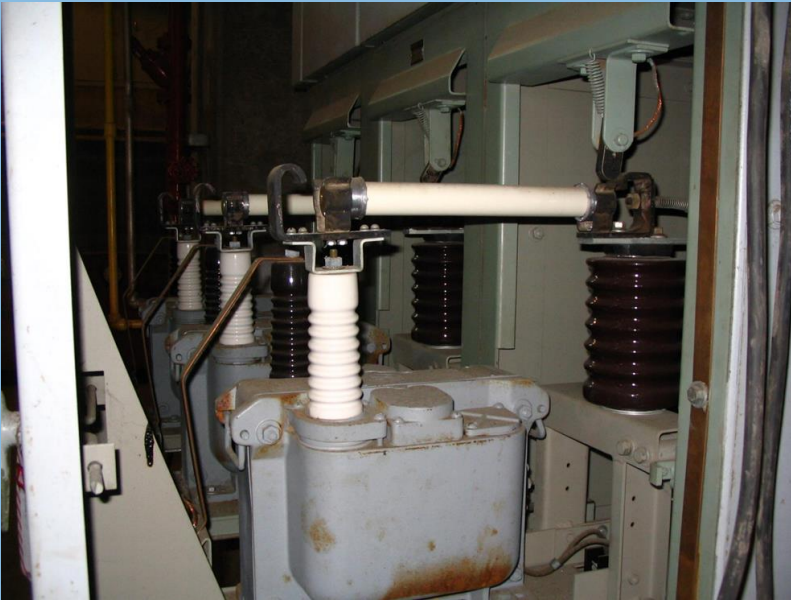
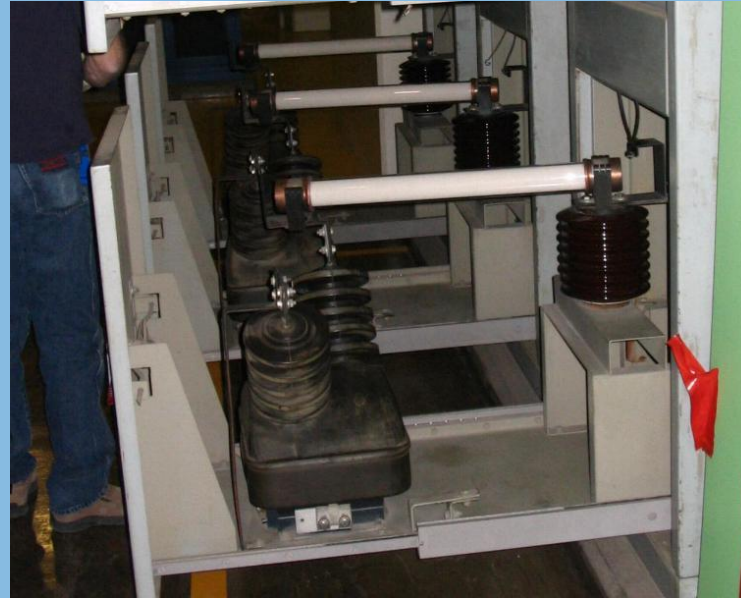
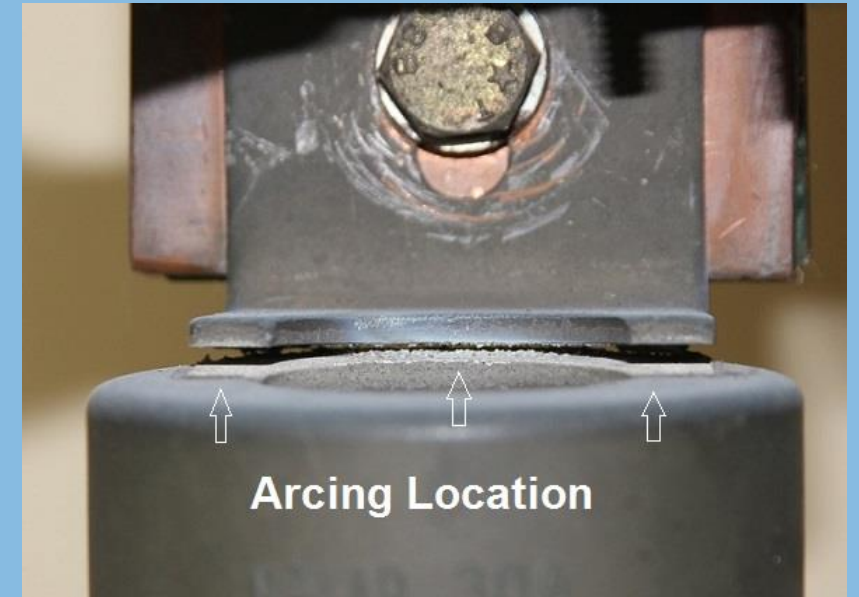
Deterioration of fuse links and connections is a frequent source of strong radiated EMI. Links open, clips break.

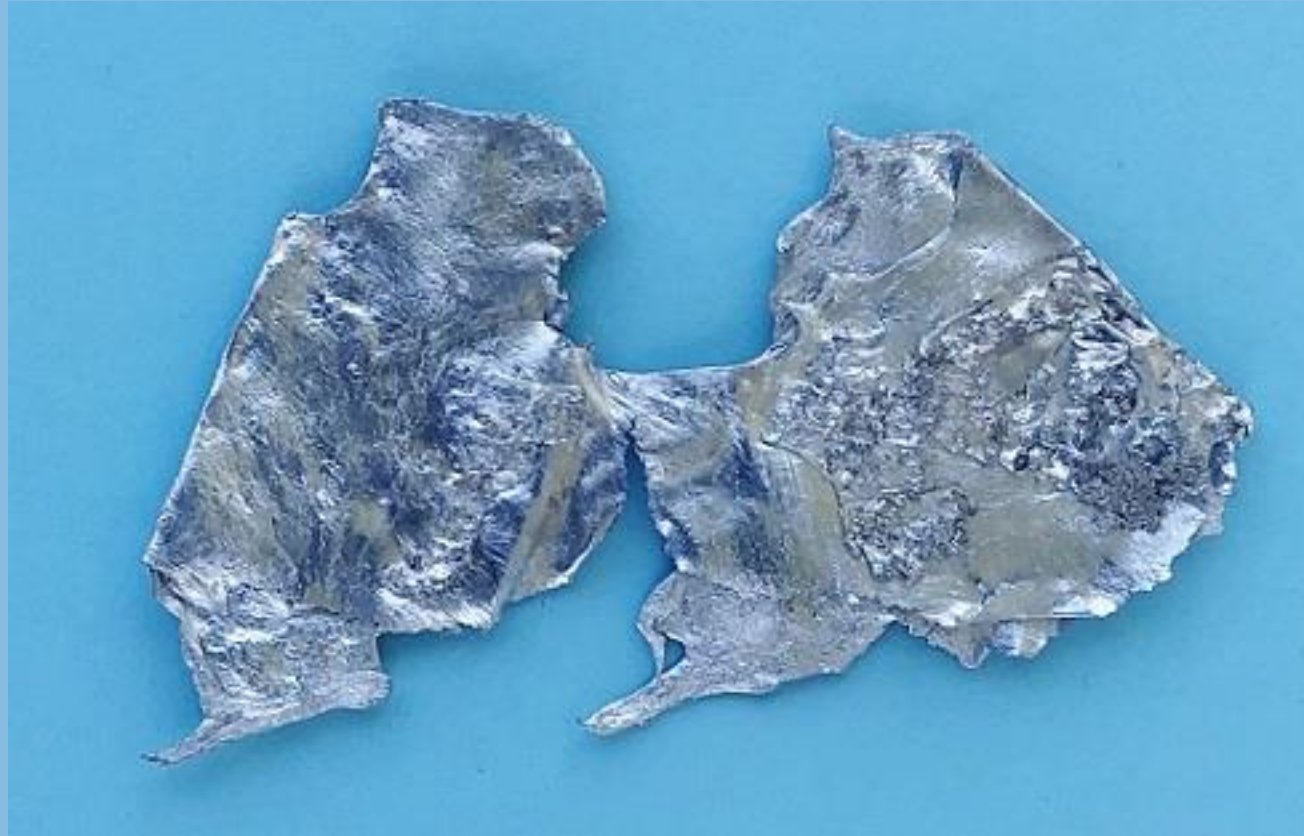
Your bus deserves a better fate than this one in Ohio.
