Noxon Rapids Interpole Connection Failures Iris Rotating Machine Conference

June 14, 2022

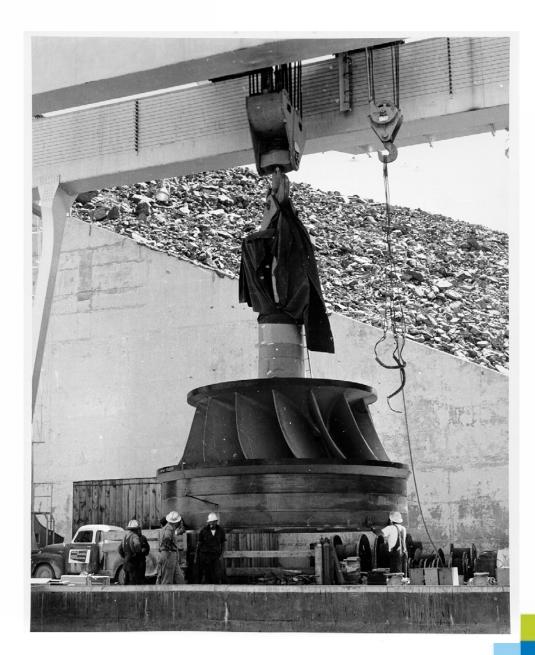
- Typical Generator
 - General Electric
 - 96MVA
 - 14.4 kV
 - 0.8 Power Factor
 - 100 RPM

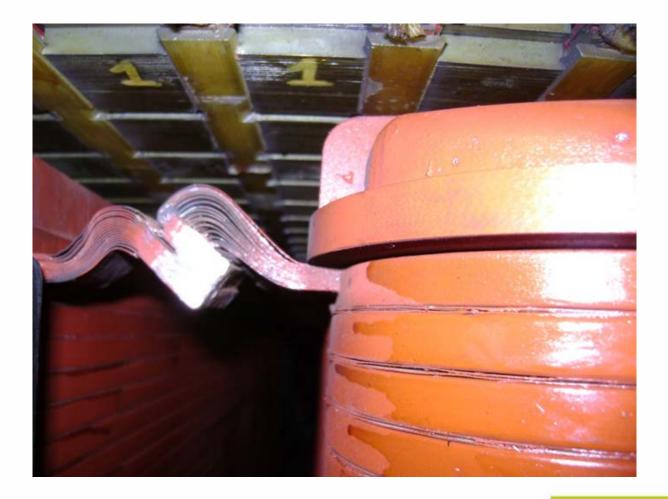
• Root Cause – Fatigue Failure

- Analyze Failure Mechanism
 - Heat of the soldering iron annealed the copper to make the copper leaves brittle
 - Safety margin was too low for overspeed event

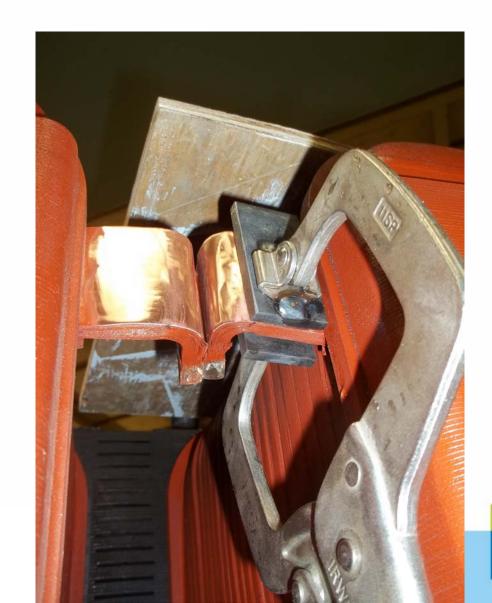
• Fabrication Tools and Jigs

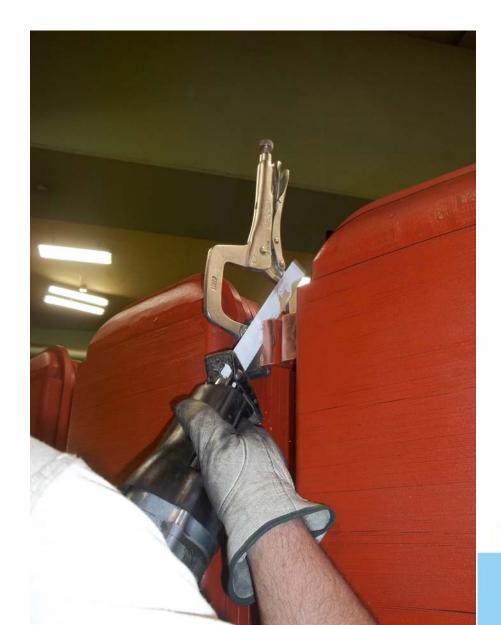
• Fabrication Tools and Jigs

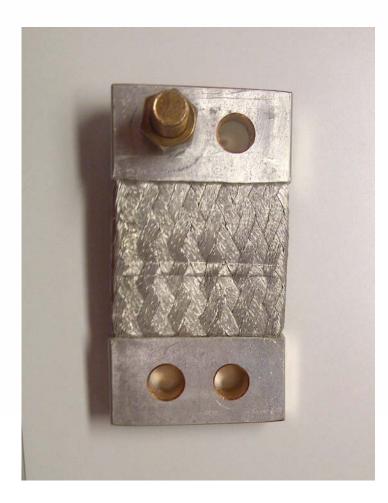
• Fabrication Tools and Jigs

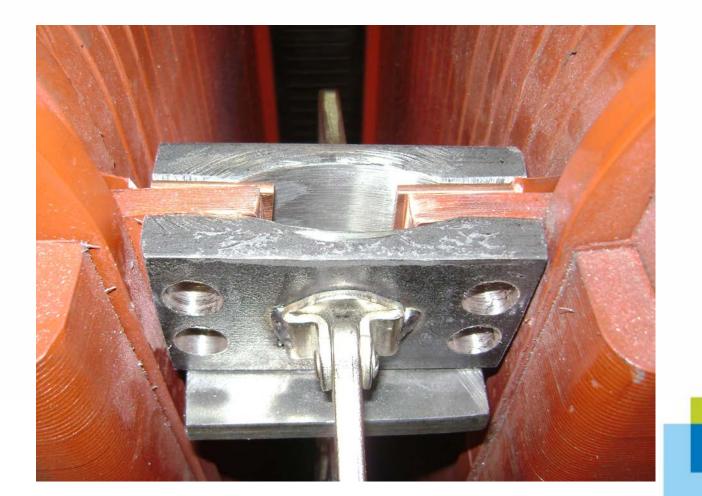
- Fabrication Tools and Jigs
- First Redesign

Prebend Braided
Connection

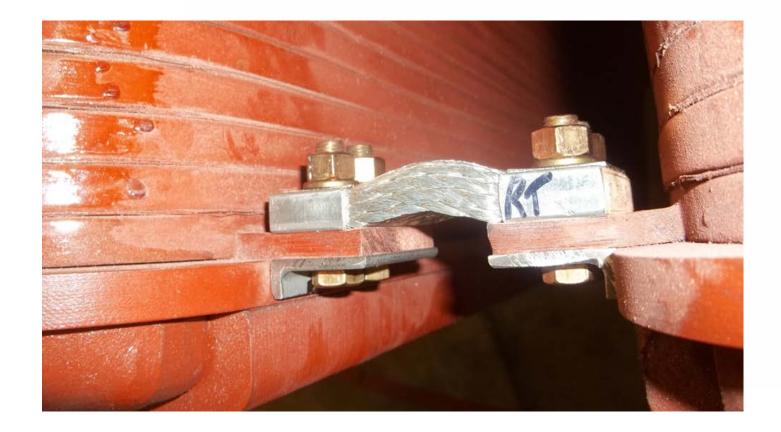
• Refined Design to include L-Brackets on the Outside
