IRMC 2023

Stator core repair by electro-etching

Case study

120 MVA 10,5 kV
3000 rpm

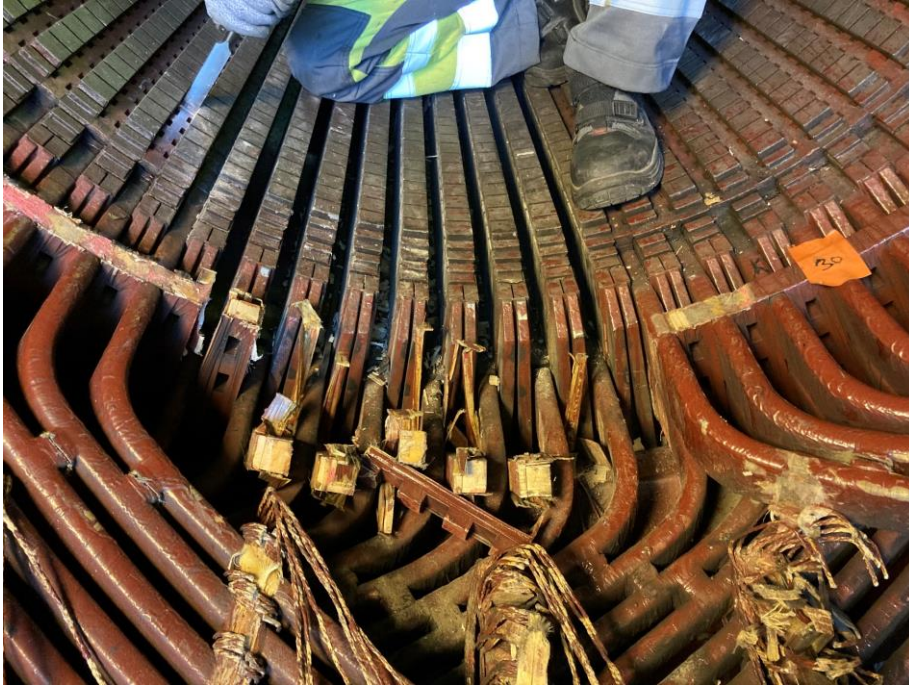
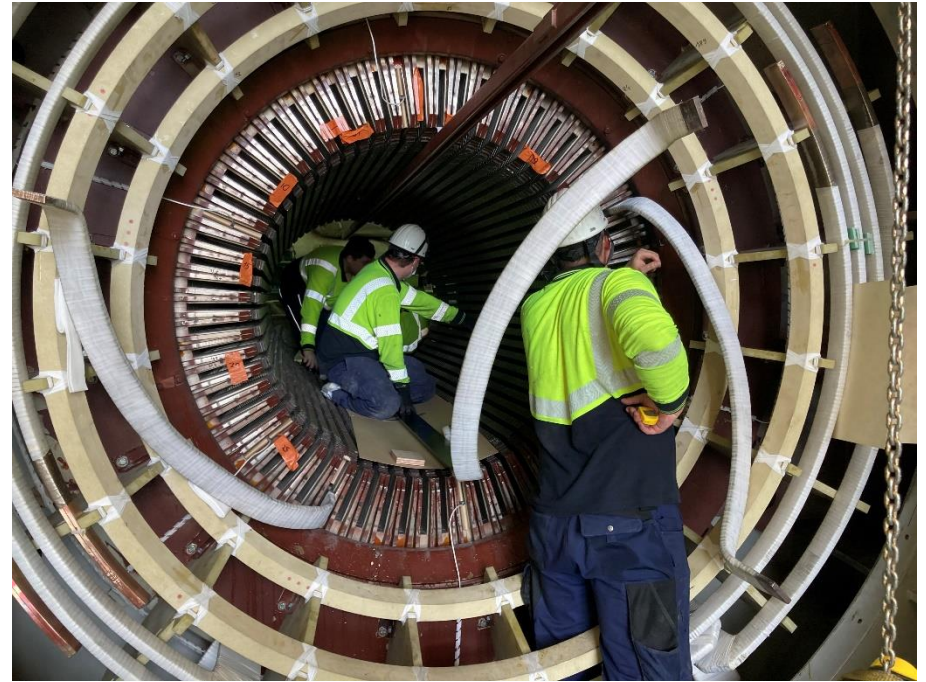
Turbo generator winding failure and rewinding

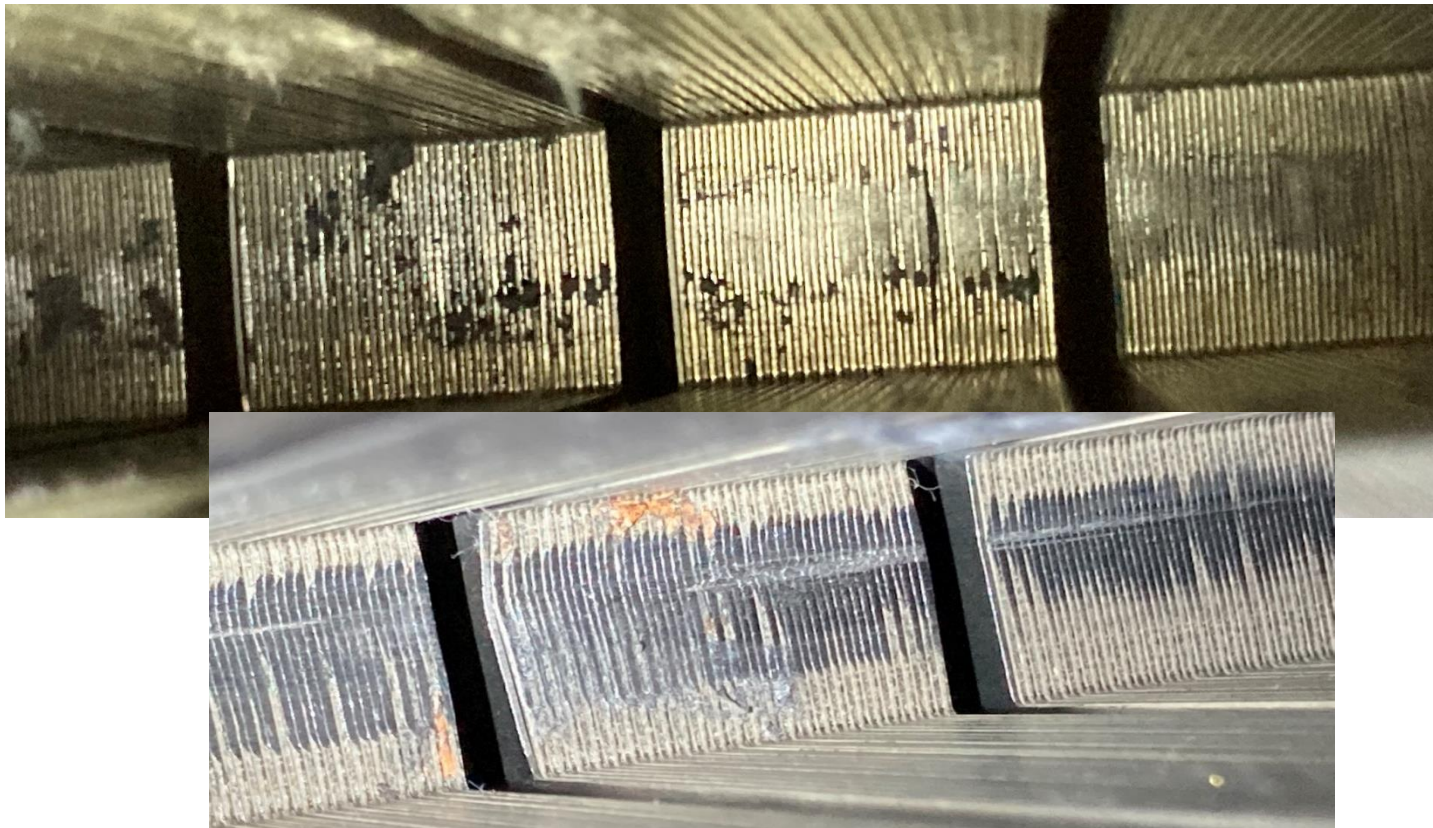
- Damages on the bottom of stator core slot, caused by forced removal of stuck stator winding bar. Damaged length approximately 40 cm.

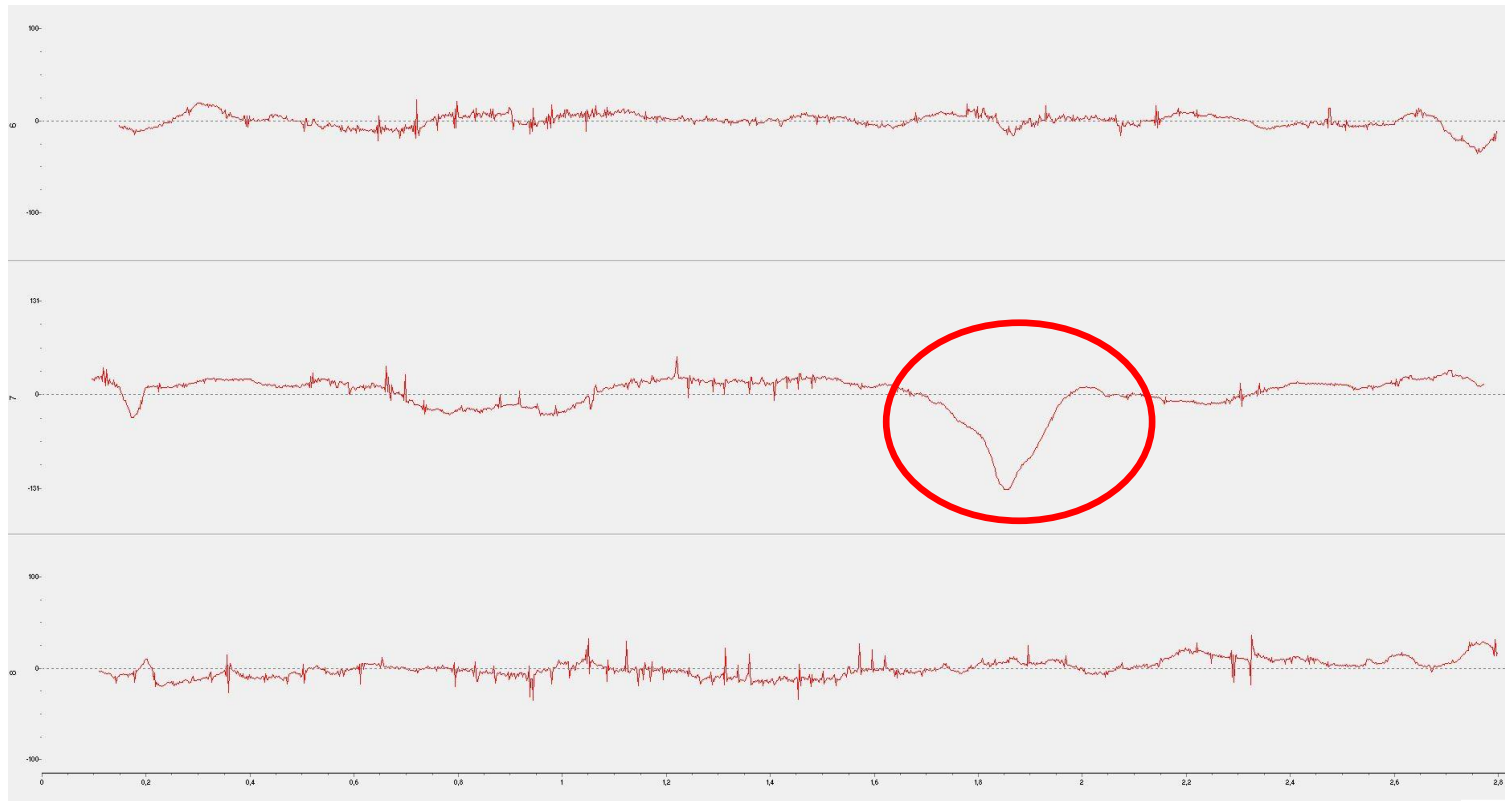
- ELCID measurement indicates a problem, possibly 5-10 °C hot spot
- $I_{\text{QUAD}} = 130 \text{ mA}$

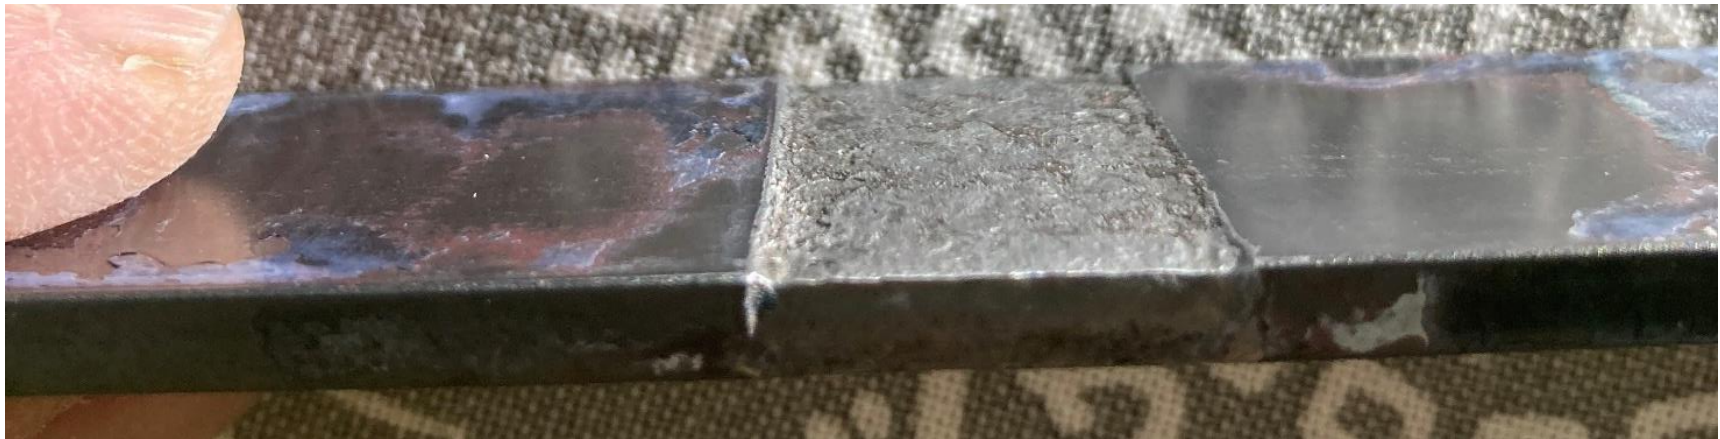
- Testing etching on a piece of structural steel
- Area 30 mm x 18 mm was etched appr. 4 h with low 2 A DC current, which removed some 0,2 – 0,3 mm of the steel surface
- Removed iron becomes iron phosphate dissolved in the electrolyte, not toxic in moderate concentration

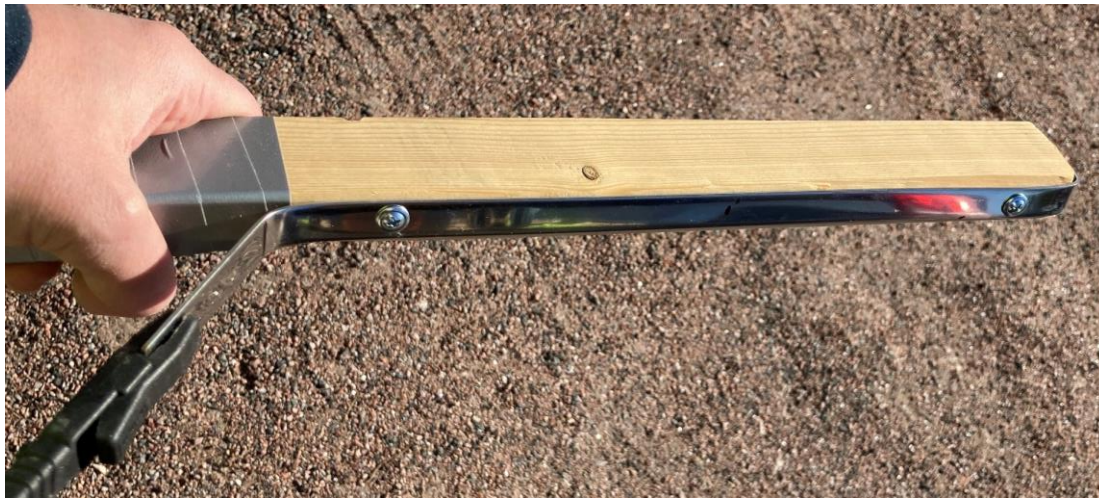
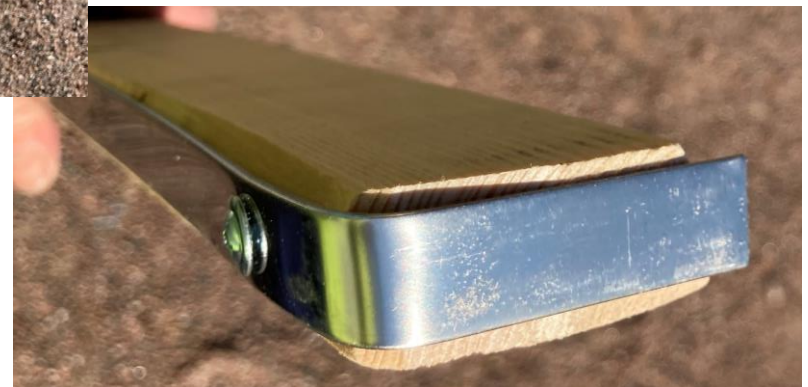
- Tool was made with correct dimensions to reach the bottom of the slot
- Cathode electrode is made of stainless steel and does not corrode

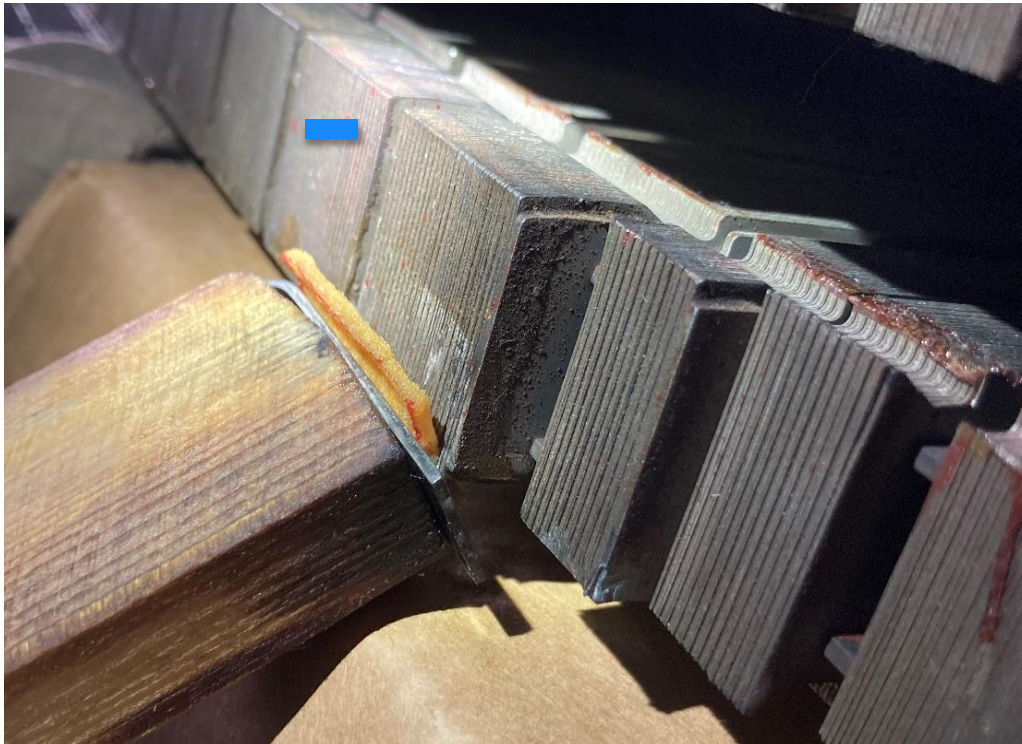
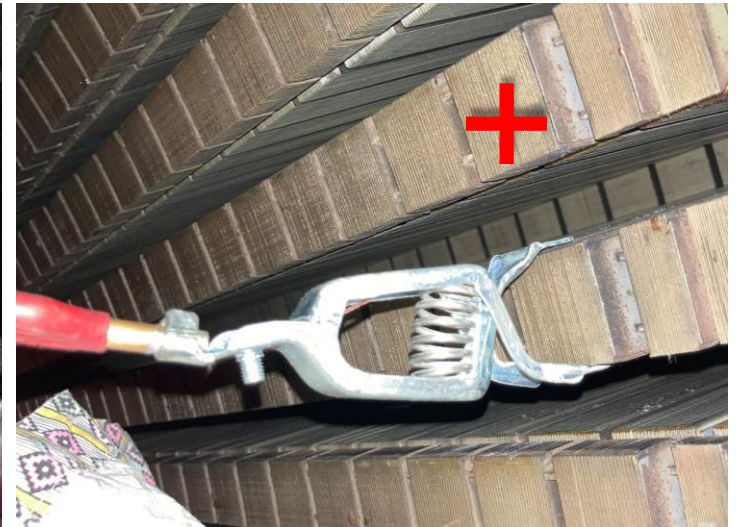
- Wooden stick holds the stainless steel cathode, piece of cloth holds the electrolyte (has to be changed in every 10 minutes or so)
- DC source supplies the current ($< 10\text{ A}$, $< 10\text{ V}$)

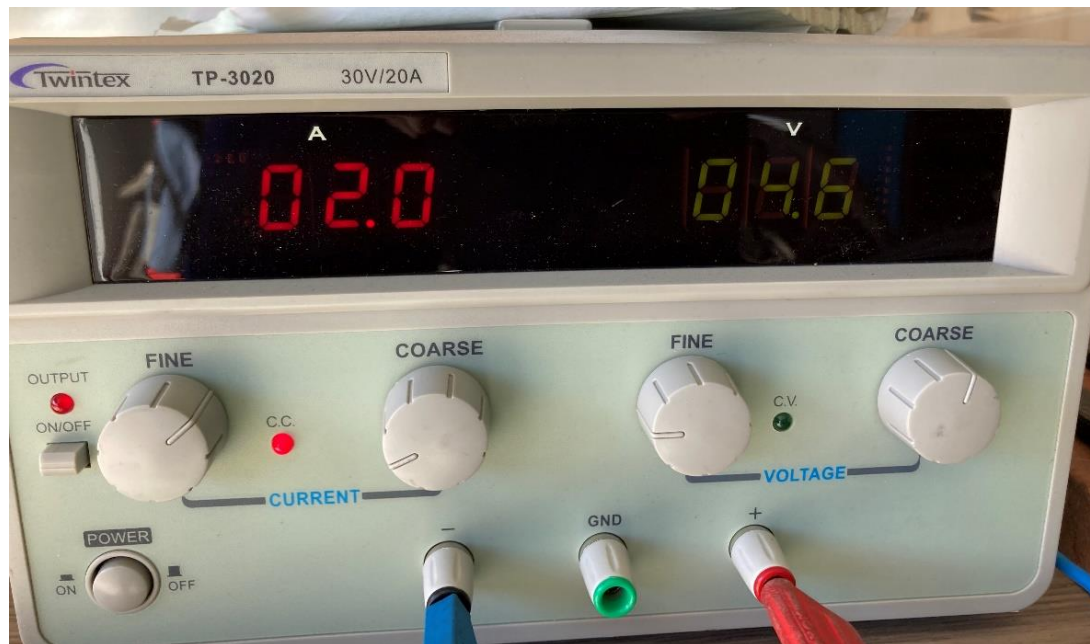
- DC source supplies the current, here $< 10\text{ A}$, $< 10\text{ V}$ but depends on the size of the area
- DC source here is just inexpensive laboratory source

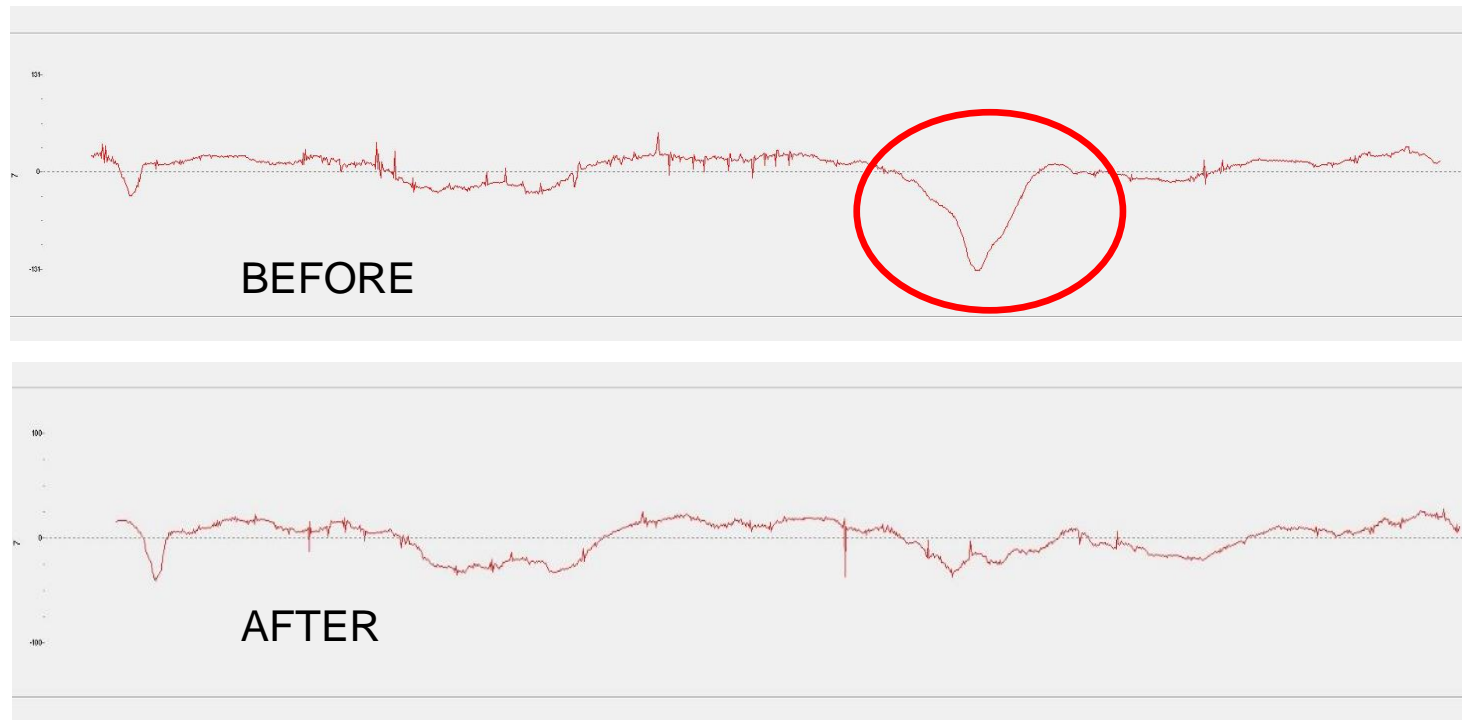
- No longer fault indication in ELCID
