Study on cause analysis and detection method of inter-turn short circuit fault of large turbine generator rotor

Zhan LIU, Zhongfeng HOU, Jiaju WANG, Shanglin LV, Haojun CAO and Yaqun Zhou
Xi'an Thermal Power Research Institute, China
E-mail: liuzhan@tpri.com.cn

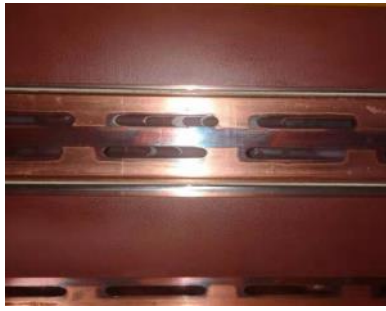
Fig.2 Failure spot close to the vents

The inner part of the rotor winding and inter-shaft insulation design has two vents, the overall composition of the internal hydrogen cooling duct. For in-slot windings, the general inter-tunnel failure occurs mostly near the cooling duct or at the inter-tunnel insulation stitching region, see Figure 2. The reason is that the installation or maintenance causes the generator internal metal foreign material, in operation with the cooling hydrogen in the air duct distribution, if there is a difference between the size of the insulation duct and winding duct size, the foreign body will stay there, the rotor heat cycle increased the number of wear, resulting in the failure of the insulation between the turns.

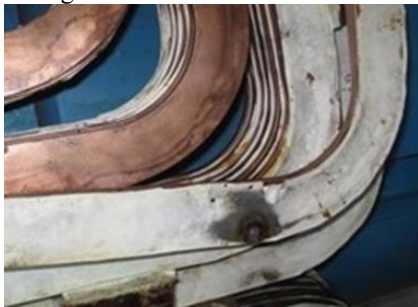
Fig.3 Failure spot around the corner

End windings are more exposed to foreign bodies than in-groove windings. On the one hand, the end winding support is relatively small, while the straight-line winding thermal stress, centrifugal force and additional thermal stress during the inlet run. On the other hand, the end winding manufacturing process will also bring hidden dangers, end winding needs to be shaped and bent, which inevitably causes the problem of gap cooperation between multi-twisting windings, especially in the area of straight line and over-angle, copper wire thickness is uneven leading to insulation wear in the operation. Taken together, it can be seen that the insulation operating environment between the ends is more demanding, easy to become a frequent area of short-circuit failure between the two, see Figures 3 and 4.

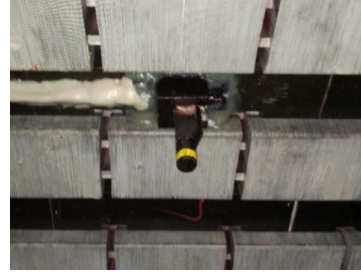
Fig.11 Layout of the probe coil

This detection method is suitable for generators with flux probes such as detection coils installed in the generator stator chamber (see Figure 11), because each rotor groove produces leakage flux on the rotor surface, when the generator is running, each rotor slot is sensing voltage when it passes through the probe, which is shown as the leakage flux of each groove produces a peak of the induction voltage on the detection coil. Each peak represents the size of the leakage flux around a rotor slot. If there is a short circuit between the turns of a coil, the wave peak corresponding to the two grooves associated with it

will be reduced because the number of amps in the two grooves is smaller, and therefore the leakage flux is less, so the voltage induced in the flux probe is reduced. Since the leak flux is only one of three components in the air gap flux (the other two are the armature reaction flux generated by the rotor main flux and stator current), the highest detection sensitivity for the leak flux requires measurement when both components are approximately zero. The main limitation of this experiment in the past was that measurements under different load conditions had to be carried out from the empty load to the full load range, and the adjustment load caused the total magnetic pass-through zero to occur for each pair of poles.

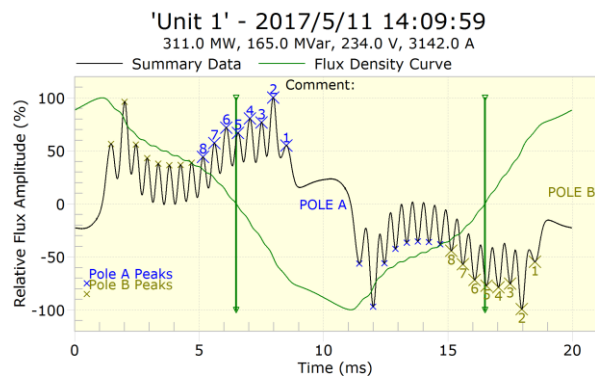
Fig.13 Flux peaks corresponding to each slot

The detection graph and data of the detection coil waveform method are shown as Fig.13 and Table 1.

Coil	Pole-1	Pole-2	Feature value	limit
1	55.2	-54.9	0.47%	15%
2	99.9	-99	0.88%	8%
3	83.2	-81.2	2.41%	8%
4	86.7	-85.5	1.42%	8%
5	78.5	-79.5	1.18%	8%
6	67.1	-66	1.68%	8%
7	49.4	-49.1	0.49%	8%
8	33.9	-40.1	15.18%	8%

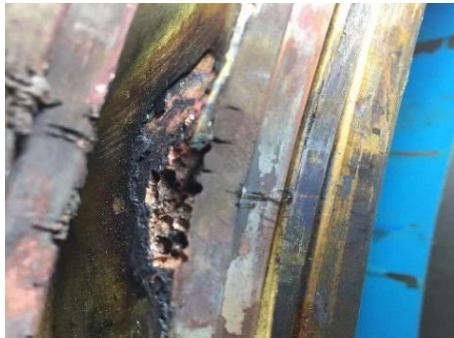
Fig.14 Failure spot

After the pull-out ring disintegrates, a short circuit between the coils of the pole 2 8th set is found, as shown in Figure 14. The insulation between the crucibles is partially damaged and the surface of the

copper conductor is ablation at the corresponding position.

After cleaning the inter-thumps insulation, after repair RSO and detection coil waveform results are shown in Figures 15 and 16, the results show that the short-circuit fault between the crucibles has been eliminated, this test waveform can be used as the initial data, pending further tests for comparative analysis.
