Primary Heat Transport (PHT) Motor Rotor Retaining Ring Failure

Ali Malik

Ontario Power Generation - Darlington Nuclear

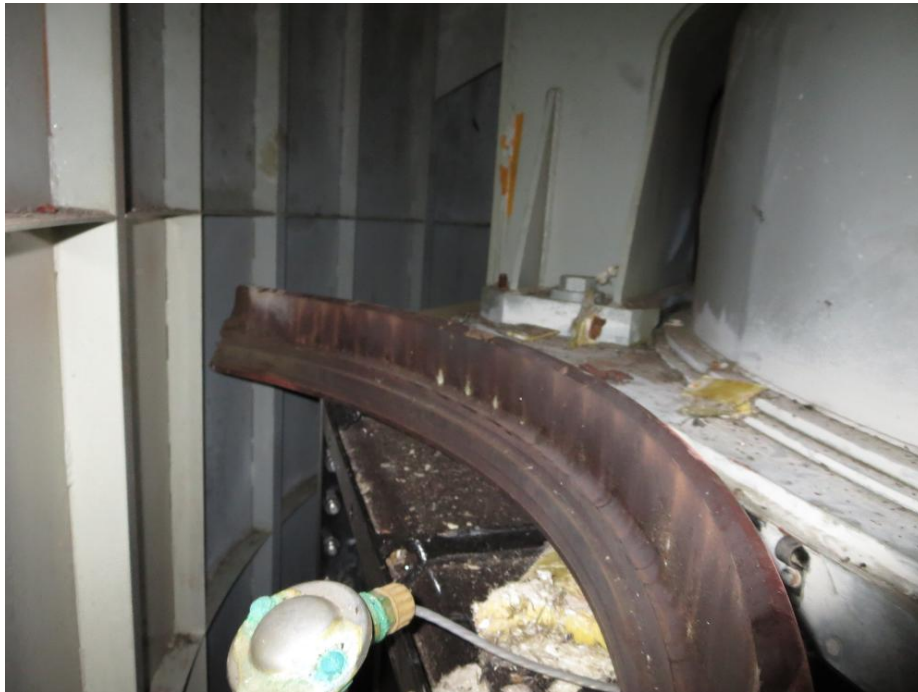
Failure of Rotor Retaining Ring

- ❏ On December 04, 2015, Darlington Unit 1 PHT pump motor 1-PM1 electrical protection tripped. Onsite investigation of the failure indicated that the opposite drive end (ODE) rotor stainless steel retaining ring came loose from the rotor in two pieces. One piece of the retaining ring was retrieved onsite from its resting place on top of one of the stator air coolers after its ejection from the rotor. This resulted in a complete winding failure, and a 20-day outage.

The PHT motors are a Totally Enclosed Water to Air Cooling (TEWAC) design.

The shroud enclosure contained the ejection of the failed rotor retaining ring.

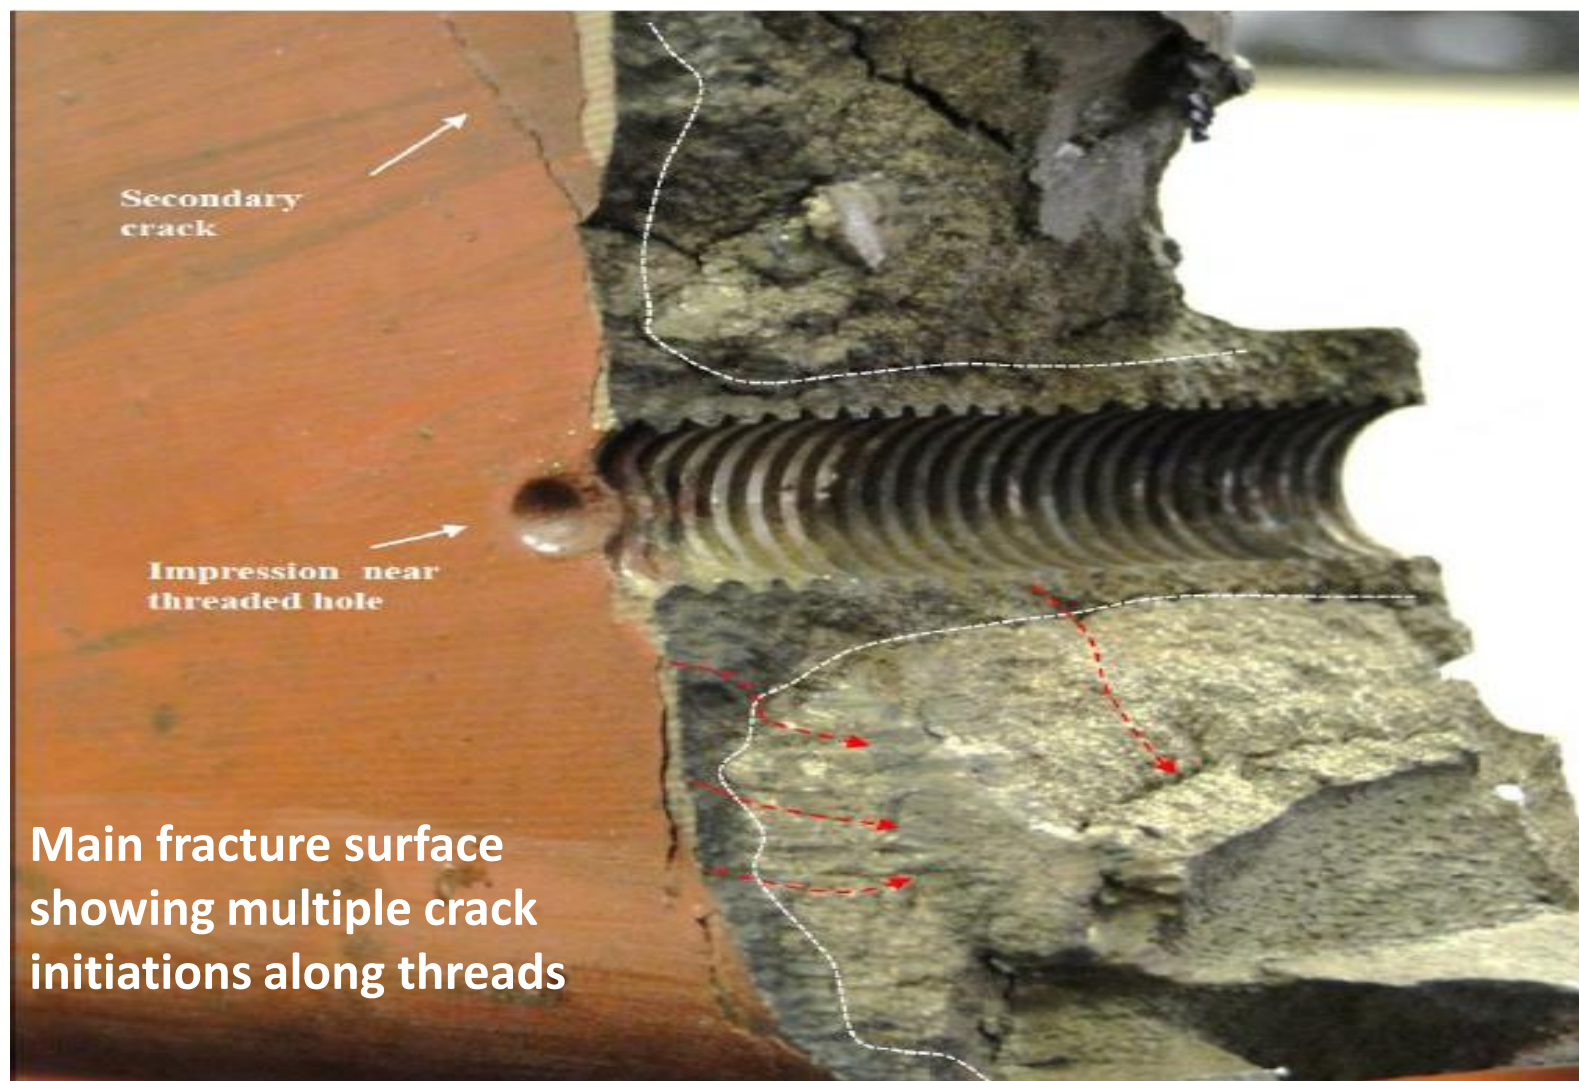
Retaining Ring Failure Assessment

- ⚡ SCC was a slow process until the ring was weakened sufficiently to break apart from centrifugal forces all at once.

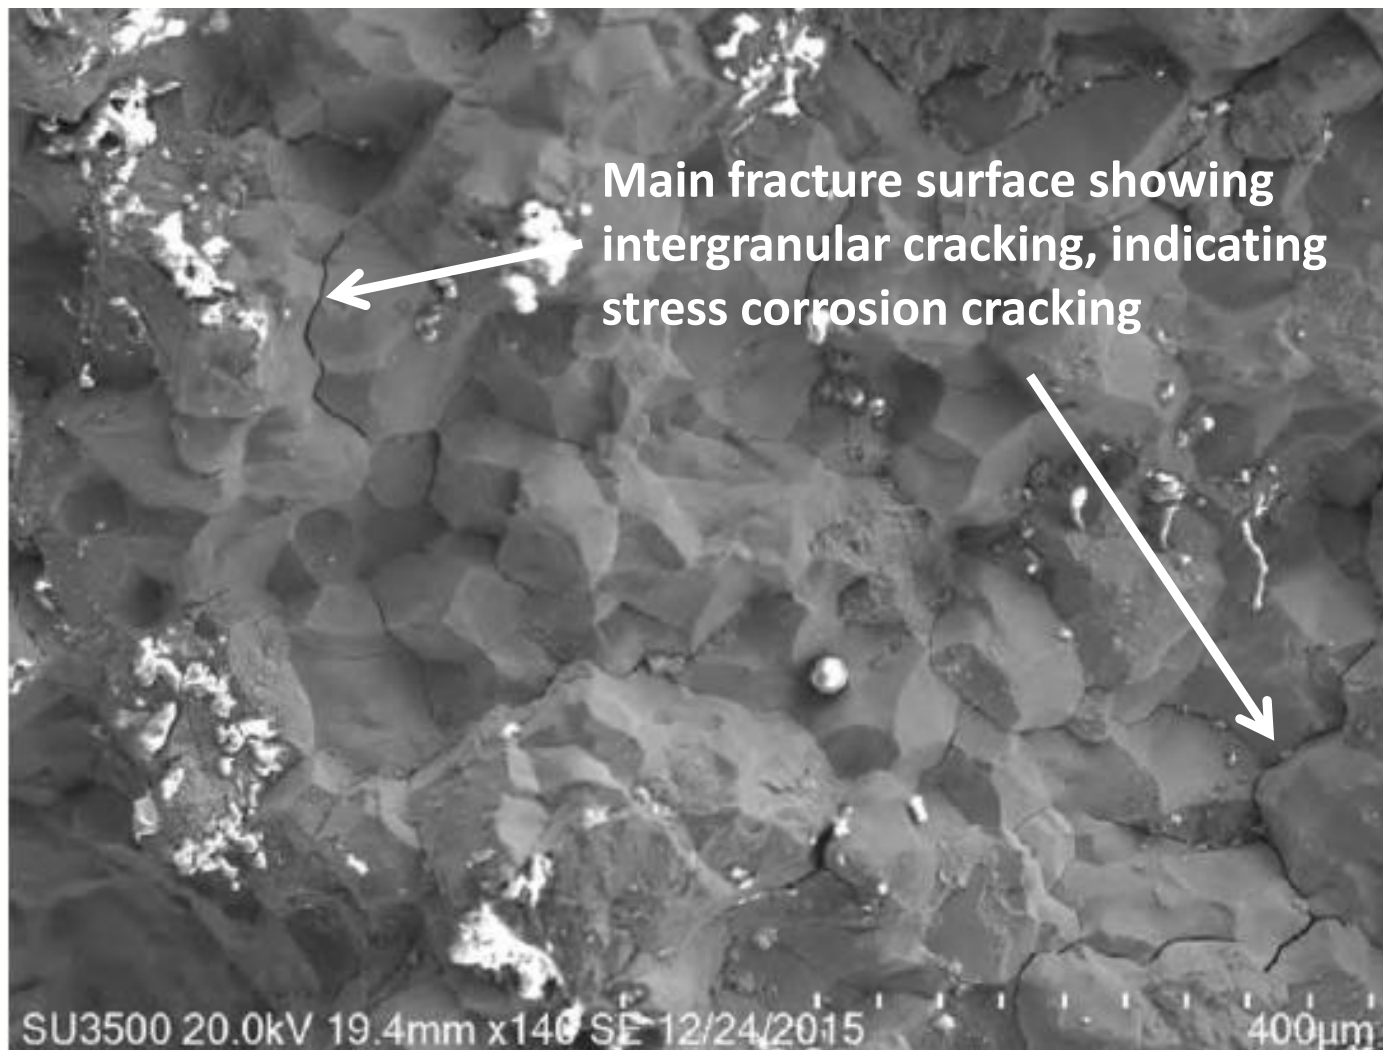
Retaining Ring Failure Assessment

- ❏ Multiple techniques were considered to detect this degradation however deemed not sufficient primarily due to access/space restrictions
 - ❏ Boroscope
 - ❏ Attempted but not successful due to space and access restrictions
 - ❏ Ultrasonics
 - ❏ Considered but deemed not sufficient as it requires direct contact with the retaining ring
 - ❏ Eddy current
 - ❏ Considered but deemed not sufficient as it requires direct contact with the retaining ring
 - ❏ Radiography
 - ❏ Considered but deems not sufficient as there are many layers of material which would attenuate the beam making it very difficult to resolve the required detail.
