# Experience with Stator Insulation Testing & Turn/Phase Insulation Failures in the Power Generation Industry

May 7, 2018

**Heedong Kim, Taesik Kong**

Korea Electric Power Company  
Research Institute, Daejon, Korea

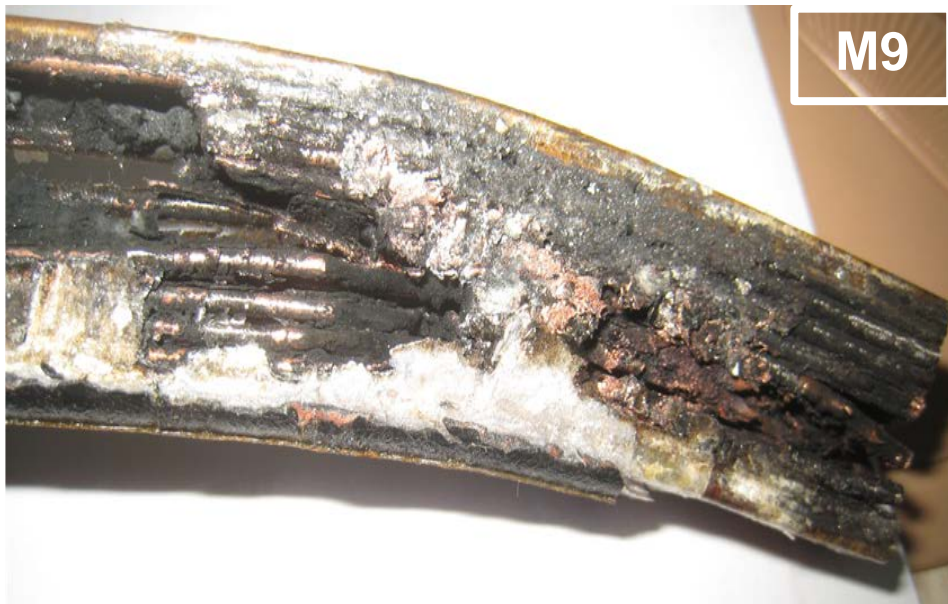
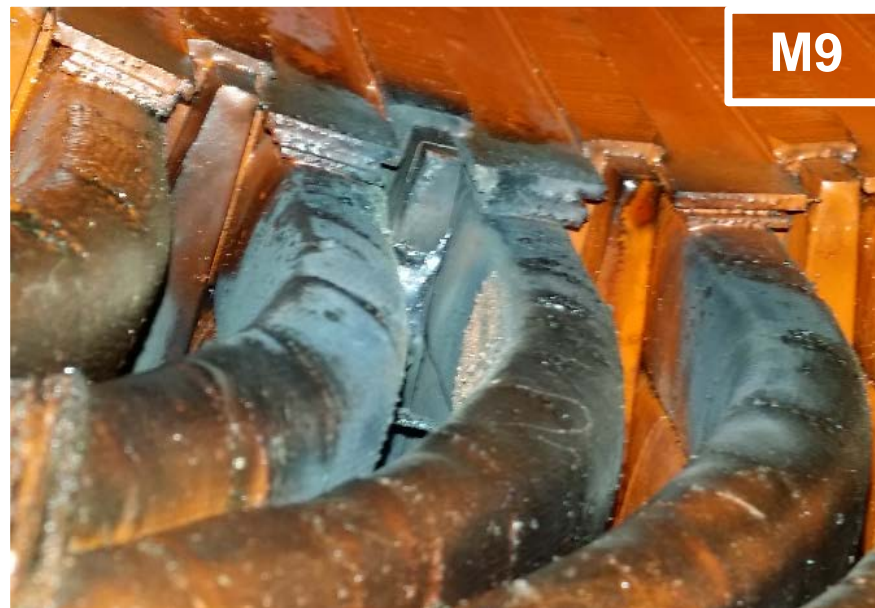
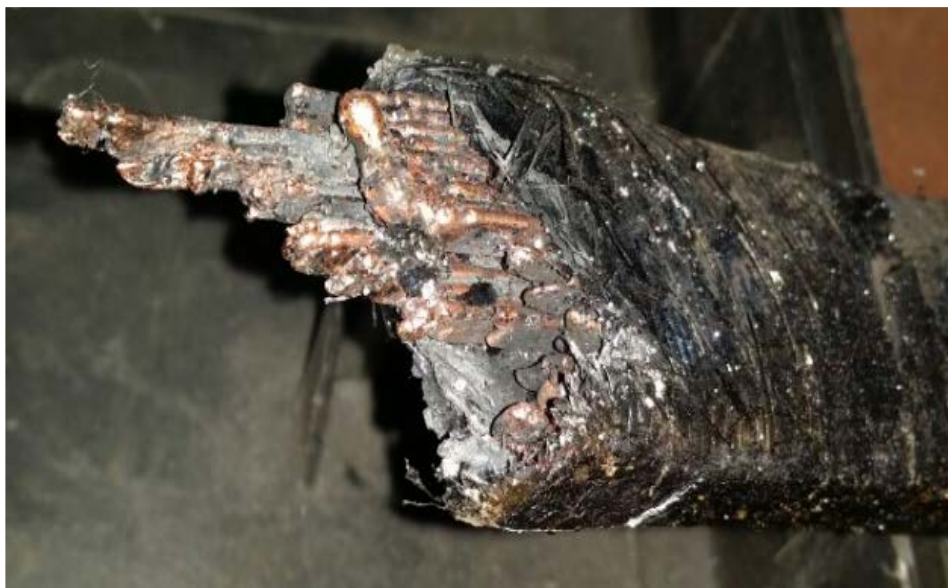
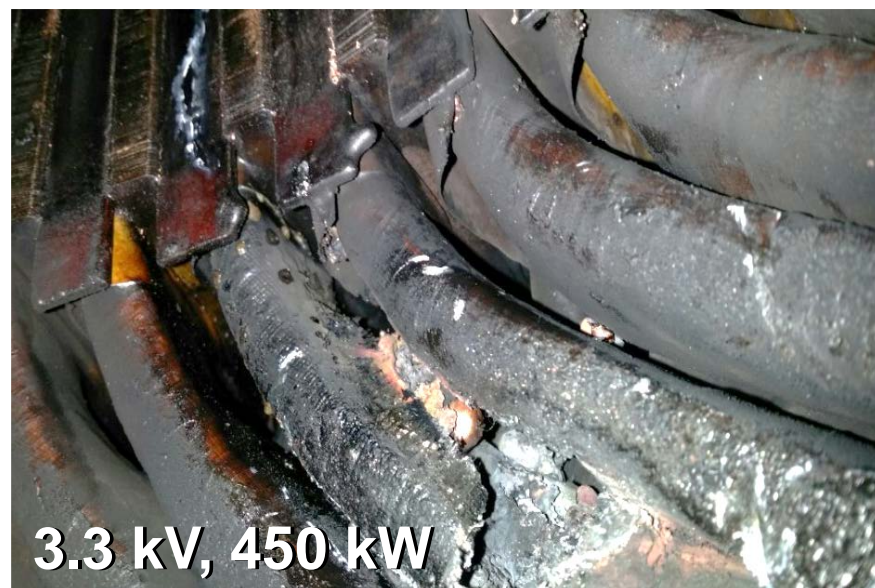
- ▶ No noticeable trend in correlation between turn failure & application, rated power, number of poles, years of service
- ▶ 7 of 13 failures occurred at motor startup
  - 6 of 7 failures located at EW slot exit (M1, M2, M4, M5, M6, M9)
  - 2 of 3 failures in 1<sup>st</sup> or 2<sup>nd</sup> coil (M5, M9)
  - Typical failures: fast risetime voltage surge & mechanical forces
- ▶ 6 of 13 failures occurred during operation >12 hrs after startup

- ▶ Melted copper & burning over wide area observed for ALL cases
- ▶ Turn failure does not necessarily cause GW insulation failure
  - Turn fault can cause tripping of open phase, imbalance, phase current relays before GW failure
  - M12: no visual signs of GW current path + high IR value
  - Turn failures in the tip of EW common w/ crossover coil designs

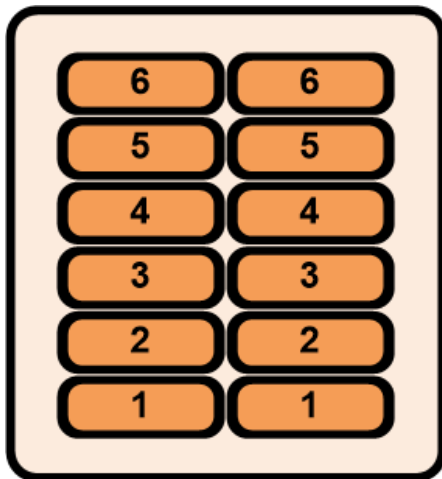
Straight-up coil

- ▶ “Crossover” coils common in MV motors w/ low power ratings
- ▶ Multiple & neighboring turns placed in slot width in same layer [15]
- ▶ Bending of coils required in EW (near tip)
- ▶ Higher electrical & manufacturing (bending) stresses in turn insulation near EW tip (terminal end coil)
