# LOOSE STATOR CORE DIAGNOSTIC METHODS

## SUMMARY

Increased partial discharge was observed on a vertical, 25 MW, Kaplan, umbrella type unit. The decision was made to perform additional diagnostic measurements. A detailed slow-roll air gap and vibration measurements were performed and the loose stator core problem was detected. The loose core vibrations were related to the increased partial discharge.

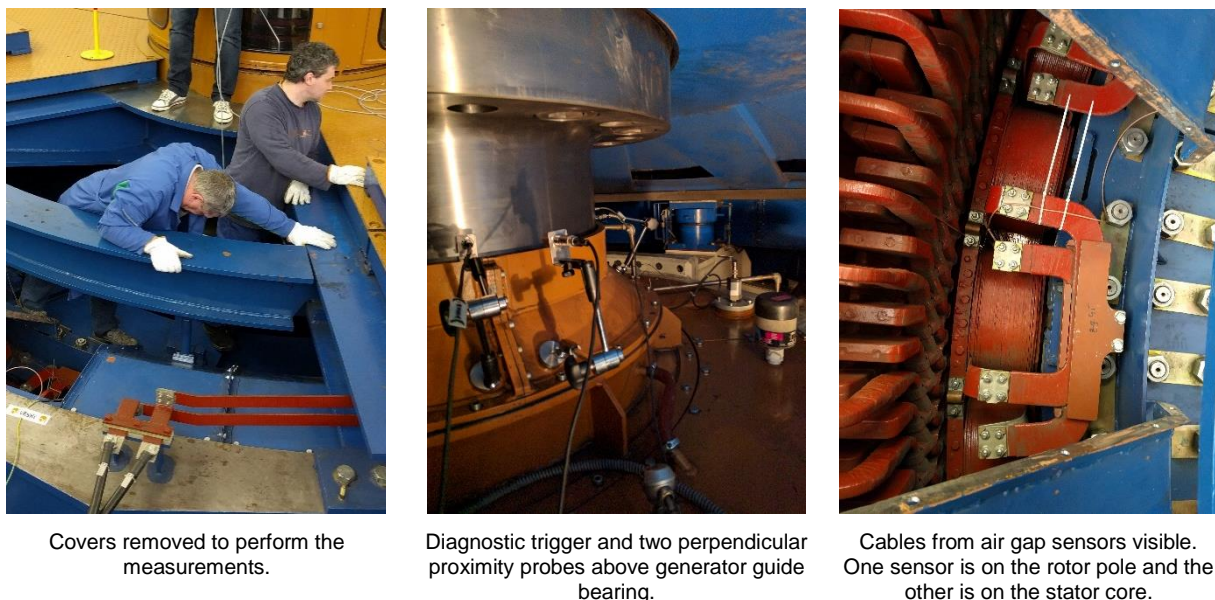
**Fig. 6 Slow-roll stator / rotor shape measurements.**

As it can be seen from Fig. 6, only a couple of covers had to be removed to perform the measurements. This makes the measurements easy to do during the overhaul (the best time would be when the overhaul is nearly finished or before it even started if corrections are to be applied during the overhaul).

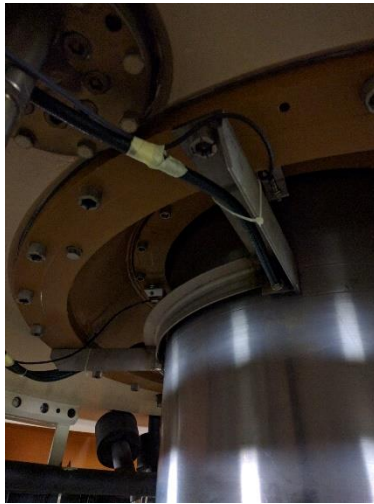
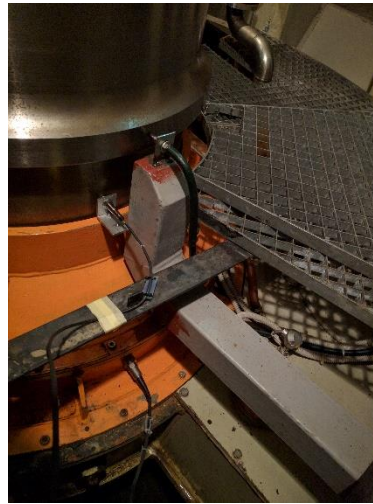
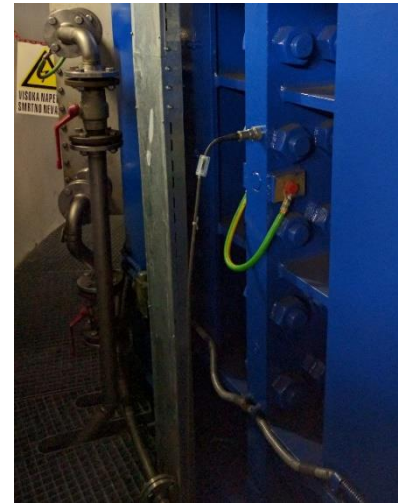
**Fig. 7 Typical sensor layout for the second measurements.**

Proximity probes installed below the generator bearing. They're positioned next to the MCM system probes.

Proximity probes installed on the turbine bearing. Next to the MCM system probes. Accelerometer seen as well.

Accelerometer placed on the stator joint in radial direction

The most indicative sensor pointing out the vibration related problems was the accelerometer located at the stator frame at the position of stator joints (Fig. 7).

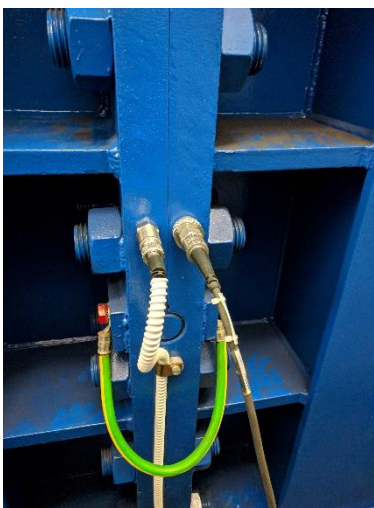
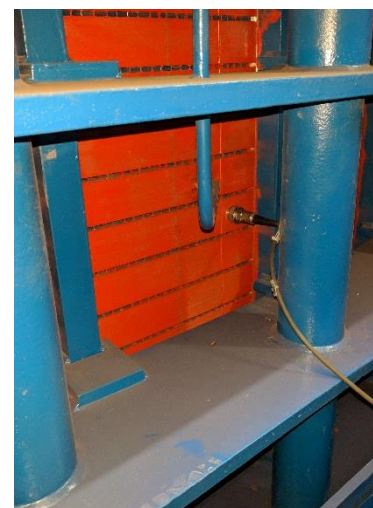
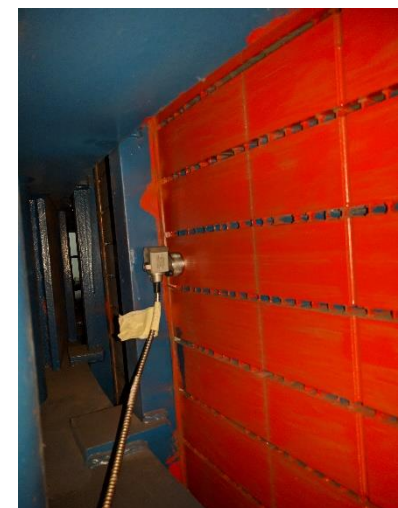
**Fig. 8 Typical accelerometer / velocity meter sensors installed during the measurement.**

Accelerometer placed on the stator joint in radial direction

Accelerometer placed on the stator core, in the middle of the, temporarily removed, cooling unit

Velocity meter placed on the stator core, at the right side of the stator joint, in the middle of the core (up-down)

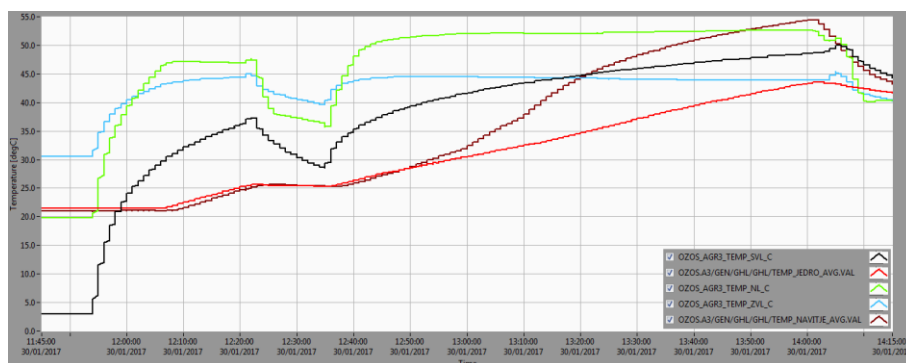
**Fig. 14 Temperatures [°C]: Black – turbine bearing, red – stator core, green – thrust bearing, blue – generator bearing, brown – windings.**

To understand the issues better, the most important temperature trends are shown on Fig. 14. These are the bearing temperature trends, stator core and winding temperature trends.

As it was already mentioned, the regime remained unchanged from ~13:10 h to ~14:00 h. This means that the amplitudes of the excitation forces (and, of course, the frequency) remain unchanged in this time period. But, from the RMS of vibrations (Fig. 15), it can clearly be seen that in this period, the vibrations are, at first, slowly decreasing and then, around 13:30 h they start increasing again and pass through a maximum value beginning to decrease again. Since the excitation forces remain the same, the vibration should remain the same if the mechanical characteristics (stiffnesses) of the construction remain the same. Therefore, one can conclude that **something has changed in the construction** and, based on the dynamics of the process it's related to the temperature dynamics (Fig. 14).

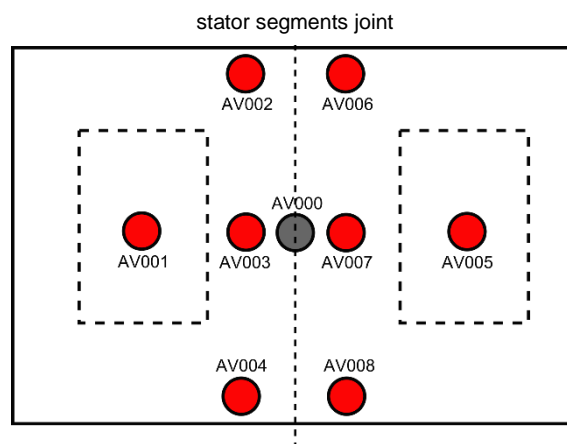
**Fig. 18 Gray: accelerometer at the stator frame (on stator joint), red: sensors on stator core. All sensors measuring radially. Side view of the stator core.**

So, 1 sensor was placed on the stator joint and the other 8 on the stator core at different positions in vertical and horizontal directions. The regimes covered are shown on Fig. 19.

The largest vibrations are visible on the stator core on the right side of the stator joint (sensor AV007, marked with Any7 on Fig. 21). At that position the vibration amplitudes reach extremely large values (up to 31 mm/s) when the stator core temperature is 43°C.

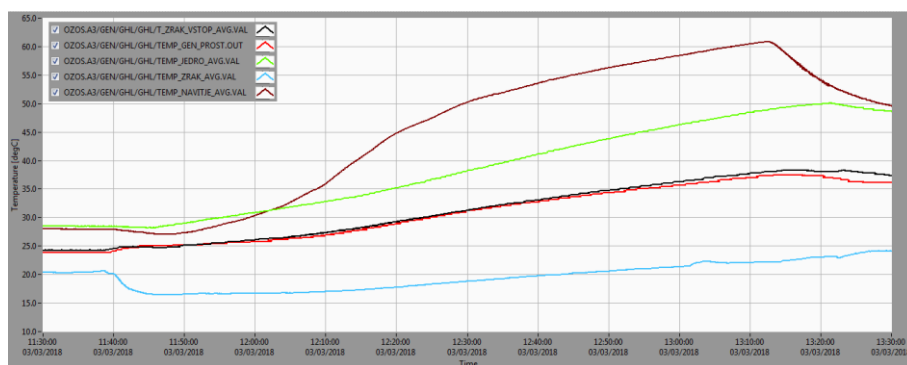
**Fig. 20 Temperature trends. Black – inlet air, red – generator space, green – stator core, blue – outlet air, brown – winding temperature.**

Comparing Fig. 15 and Fig. 21 it can be seen there are similarities in vibrational behaviours. The maximum vibrations are noticed around  $\sim 43^{\circ}\text{C}$  which is somewhat higher than the temperature at which they occurred on 30.01.2017. but the vibrational behaviour shows a similar trend. After approximately half an hour the stator core temperature increases for  $5^{\circ}\text{C}$  and the vibrations decrease rapidly which is a sign that the natural frequency moved above 100 Hz.
