MOTOR AND GENERATOR WINDINGS

Recent problems experienced

BY G.C. STONE, M. SASIC,
D. DUNN, & I. CULBERT

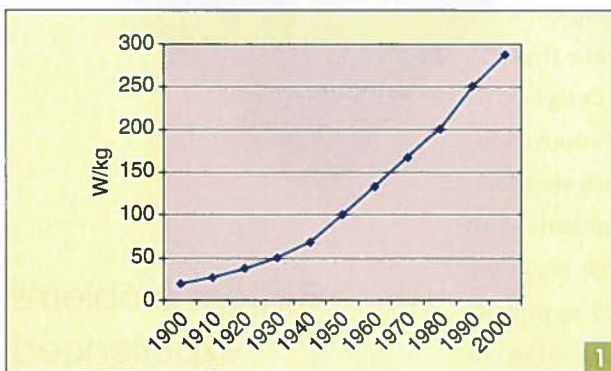
Motor output per unit mass as a function of production year [2].

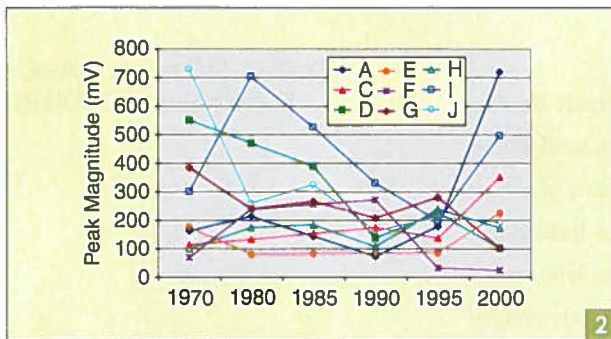
PD for nine manufacturers versus year of stator manufacture. Seventy-fifth percentile of PD results by manufacturer and year of install for 13–15 kV air-cooled machines with 80 pF PD sensors.

As part of the analysis of online partial discharge (PD) data performed on thousands of motors and generators, it has been noted that stators made by some manufacturers in the past decade have much higher PD than those made by the same manufacturer more than ten years ago [7]. Generally, the higher the PD activity, the closer a stator winding insulation is to failure. Figure 2 shows the peak PD activity versus winding manufacturing date for nine of the world's largest manufacturers of air-cooled motors and generators rated from 13 to 15 kV. This shows that for online PD readings measured in 2003, four manufacturers are exhibiting much higher PD on recently made stators than they typically experienced on their machines made before 1995.
