Experience With Stator Insulation Testing and Turn/Phase Insulation Failures in the Power Generation Industry

Heedong Kim, Taesik Kong, Sang Bin Lee^{1b}, Tae-June Kang, Namyoun Oh, Yeongjae Kim, Sanguk Park, Chaewoong Lim, and Greg C. Stone^{2b}

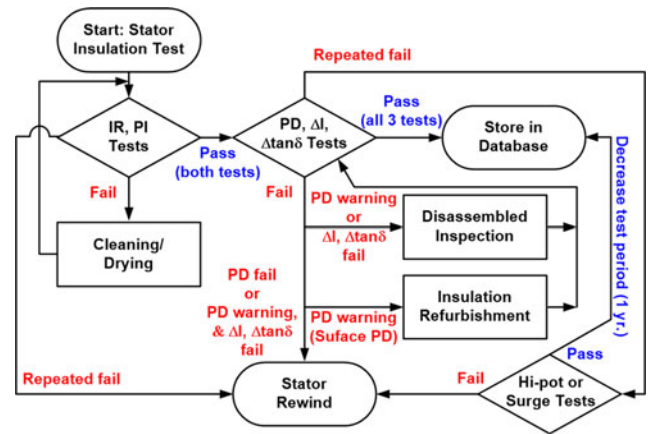
Fig. 2. Test and maintenance procedure applied to 6.6-kV motor stator insulation in domestic power plants.

performed. For 6.6 kV motors, which are most common in the domestic power industry, the IR value is measured with a dc voltage of 5 kV applied to the GW insulation for 1 min. A threshold level of 100 MΩ or higher (IR corrected to its 40 °C value) is used for determining if the GW insulation strength is sufficient for motor operation or ac testing [2]. The PI is obtained by taking the ratio between the 10 min and 1 min IR values measured at the same dc voltage level to observe the insulation's ability to polarize. GW insulation is considered to be in good condition if PI is higher than 2 [2]. IR and PI tests can provide the indications of moisture absorption, contamination, or severe damage in the GW insulation. If the motor fails the IR or PI test, the tests are repeated after cleaning and drying. The procedures for insulation cleaning and drying can be found in many resources [5]. If the winding fails the IR and PI tests again, a stator rewind is recommended (see Fig. 2).

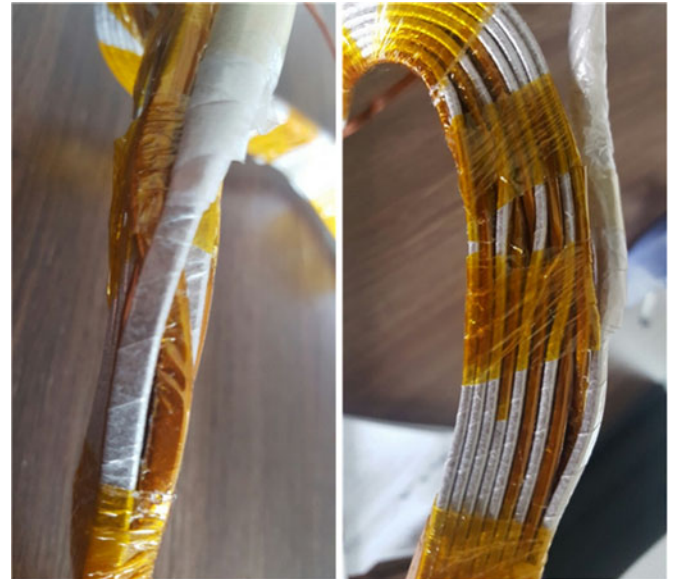
Fig. 12. Example of crossover coil design for 6.6-kV, 75-kW 8 pole motor.

up coils [18]. This increases the interturn voltage stress in form wound machines. In addition, since the neighboring turns must be placed in a different horizontal location within the slot, the shape of the individual turns are different. Therefore, it is necessary to bend the individual turns in the EW, typically near the knuckle of the EW, to insert all the turns in place. An example of a crossover coil is shown in the coil of a 6.6-kV 75-kW motor in Fig. 12. The abrupt bending mechanically stresses the insulation, and may lead to voids which make the insulation vulnerable to failure. Although one case of crossover coil failure
