# A 30 Years Reliability Survey of a Generator Family

**Relu ILIE**

**Iris Rotating Machine Conference**

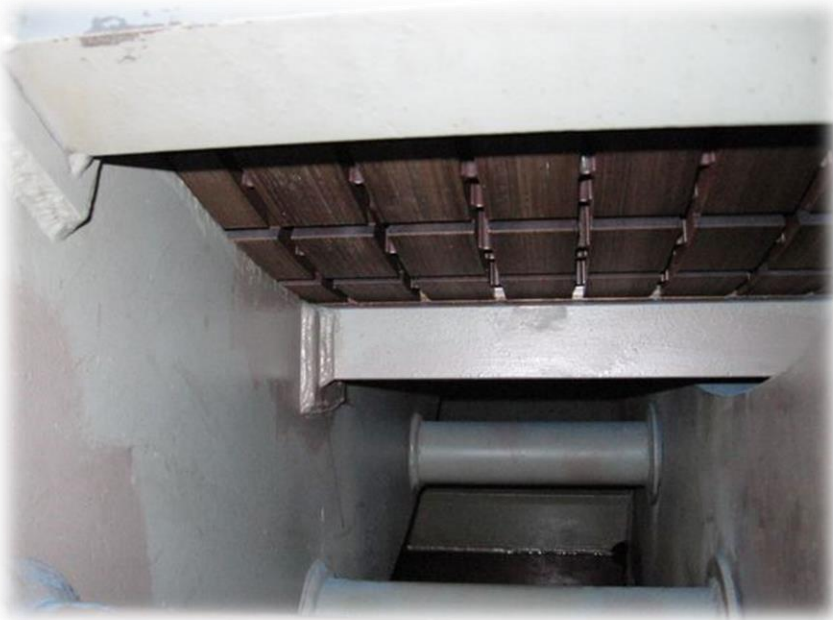
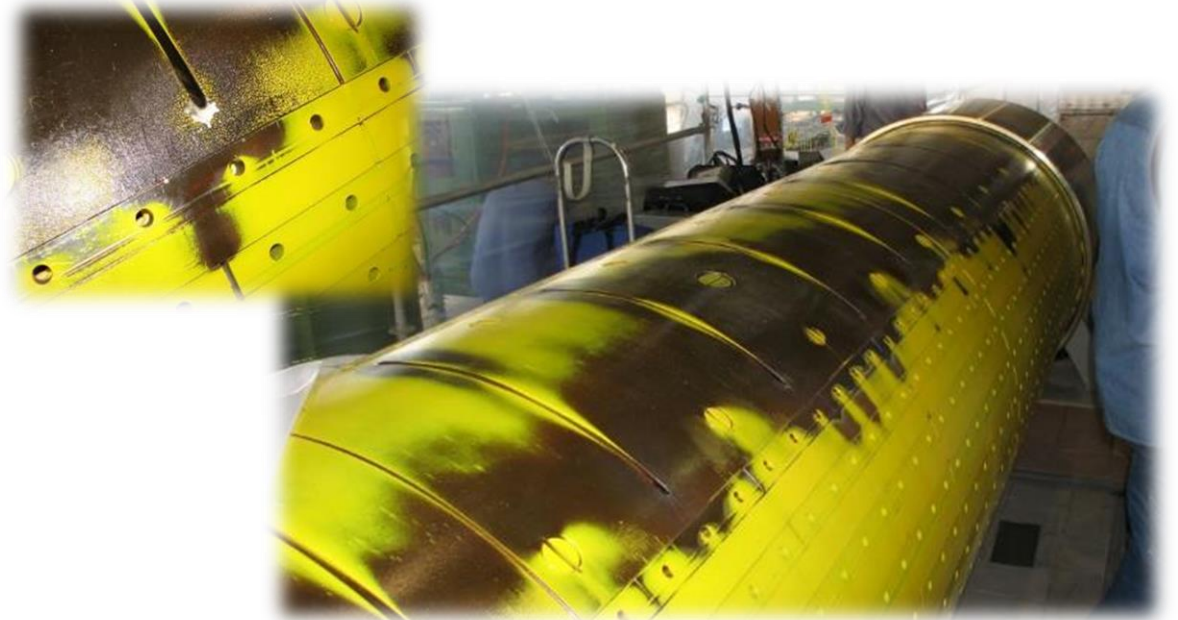
- Initially all 12 in open cycle. Later, 6 units integrated in 3-shaft combined cycle
- Initially all 12 burned distilled oil. Later, 8 units converted to natural gas
- Operated in two-shift: ~100 starts/year for open cycle, ~200 starts/year for CC
- Typical signs of negative-sequence event (unreported) found in one rotor
- A couple of seal-oil ingress incidents occurred, without direct consequences

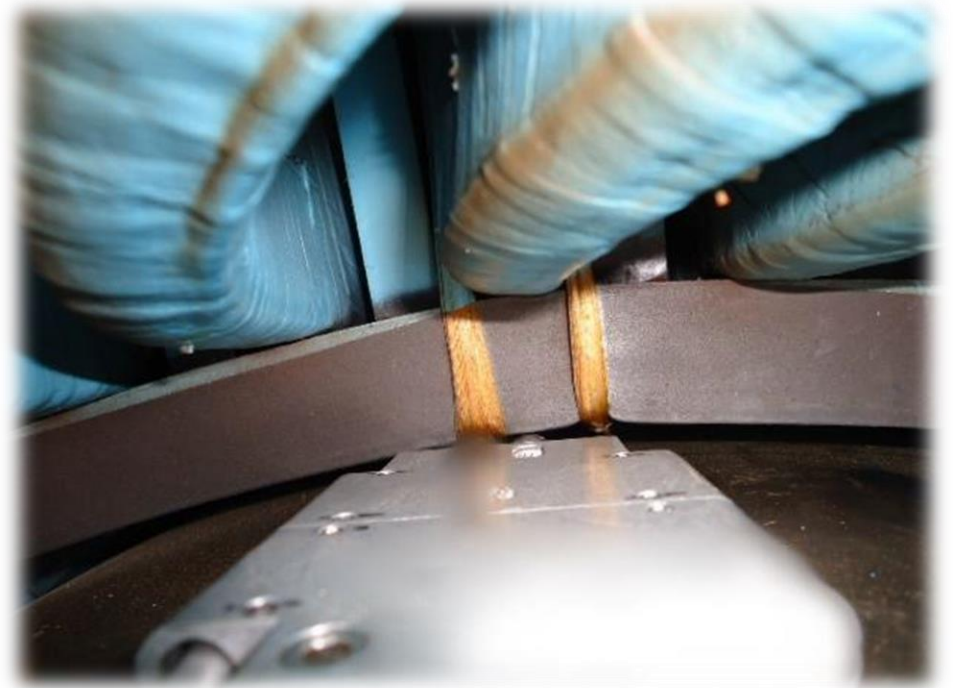
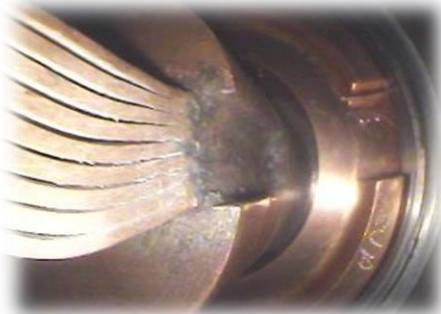
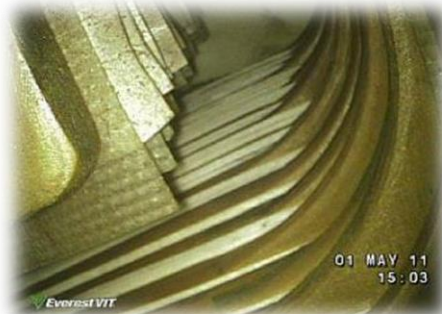
- Initially rotor-out outage performed during turbine major inspection acc. to O&M book
- Later on, maintenance updated according to OEM's documents and user's procedures
- Major outage at maximum 12 years intervals, exceptions for system / budgetary constraints
- Every generator passed during the years two rotor-out and several borescope inspections
- One unsuccessful robotic inspection attempt

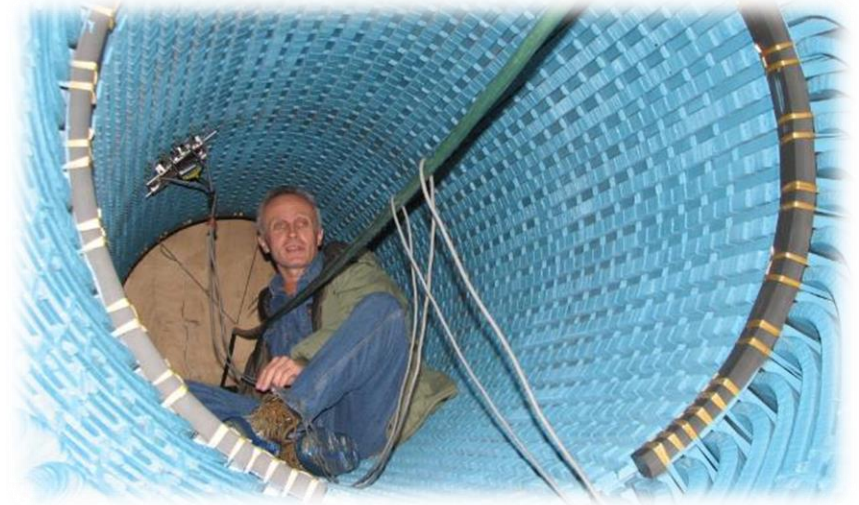
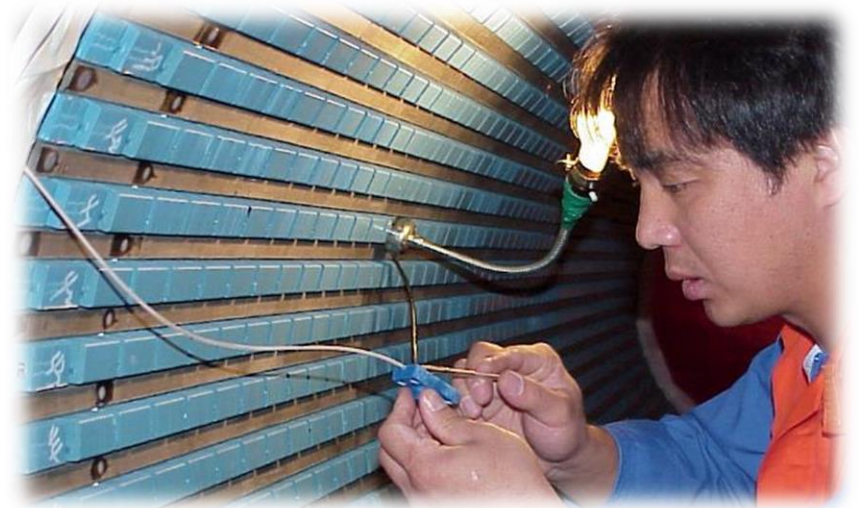
- Visual / borescope inspection of stator and rotor, electrical tests: insulation resistance, PI
- Offline tan delta and PD up to phase voltage. At major outage also ELCID, wedge tightness, RSO
- Complete rewinds opportunity used to perform NDT metallurgic inspection on forging (TIL 1292)
- Flux probes installed in 9 out of 12 generators: 4 w/o shorts, 3 with 1 short, 2 with 2-4 shorts
- No online stator winding PD monitors installed. No special issues on stator insulation
- In some generators EMI done, without findings

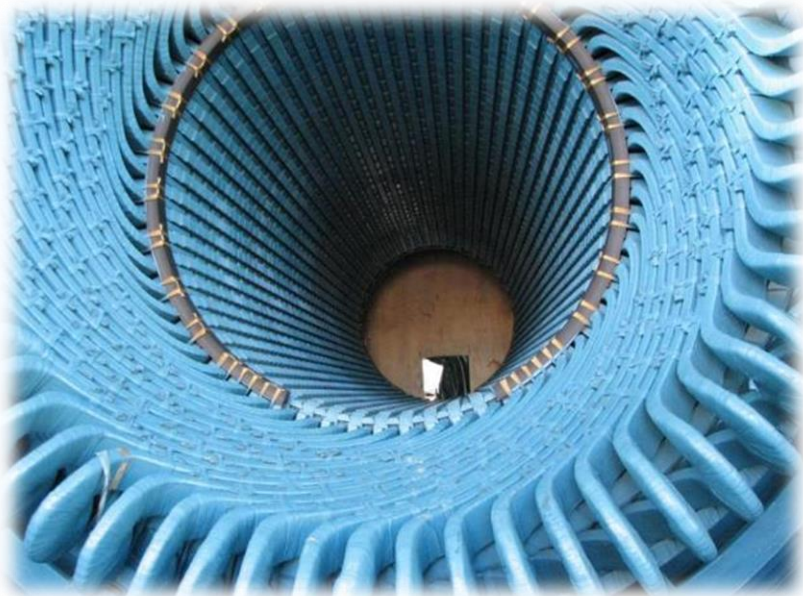
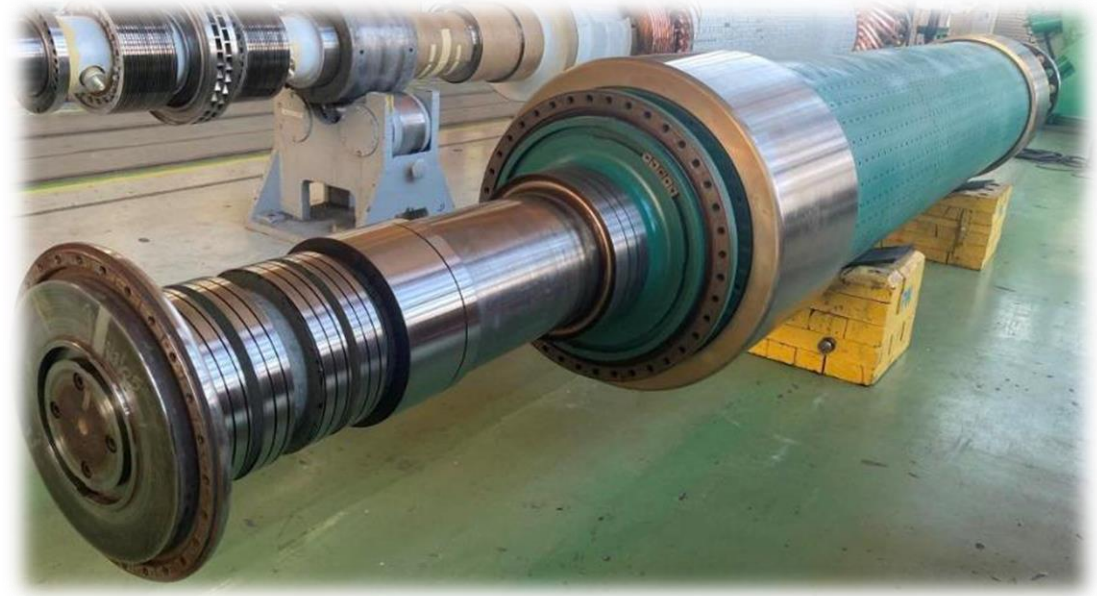
- **Spare rotor**

- Acquired in 2010, after interchangeability study by OEM. Used 3 times
