# Challenges of Rewinding Old and New High Voltage Generator Stators

Virtual Iris Rotating Machine Conference

June 24, 2021

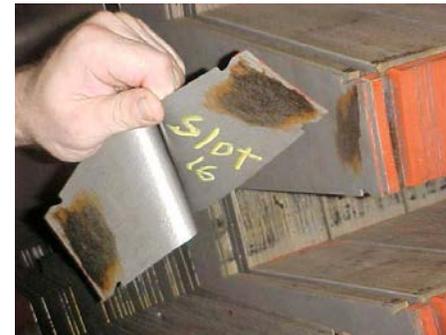
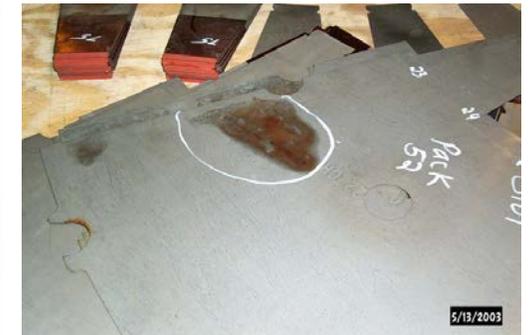
- Original El Cid test had multiple areas of concerns (areas under the curve)

- Core Loop Test Numerous hot spots
  - 90 degrees C temperature spike in 2 minutes
  - 140 degrees C temperature spike in 10 minutes
  - Scheduled one hour test - had to be stopped after 10 minutes

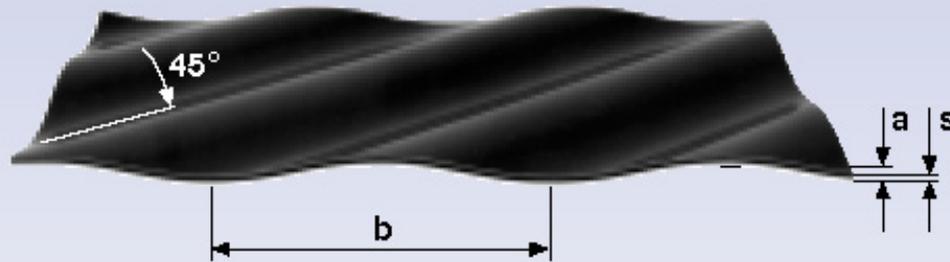
Structure of electrically conducting side ripple springs

**a = free spring deflection = 5 mm**  
**b = wave cycle = 60 mm**  
**s = thickness**

- Krempel semi-conductive side ripple springs
  - Proven track record
  - Resistance to steady state pounding forces
  - Maintains sideways load on coil and continuous contact with core iron
