Magnetic unbalance problem on 60 year old hydrogenator – analysis and solution

Jun 22nd 2021

Ozren Husnjak, Veski Ltd (Croatia)

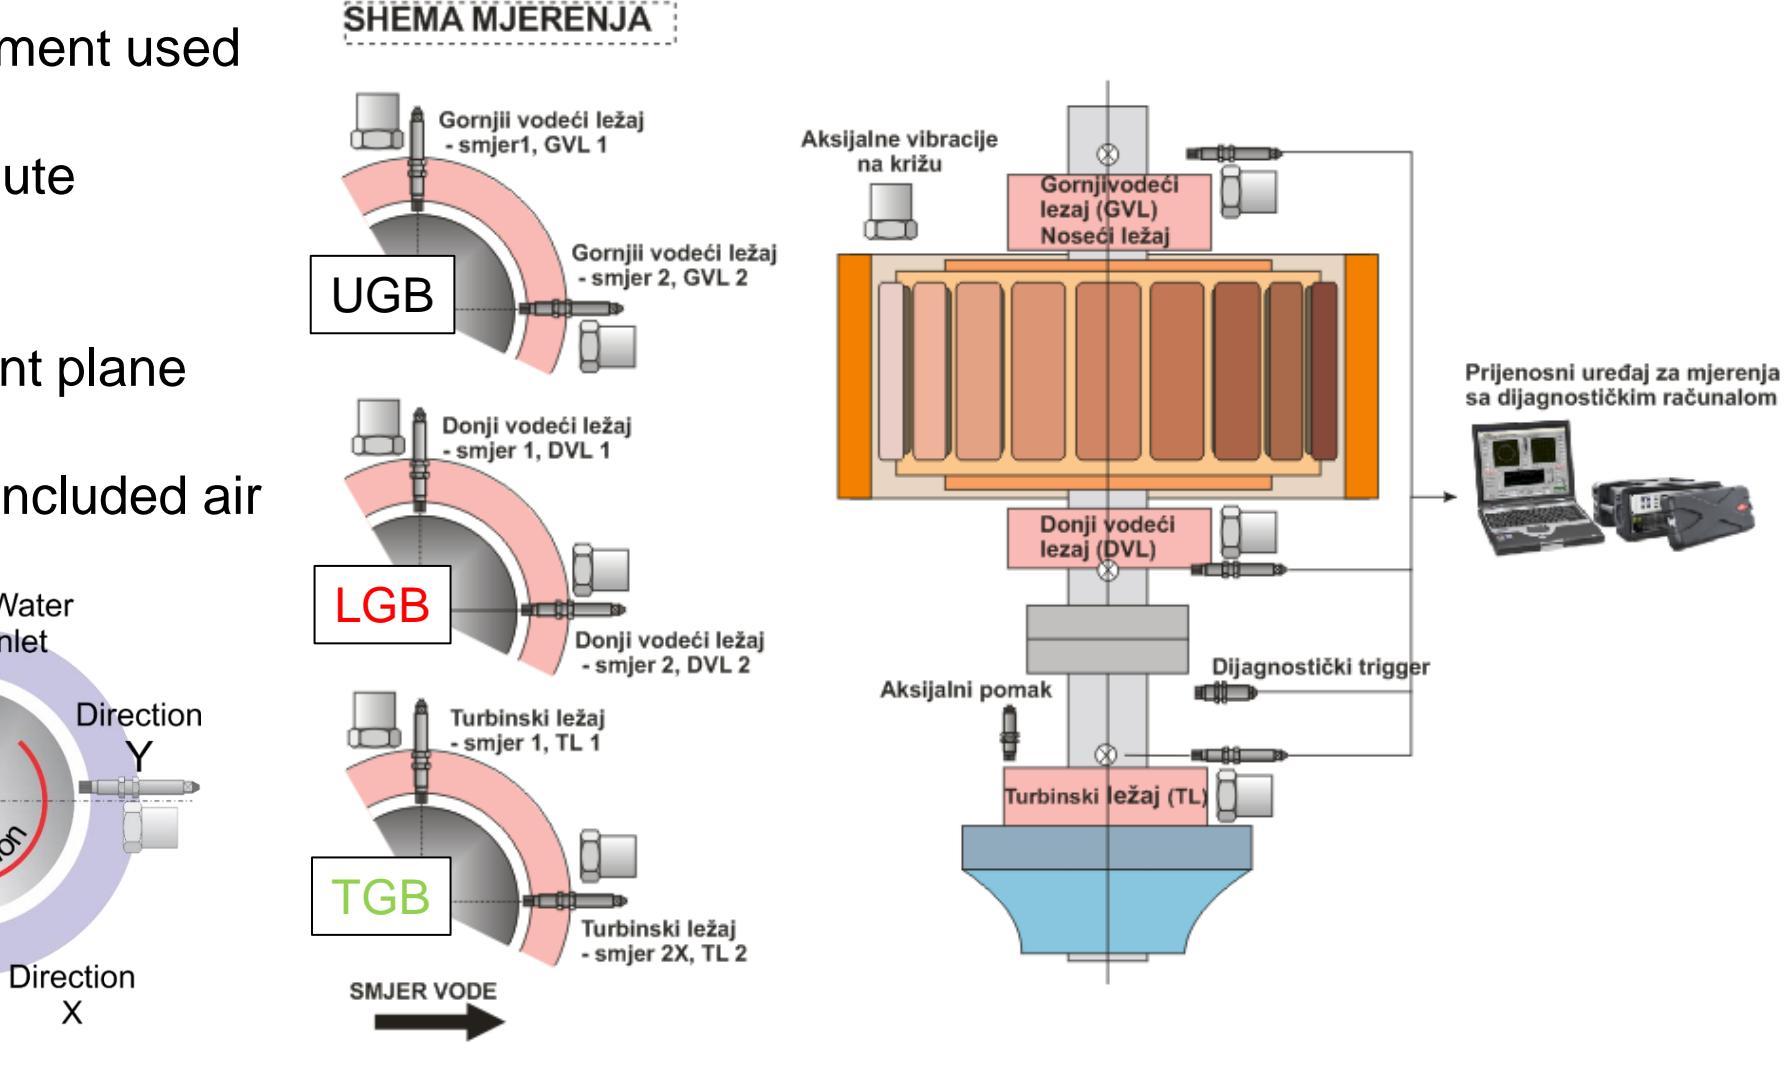
Measurement layout (typical)

- 18 channel portable instrument used
- typically relative and absolute vibrations measured
- 4 sensors per measurement plane
- additional measurements included air gap and magnetic flux Water measurements inlet

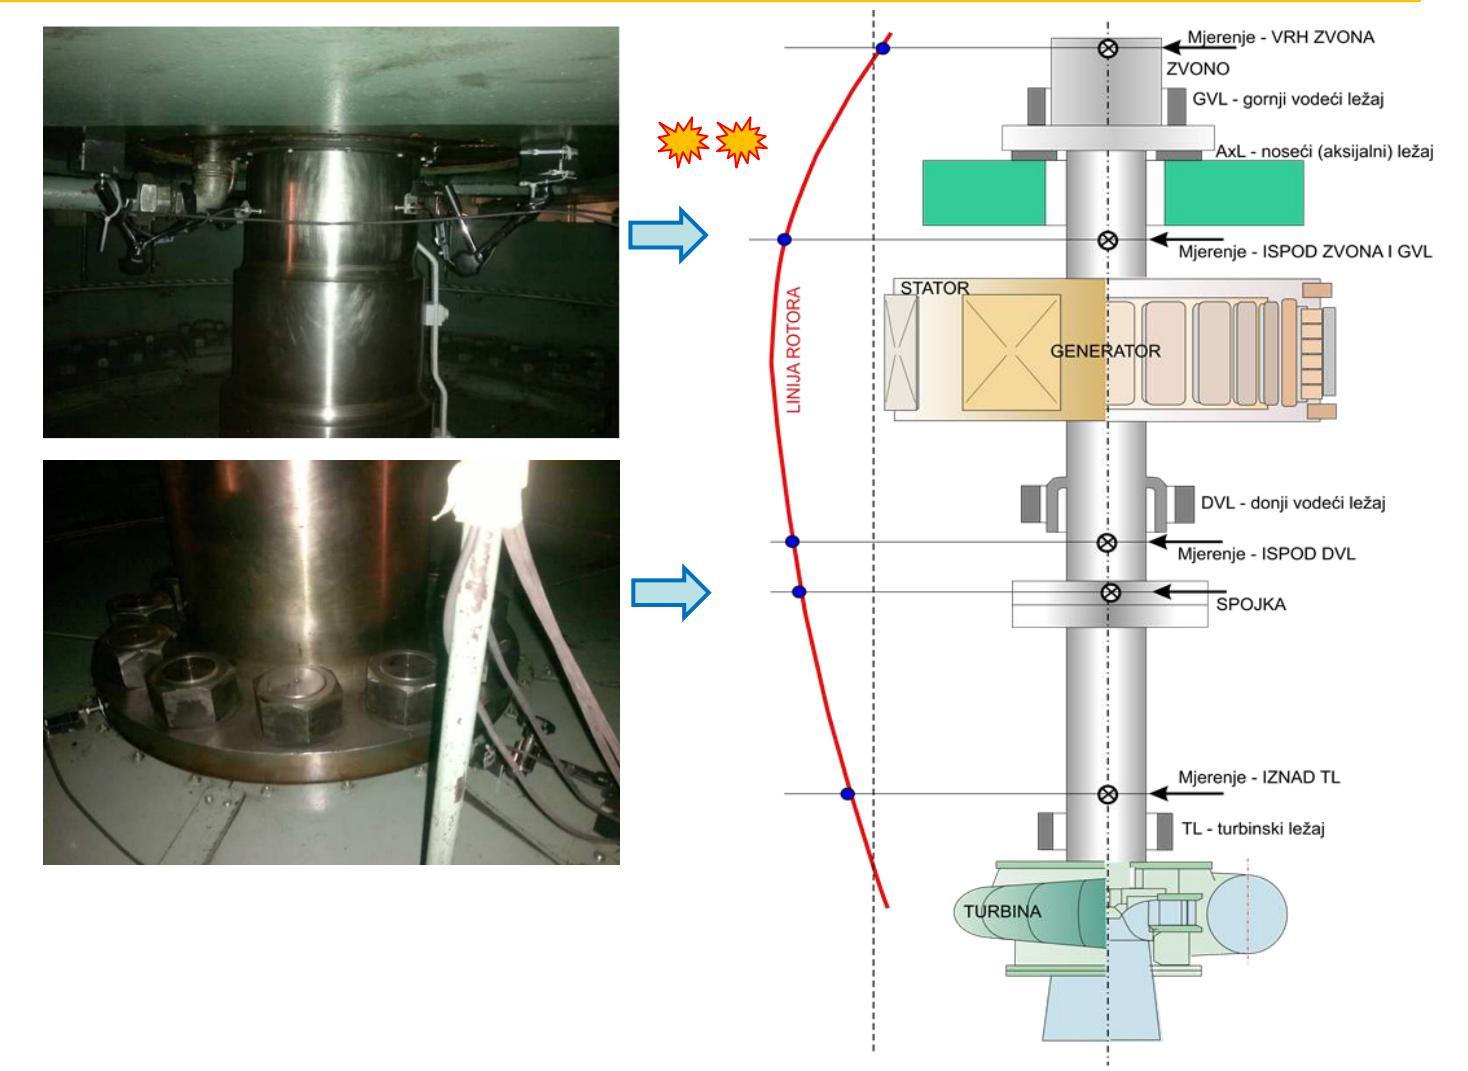
Year 2013. / Unit 1. / Dynamical rotor line prior to overhaul

Dynamical rotor line measurements just prior to the overhaul

- dynamical rotor line is, basically, rotor ODS at the 1x (which is dominant)
- multiple measurement planes (5)
- indicated on the figure

The dynamical rotor line indicates:

- there is no solid connection (shrink fit is lost) between thrust collar and shaft
- additional proof is out-of-phase movement when comparing vibrations above and below thrust collar

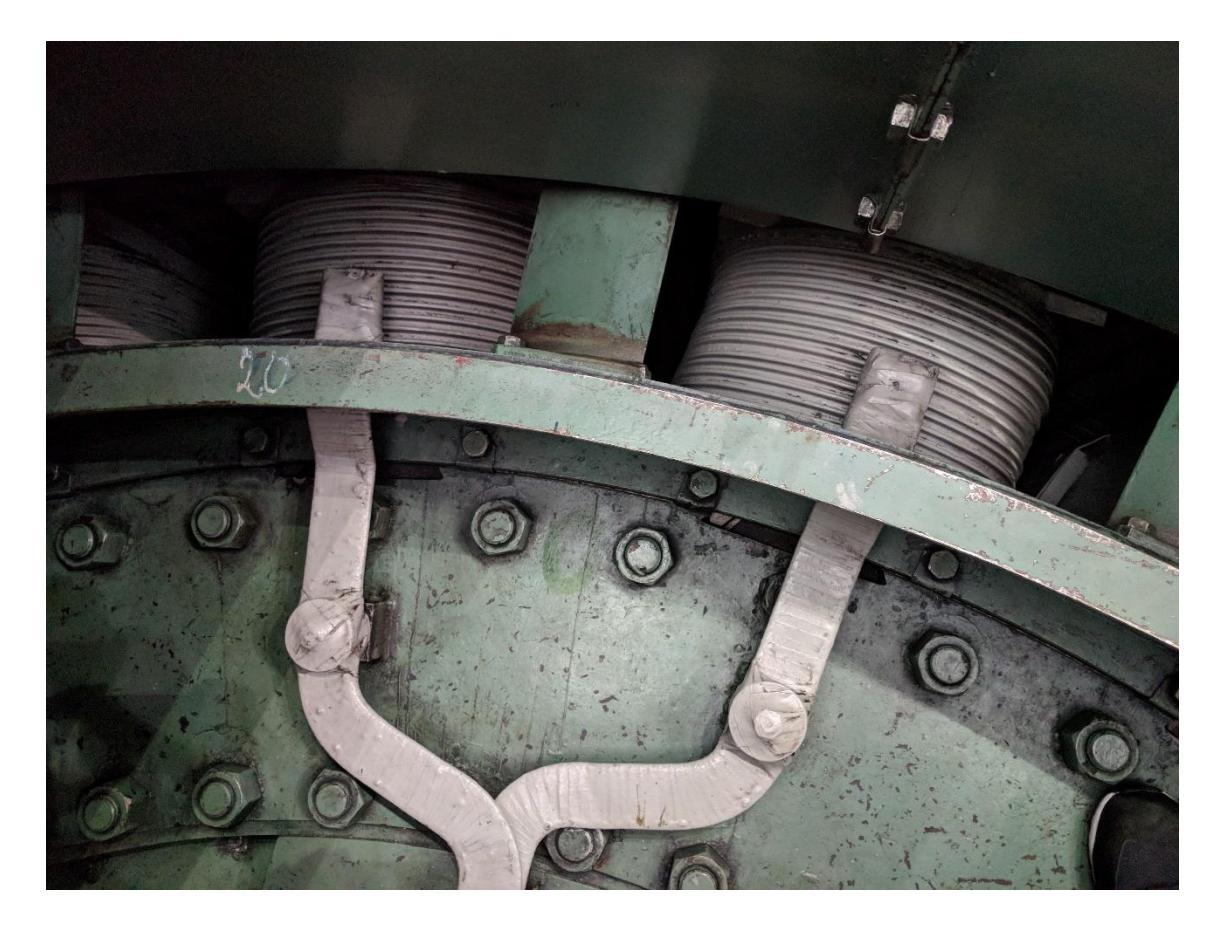
Rotor poles and excitation leads

Air-gap & Magnetic flux measurements to the rescue!

• balancing can only be done to reduce vibrations to certain extent
