BE KIND REWIND

Sometimes you really can't fix it!

IRMC June 28, 2023 Houston, TX

Synopsis: We attempted a repair and ended up rewinding.

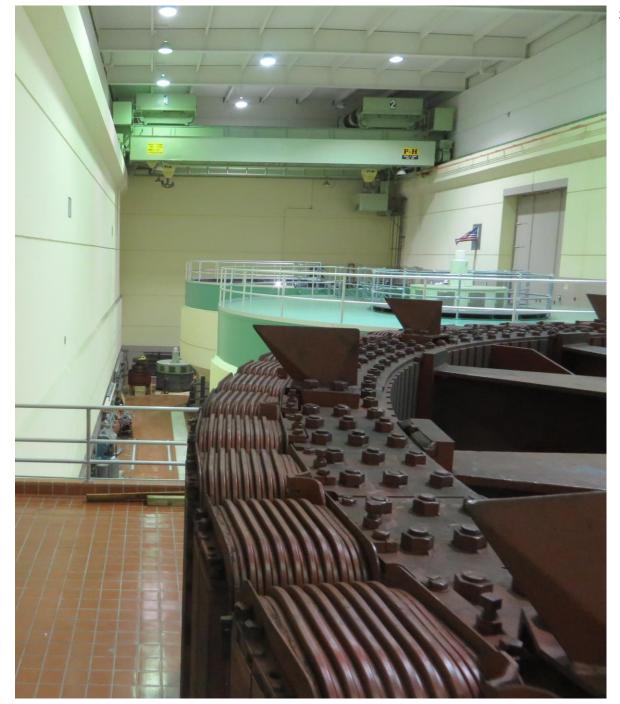
- Late Summer 2016
- Generator differential trip on start-up of Unit
- Fault between A and B phases
- 64G relay did not trip due to a loose wire
- Visual inspection found failure near slots 1 and 2

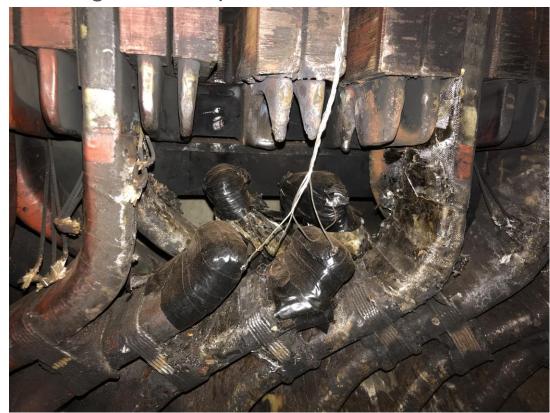
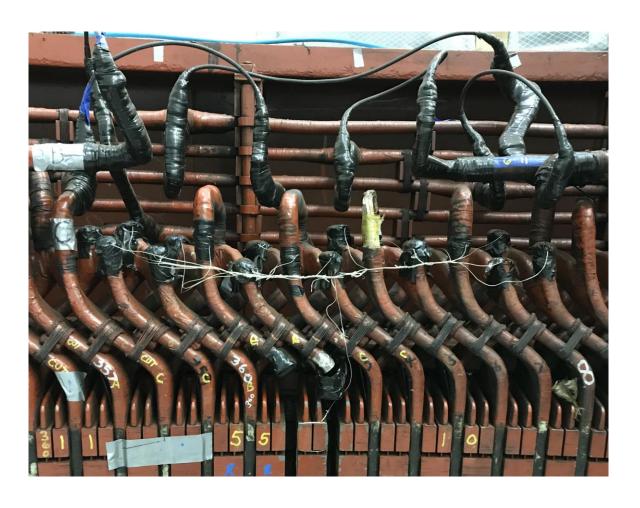
- Contractor's inspection revealed widespread issue with the top core lamination
- "Heavy" lamination had migrated toward the bottom coils
- Affecting 30-50% of slots
- Likely cause of the slot 165 failure
- Unit 1 had the same issue
- Could not proceed with repair
- Contractor was very helpful!

- Developed and resolicit to rewind both units
- Awarded another 3 years later
- Replacing both winding and core
- Resolution still in progress
