# Hydro Generator Rotor Earth Fault

## Installation of Carbon Dust Collection System

Peter Kelly, ESB Ireland

25<sup>th</sup> IRMC – Iris Rotating Machine Conference Houston, TX, June 26-29, 2003

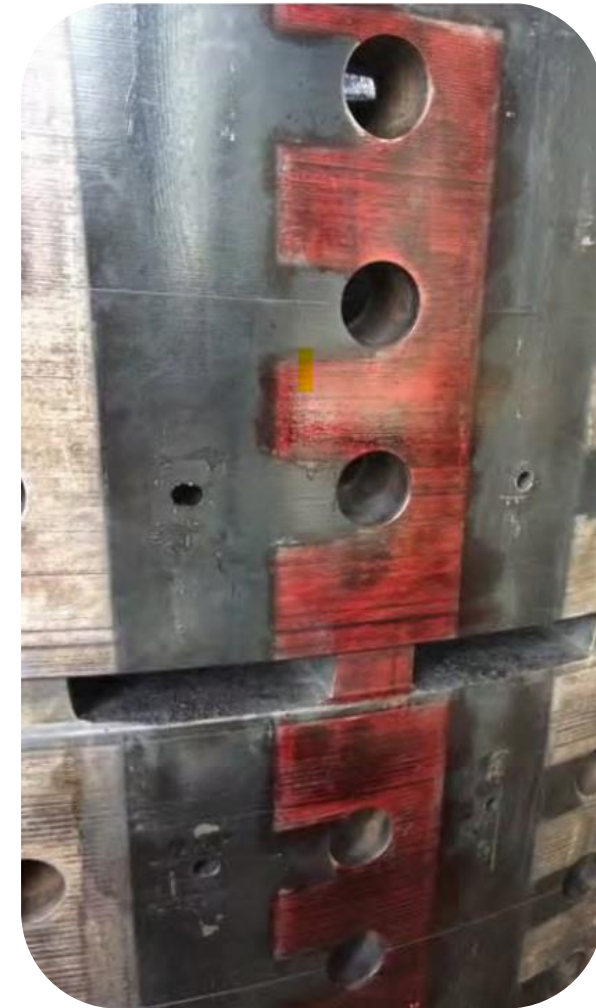
Rotor Rim Exhaust

- Significant carbon dust and oil deposits on the poles
  - Pole windings
  - Pole shoe
  - Pole shims
  - Rotor rim
- Due to the carbon dust built up, tracking paths to ground
- Contamination found on the inner radius of the rotor pole windings
  - No filler, silicon, RTV etc. inserted to prevent debris between pole winding and shoe
  - This was found to be the root cause of the rotor earth faults
  - Once cleaned, IR values were measured in the MΩ range
