Overhaul and repair management of a strategic generator in Western Australia

May 2022

Generator Overview

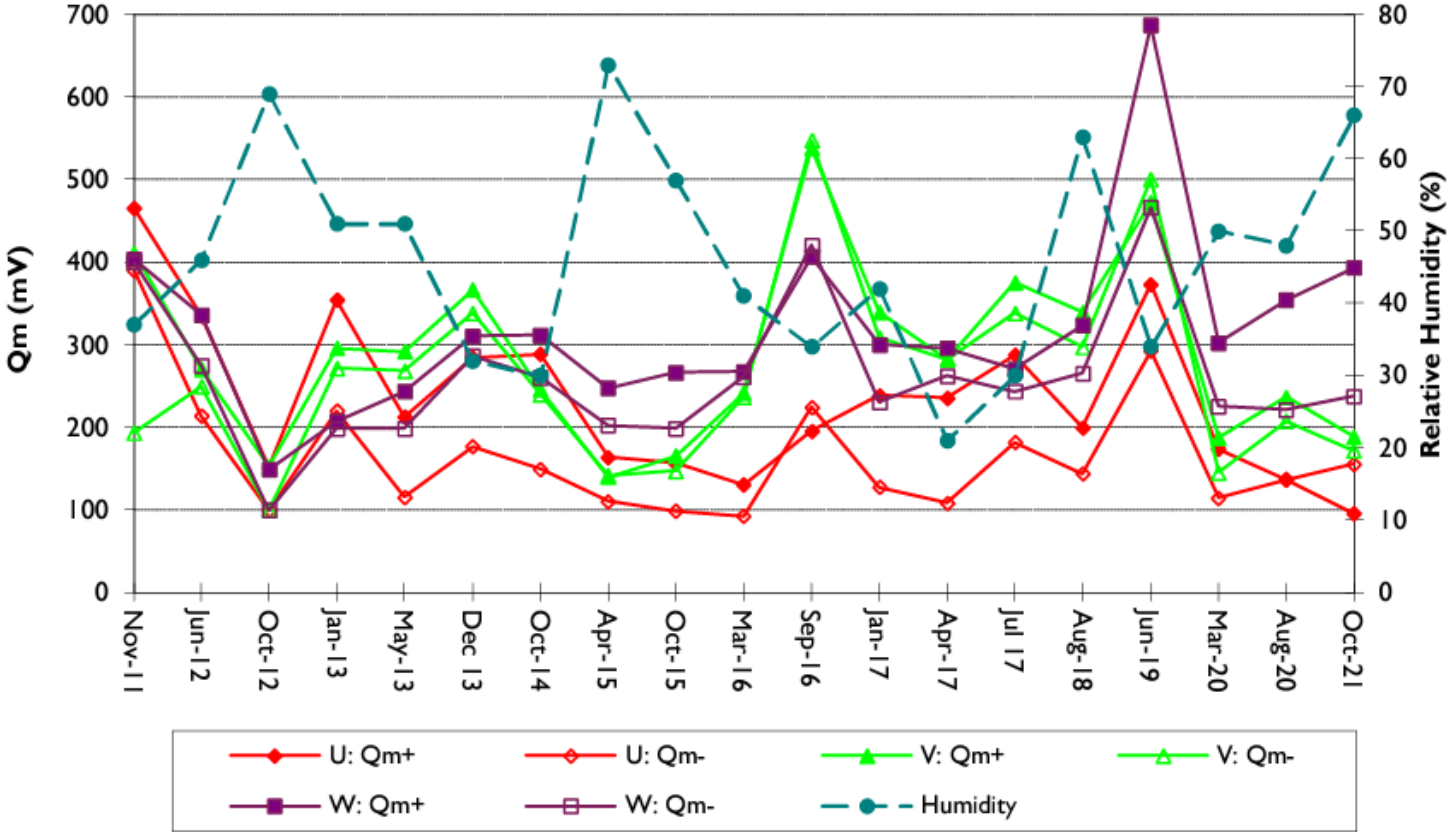
Trend of Qm

Five sessions-moving average trends show an increasing behaviour of PD amplitudes for phases W, while phase U and V shows a stable behaviour. Qm average exceeds the Qm average of similar machines

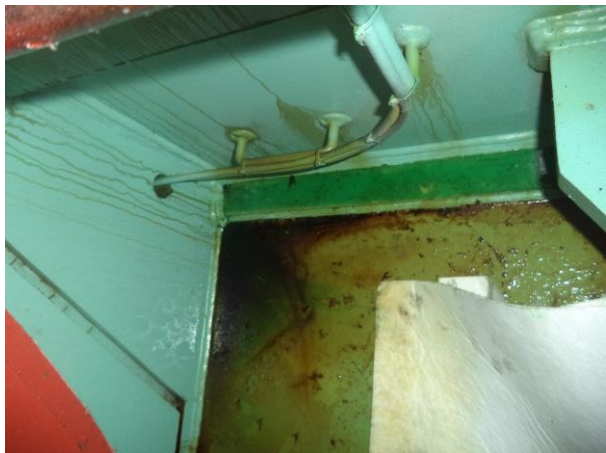
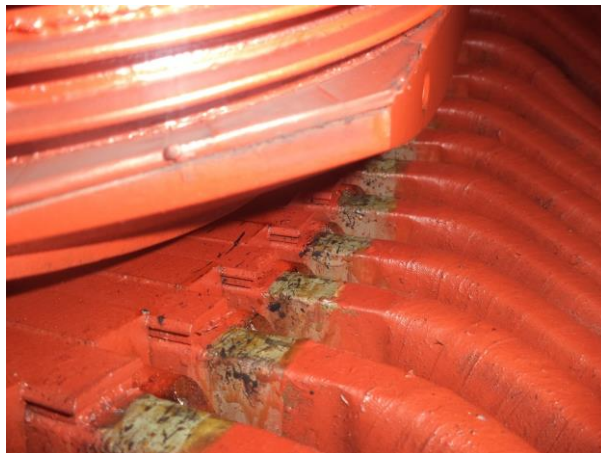
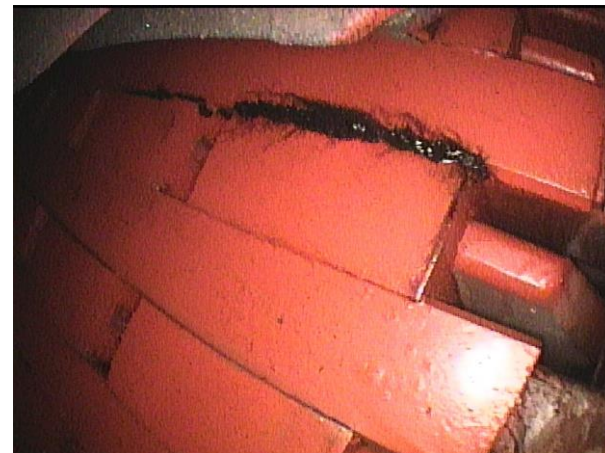
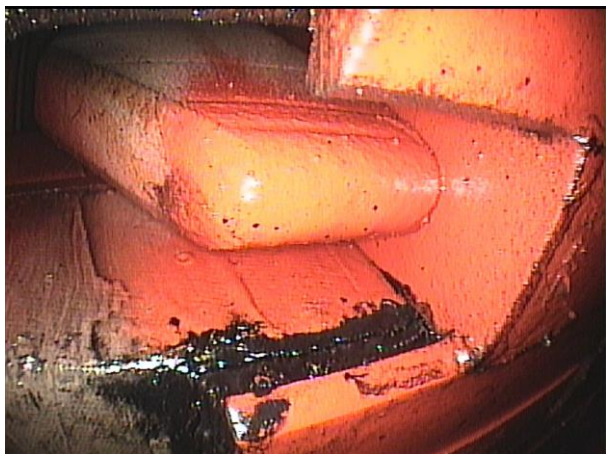
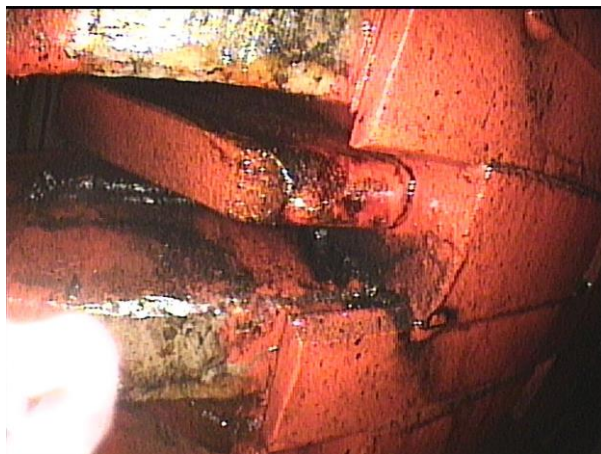
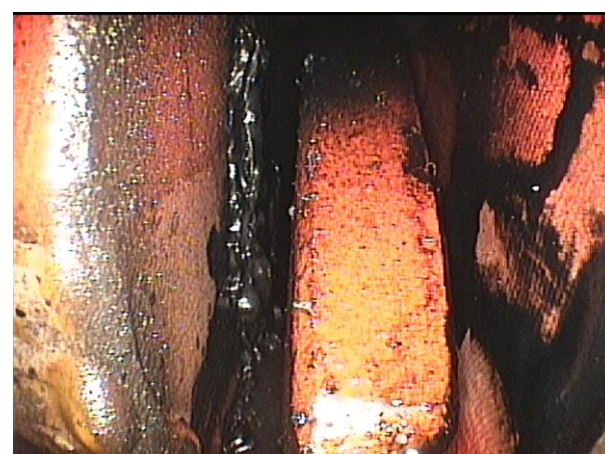
Visual Inspection

The on-line PD measurement analysis suggested end winding discharges on the W phase supported by visual evidence of grease deposits and discolouration seen on the coils at the slot exits and between the phase groups. The risk rank is medium, with internal surface contamination as the major contribution to the operational risk.

- Discoloration at the stress-grading junction indicating surface discharge
- Indicative of endwinding discharge

- Oil leakage and pooling inside bearing housing
- Ineffective machine sealing

- Grease deposit at slot exits and between HV coils in endwinding
- Dirt and grease contamination on wedges

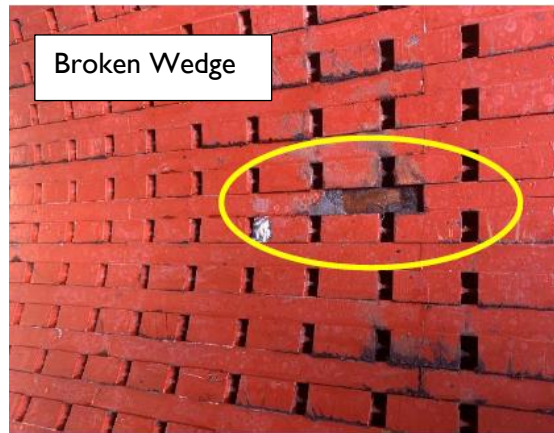
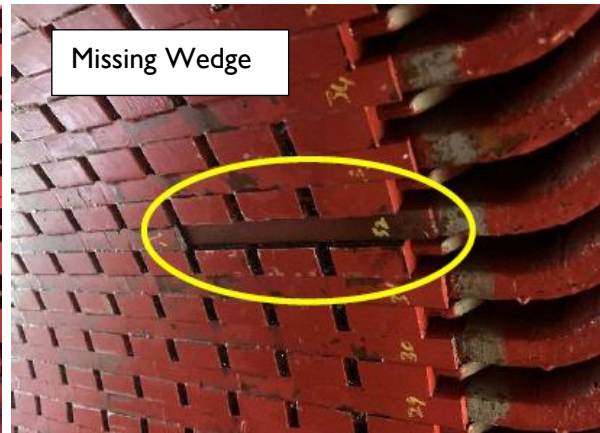
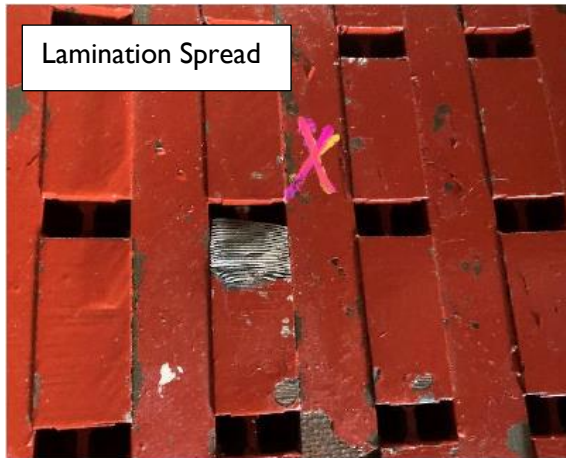
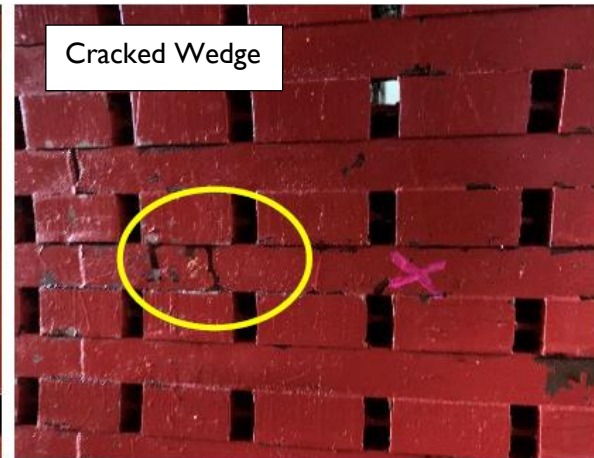
Repair Assessment – Stator Core

Dirt and grease contamination on the surface of stator wedges and inside the radial ventilation duct.
Greasing was identified at the slot exits where wedges were found loose, broken and missing.

Oil stains dripping from the back iron core and on the keybars.
Oil pooling at the bottom of stator housing.

- Generator was successfully commissioned and coupled both sides on-site.
- Hemp packing qualified the machine seal
- Online Partial Discharge Activity was reduced.
- Broken and missing wedges were fixed.
- Grease and dirt contamination was cleaned.

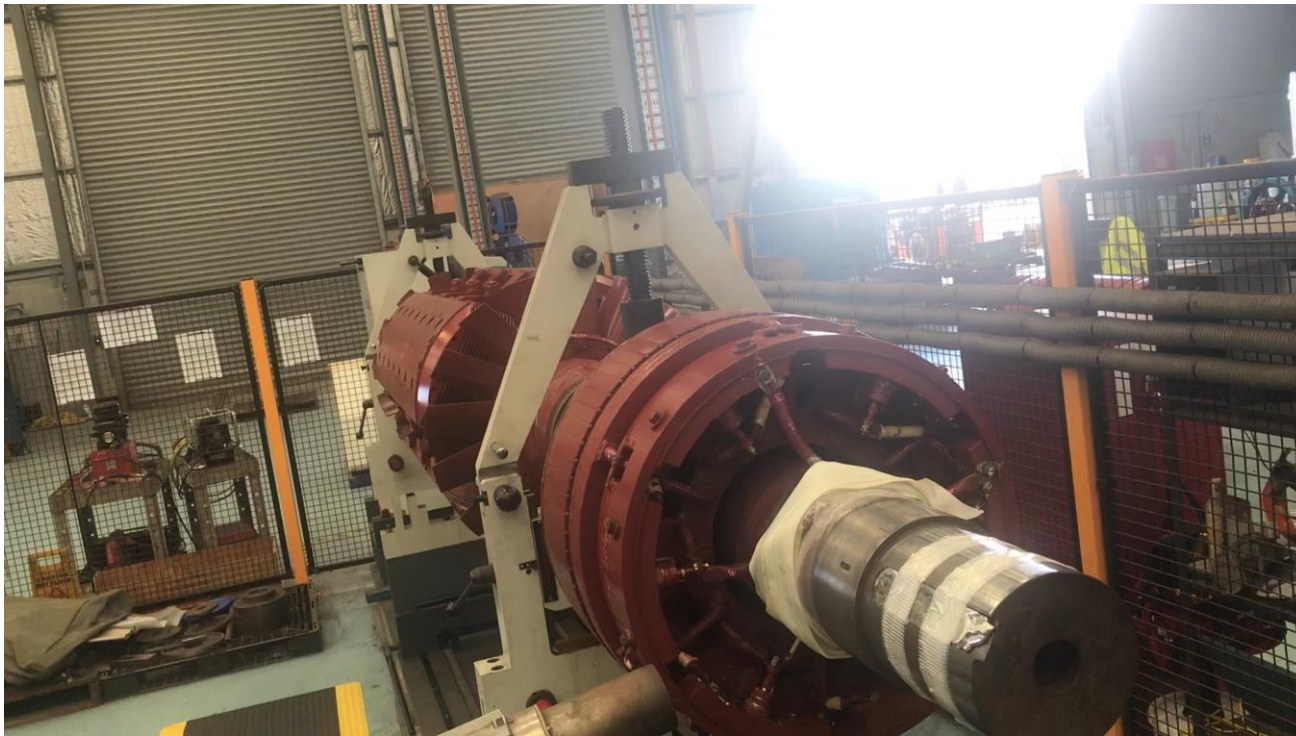
- Rotor dynamic balancing at G1.0 after Cleaned and baked at 130°C
