Overhaul and repair management of a strategic generator at a chemical works in Western Australia

Shinko 6970kW 7600kVA 6.6kV 831A 50HZ 4P 1500RPM 0.80PF Pilot excitation 60V 7.2A

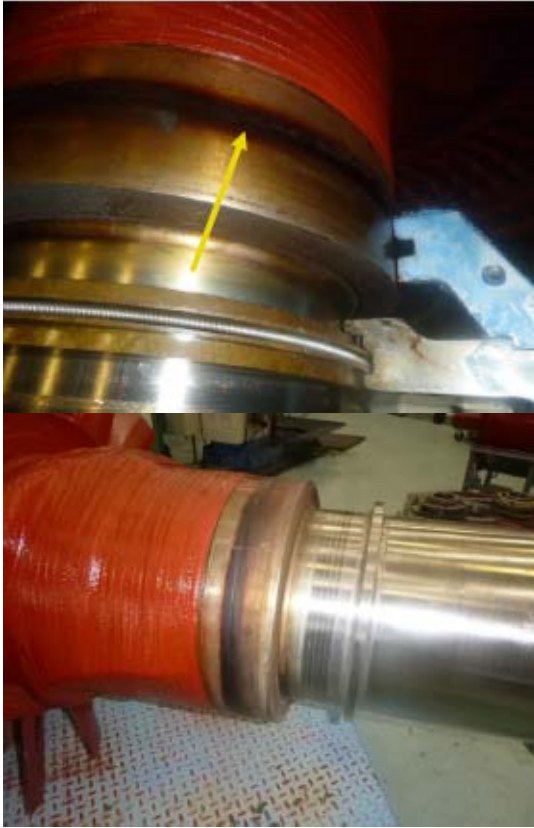
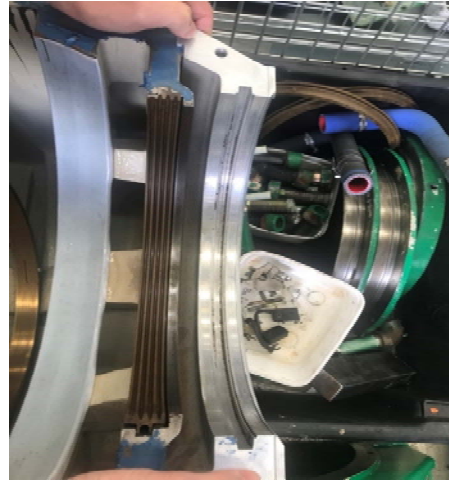
Oil staining on the bearing seal on both sides of the shaft was evident

SINFONIA (earlier known as SHINKO, OEM) was involved to provide the bearing machine seal installation instruction and drawing, to rectify the oil ingress into the bearing.

The assembly of the machine seal and shaft seal was completed per the OEM instructions. The instructions included aligning both halves of the labyrinth seal and including a hemp packing material on the inside groove of the machine seal and the torque values for the fasteners, pressure equalizing hoses were fitted across the labyrinth seal between the machine side seal chamber and bearing sump. New RENK centre flange-mounted bearings were fitted to replace the original bearings.

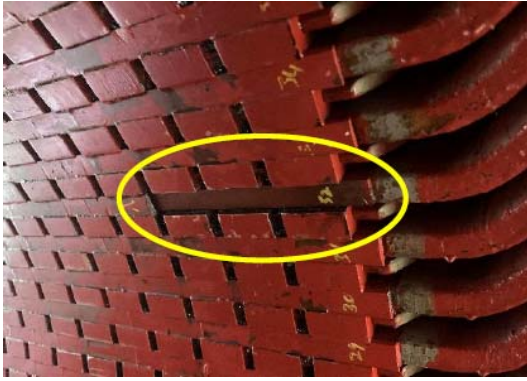
Dirt and grease contamination was found on the surface of stator wedges and within the stator core radial ventilation ducts. 3 slots were identified loosely wedged and some stator wedges were found to be missing.

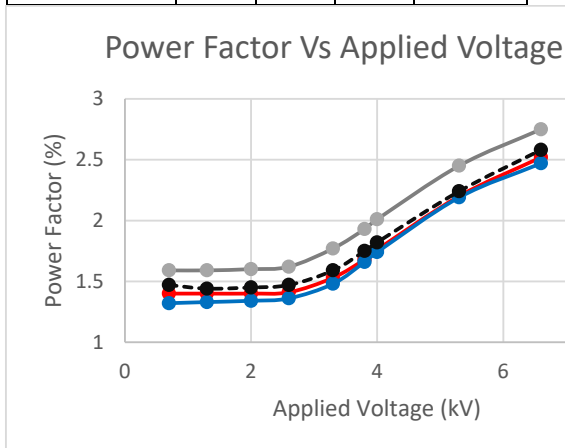
The power factor and tip up were the main parameters adjudicated. During the testing, the voltage was applied at the interval of 10% line voltage and the measurements leakage current, power loss (watts), Power Factor (%) and capacitance were recorded.

DDF Test Analysis	Phase U	Phase V	Phase W	UVW - Combined
Power Factor at 1.3kV	1.40	1.59	1.33	1.44
Tip-up % from 1.3kV to 4.0kV	0.36	0.42	0.41	0.38
Change in Capacitance from 0.7kV to 6.6kV	2.1	2.2	2.2	2.2

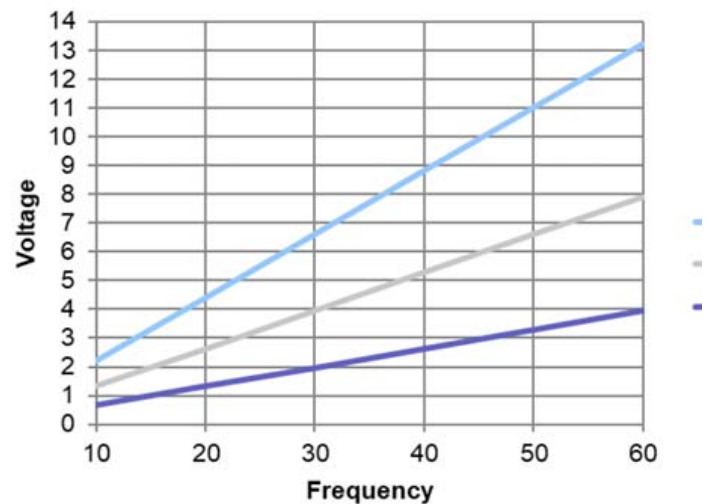
The generator was soft started with the test supply initially set at 10Hz. A crane with a soft sling around the shaft was used to lift the bearing and initiate rotation. Excitation was applied to follow the provided V-F curve as the machine was accelerated to full speed. 1500rpm and 6600V.

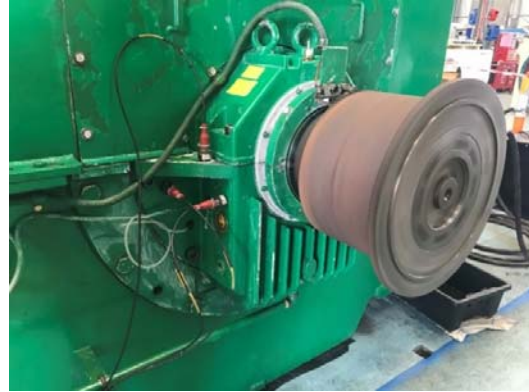
Dynamic testing was performed with the heat exchanger mounted and without water circulation to provide the correct airflow within the generator housing, the winding temperatures at the end of the test were $\sim 88.9^{\circ}\text{C}$ and 96.9°C .

- Shaft induced voltage was measured at 123mV.
- Run down on the first test run was recorded as 20 minutes 2 seconds.

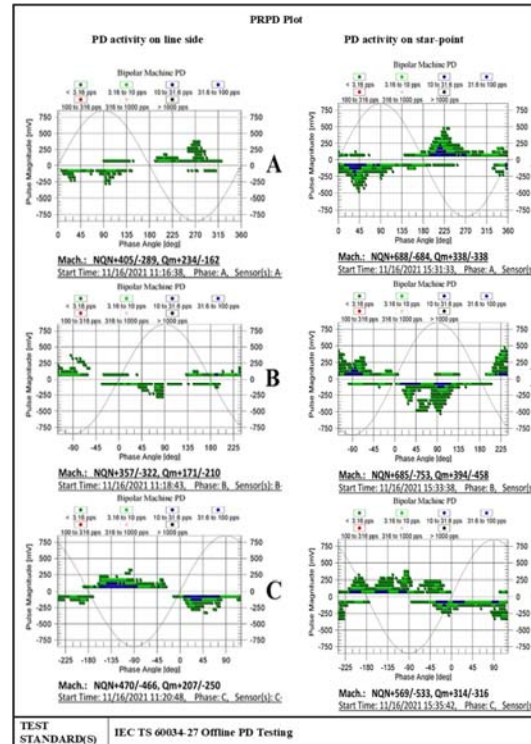
During the online partial discharge testing, all the phases exhibited a moderate to high level of partial discharge activity. The classic partial discharge activity had no polarity predominance indicative of voids and discharge within the main wall insulation. Non-classic pulse distributions were indicative of PD activity on endwinding at the RTDs and cross-coupling among the phases.

The partial discharge activity after the overhaul was improved and was qualified lowest on the original line side orientation. The stator winding was re-configured with this orientation.
