IRMC 2023
The 25th Iris Rotating Machine
Conference

Partial Discharge Levels Before and After Partial Stator Winding Refurbishment in PSHPP Velebit

PSHPP Velebit

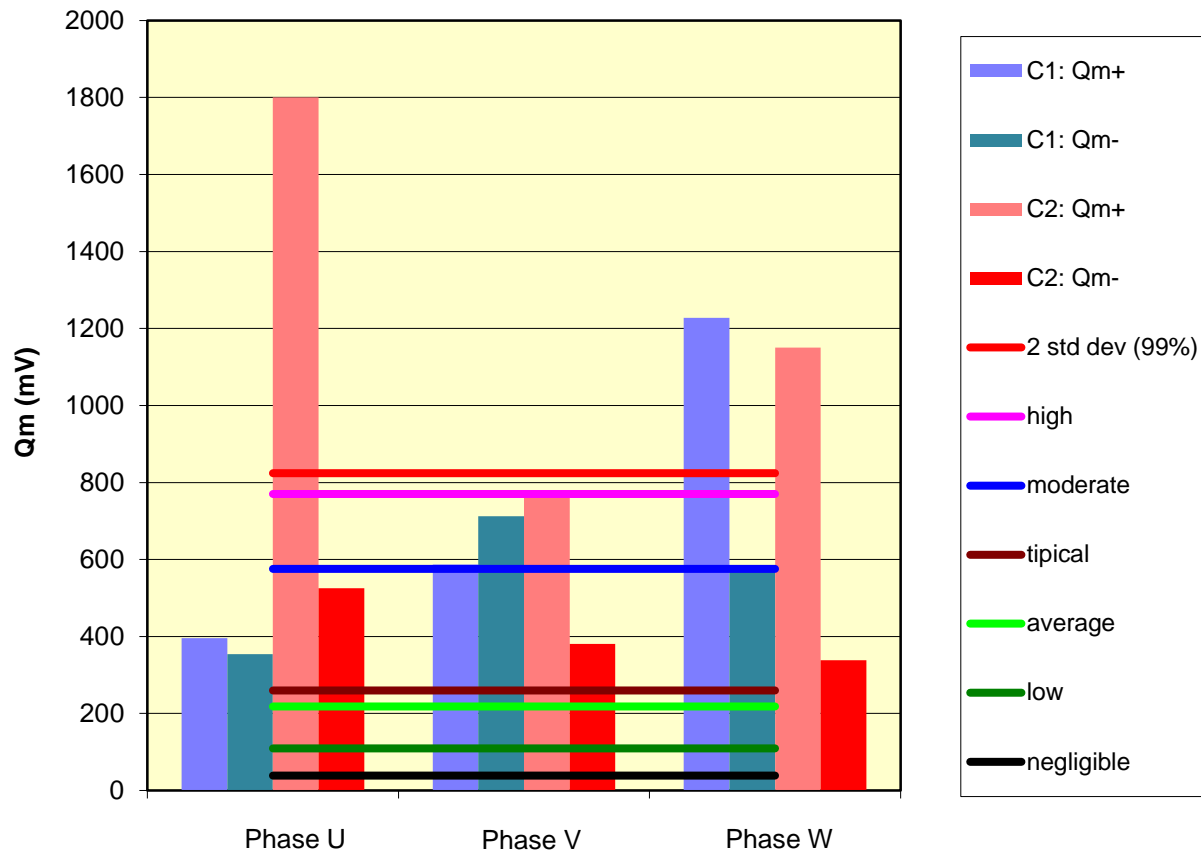
MG2 – Measurements in 2015

(two highest results are shown)

Trend variable due to outage activities (cleaning, re-painting and recovery of corona damage)

Due to high PD levels, continuous operation on upper voltage range and visual inspection of winding where at least one third of stator bars showed degradation due to partial discharges, it has been decided to refurbish the stator winding.

All bars would have the semiconductive (slot part) and gradient (slot exit) layers of insulation replaced.
