## **RESONANCE RELATED PROBLEM, DIAGNOSTICS AND SOLUTION PROPOSAL ON VERTICAL FRANCIS HYDROGENERATOR**

### **ABSTRACT**

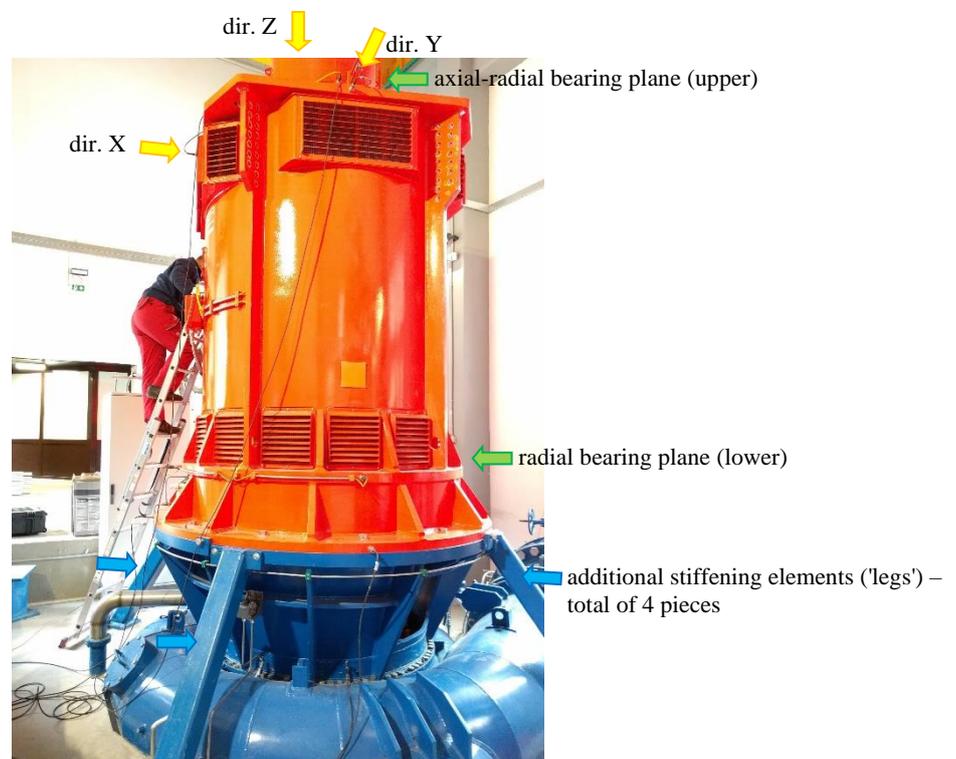
Fig. 1 shows the photo of the unit with the measurement directions marked. The directions X and Y are radial and the direction Z is axial. The appropriate bearing planes are also marked – upper bearing is axial-radial and the lower bearing is radial. Both are rolling element bearings.

*Fig. 1 Photo of the unit with typical measurement directions and planes marked. Measurement directions are X, Y and Z.*

The photograph also shows additional stiffening elements ('legs') whose bottom part is anchored to the concrete foundation and the upper part is next to the generator pedestal flange. As needed, these 'legs' can be attached to the flange or separated from it – in both radial and axial directions.

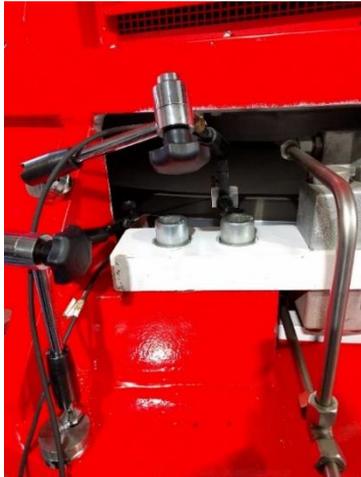
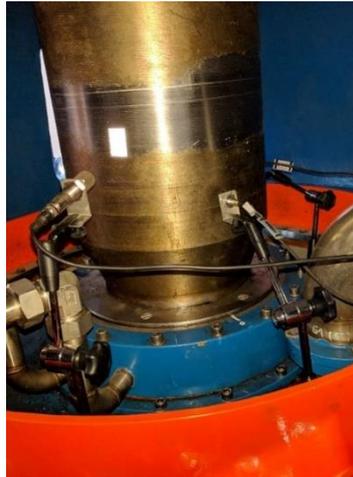
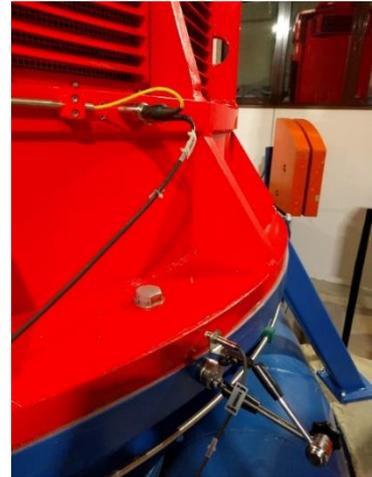
Axial and radial measurements on a flywheel

Radial displacement measurement in the turbine cover area

Radial generator flange displacement measurement relative to the turbine

*Fig. 2 Photos of measurement sensors on some measurement positions.*

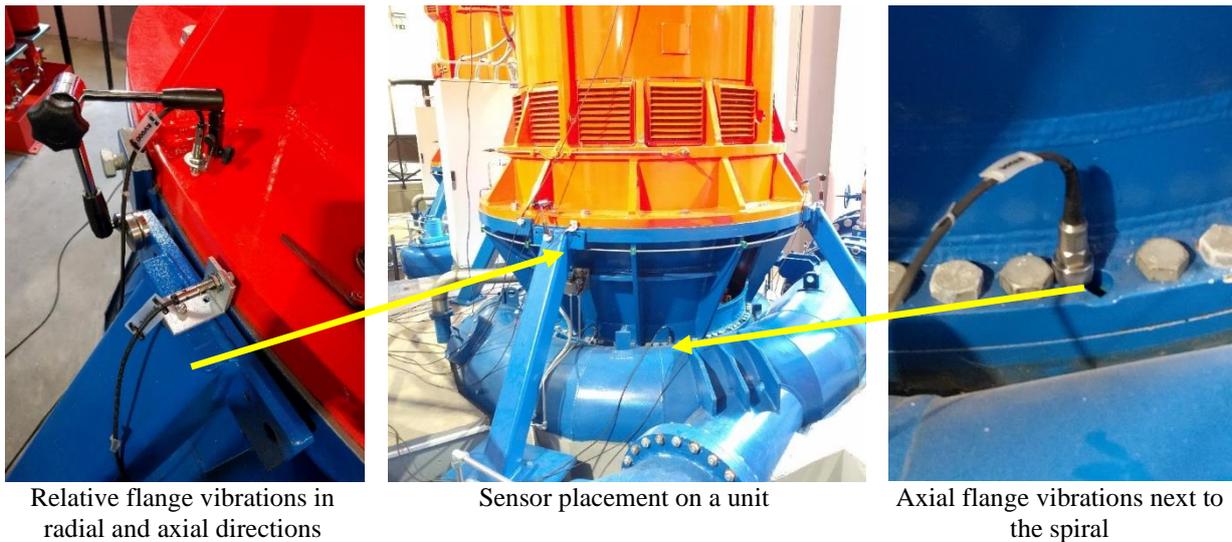
*Fig. 6 Photos of the sensors on measurement positions relevant in evaluation of pedestal stiffness and foundations stability.*

The first important results were related to the axial flange position and its displacement when the water entered the spiral case. It is a static (DC) position, that is, a distance from the sensor's tip of 4 sensor placed on additional stiffening elements. It should be noted (as it is visible from [Fig. 6](#)) that the stiffening elements are separated from the flange and, since they are firmly connected to the foundations (screwed into it) and do not vibrate when the unit is running (which was proven with measurements) they should be treated as a foundation. Therefore, flange displacement relative to foundation can be measured.

Therefore, since the statical (when the water entered the spiral) and dynamical (large flange axial vibrations) unit instabilities were confirmed – the overhaul procedure should only take into account the unit foundations. In other words, the problem solution lies in increasing the stiffness below generator pedestal.
