Study on cause analysis and detection method of inter-turn short circuit fault of large turbine generator rotor

ZHAN LIU

Xi'an Thermal Power Research Institute

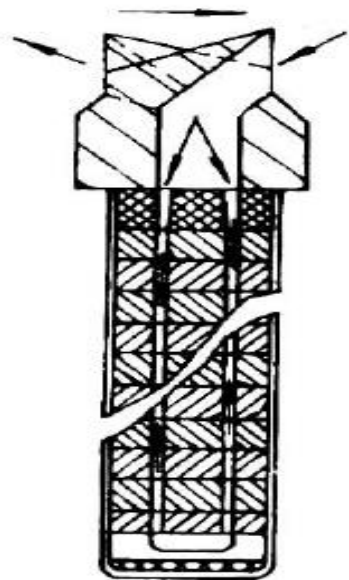
The cooling design of the rotor winding grooves of large turbine generators with 600MW and above capacity class is shown.
