IRMC 2024

324 Generator Failure Discoveries, Concerns, & Repair

W. Howard Moudy
Director of Operations
National Electric Coil
hmoudy@national-electric-coil.com
724-787-4967
www.National-Electric-Coil.com

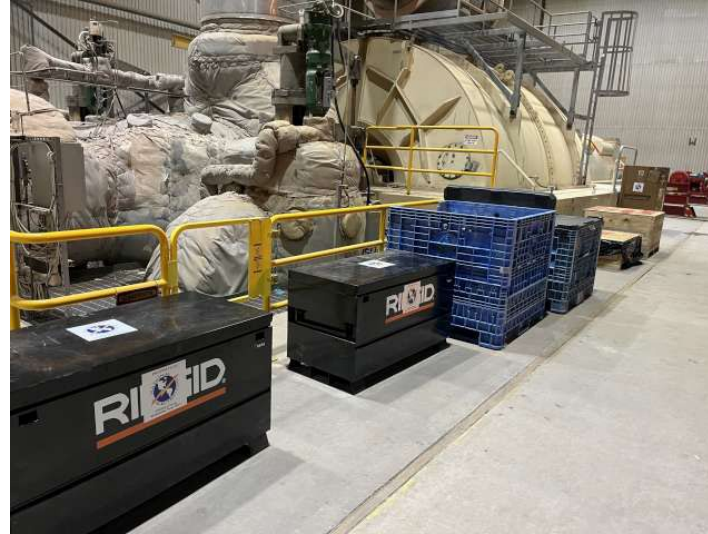
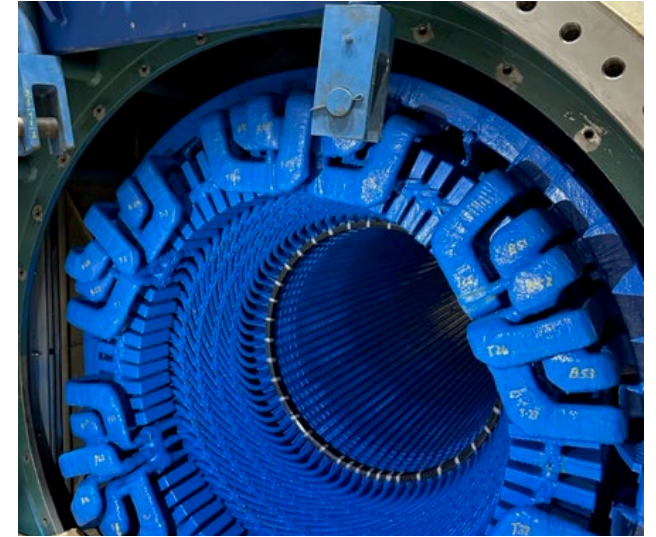
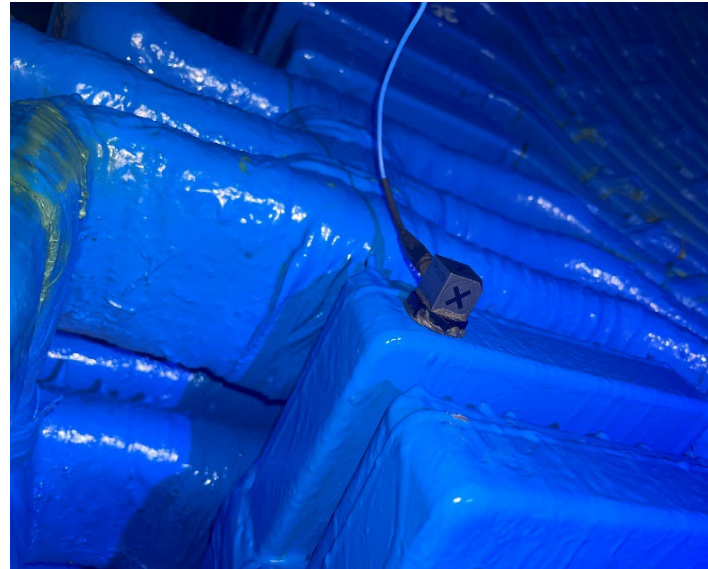
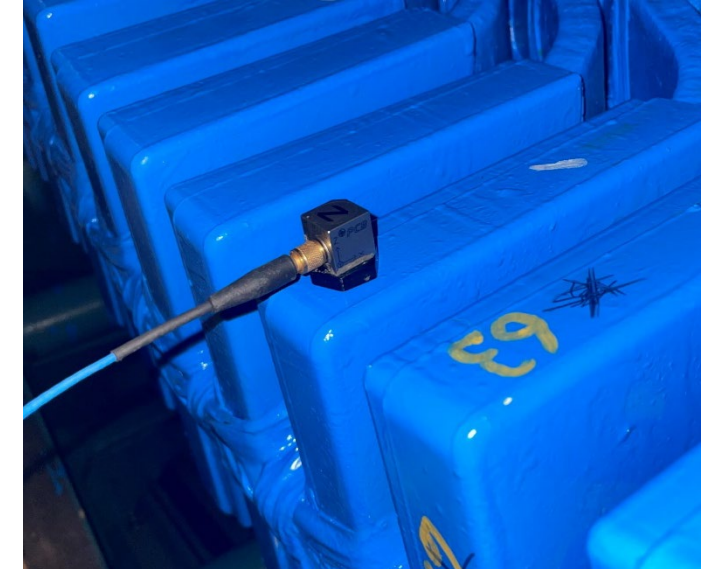
NEC Mobilization

- Early expectation that known issues with the EE end winding and in specific phase straps were at the core of the failure.
- TE end winding discovery identified as likely problem or at least contributor
- Bump testing performed

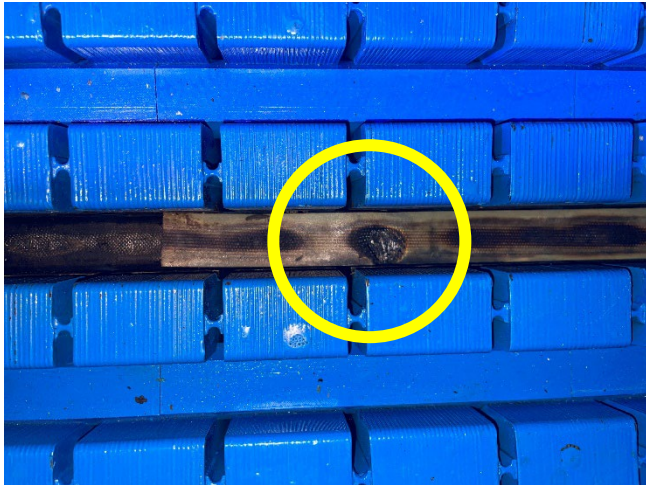
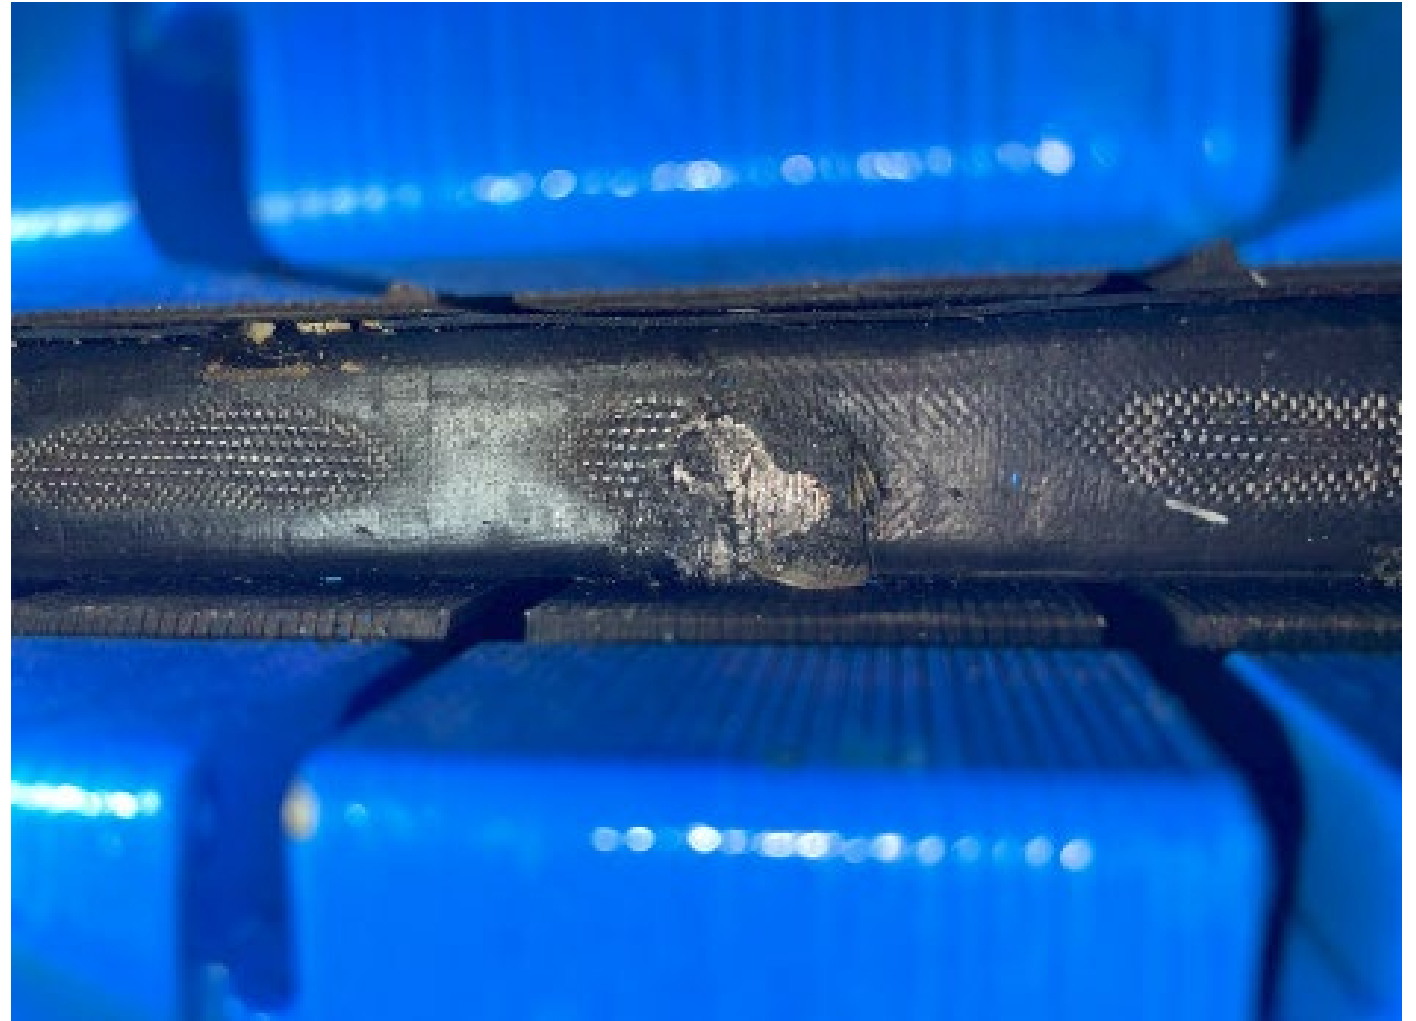
Probable Origin of Overheating & Point Of Failure

- Most significant burning found **14” from the TE of the core in slot #63**

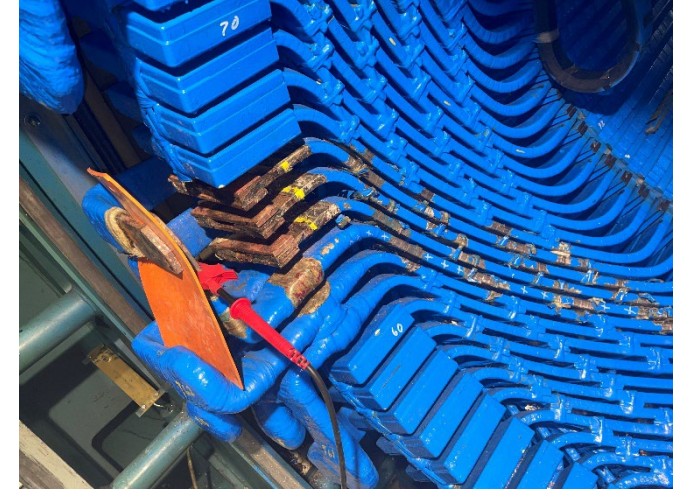
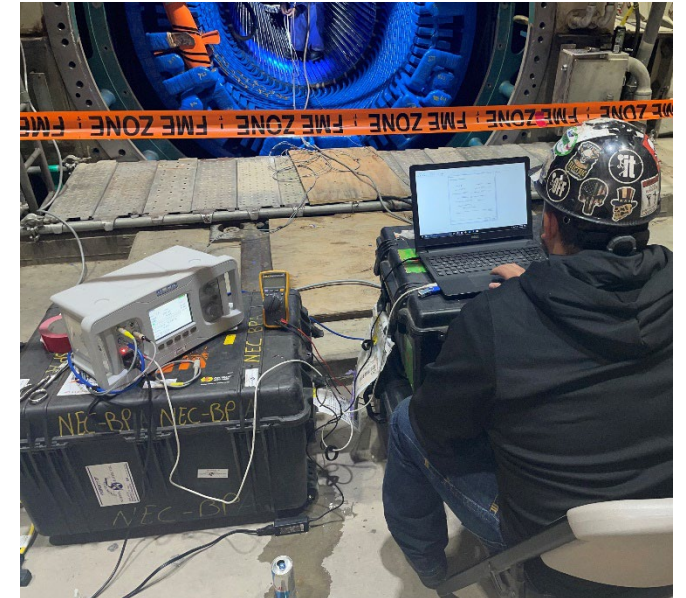
Top Coil Slot #63

Isolated from T2 – T5 Phase

- Good winding resistance (megger) testing results.
- Polarization Index (PI) - at 10 kV DC.
 - $PI = R_{10min}/R_{1min}$:
 - Phase A $PI = 21.7G\Omega/2.70G\Omega = 8.04$
 - Phase B $PI = 21.7G\Omega/3.57G\Omega = 6.09$
 - Phase C $PI = 15.6 G\Omega/3.03G\Omega = 5.16$
- A ramp test graded DC Hipot was performed on all three phases up to 37 kV DC with leakage measured at 37.0 kV DC:
 - A - 4.3 μ Amps
 - B - 5.0 μ Amps
 - C - 4.9 μ Amps.

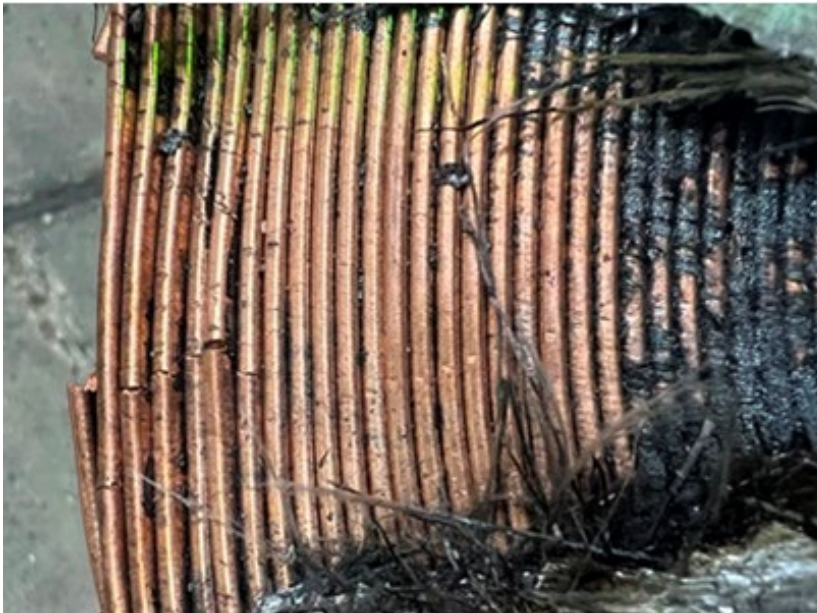
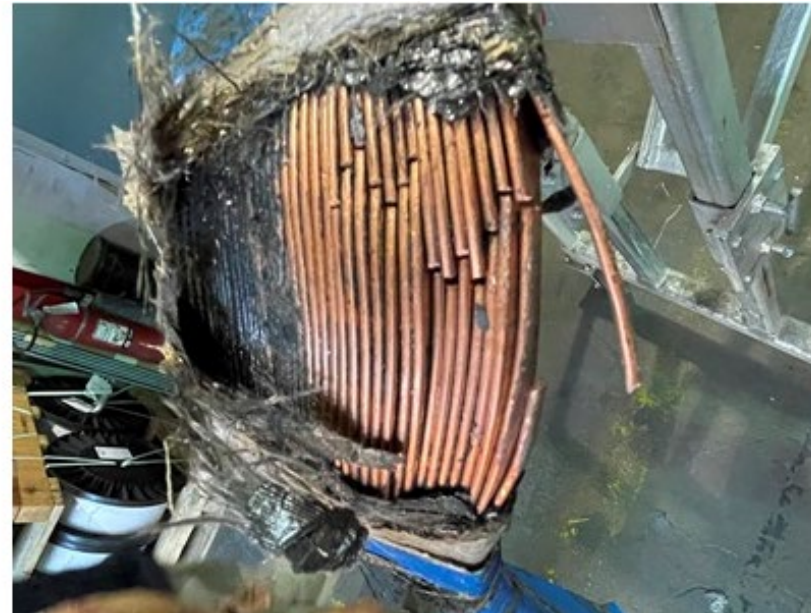
Failed Coil Arrival - Cracked Strand Discovery WHY?

- Cracks in shipment due to copper hydrogen embrittlement from extreme heat in the generator hydrogen atmosphere
