CASE OF IPB VIBRATION MONITORED AFTER TWO WELD FAILURES

Company: Coal-fired Power Plant in Arkansas, U.S.A.

Machine: Unit 1, 25 kV 836 MW two-pole hydrogen-cooled generator in operation since 1983

Summary: Arc flash at welds on busbar adapter for flexible links at generator bushing

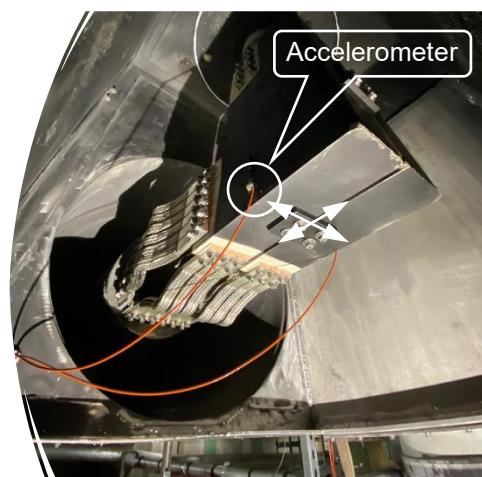
Vibration Monitoring and Findings: Two dual-axis EVAII optical fibre accelerometers were installed per phase to measure vibration in two orthogonal directions in the horizontal plane. The output was connected to a GuardII+ continuous monitor for long-term storage and trending.
