# CASE OF IMPROPER PROXIMITY SENSOR INSTALLATION DISCOVERED BY SHAFT CURRENT MONITORING

**Company:** Hydro Power Plant in Quebec, Canada

**Machine:** Unit 12, 13.8 kV 83.34 MW 128.6 rpm 56-pole hydro generator rewind in 2024

**Summary:** A shunt resistor that measures the shaft current was burnt due to high current

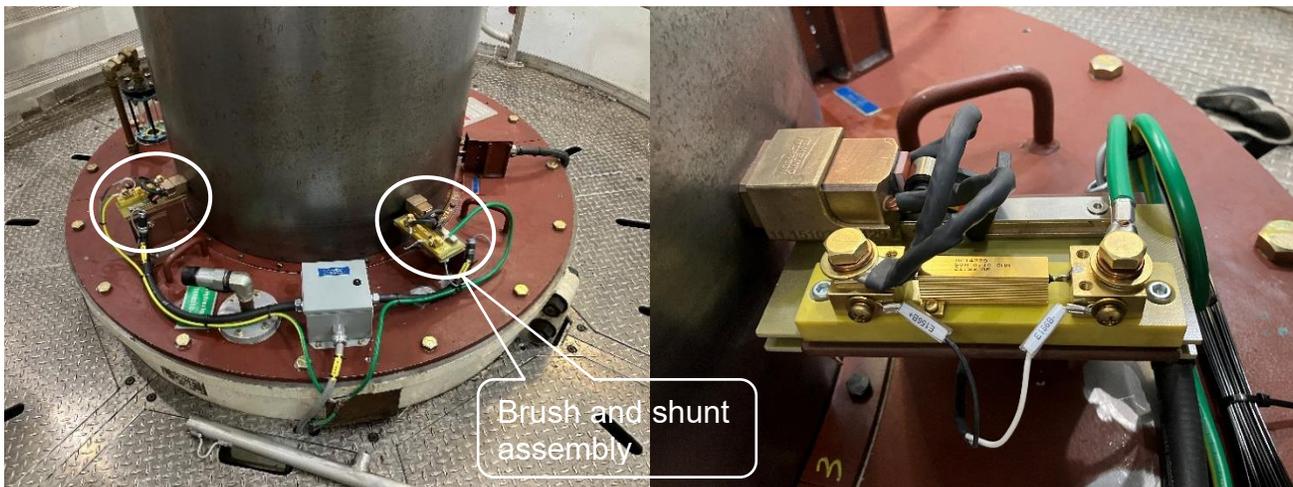
**Background:** A GuardII+ continuous monitor was installed to measure partial discharge and shaft voltage/current during the outage in 2025. Two sets of carbon brushes and resistive shunts were installed at 90° to each other on top of the turbine bearing to measure the shaft current.

**End User Report:** The GuardII+ monitor captured an instance of very high shaft current of 83 A peak-to-peak at both current channels, as shown in Figure 1 and Figure 2. One of the shunt resistors was found to be burnt one day later. The resistance was 0.1  $\Omega$ , which was incorrectly used for a historically low shaft current. The shunt was replaced with a 1  $\Omega$  model after the incident.

**Findings and Confirmation:** A proximity sensor was improperly installed at the upper guide bearing. It was in contact with the shaft and was not insulated. This formed a current loop with the shaft and therefore caused a high current as well as occasional sparking. The customer fed back that the high current has not been recorded again by the GuardII+ monitor after the sensor was removed.
