# USING MAGNETIC FLUX MONITORING TO DETECT SYNCHRONOUS MACHINE ROTOR WINDING SHORTS

Copyright Material IEEE  
Paper No. PCIC-2011-17

**Abstract** - The rotor windings of synchronous motors and generators are usually very reliable. However, the turn insulation in such machines will eventually degrade and puncture due to thermal aging, load cycling and/or contamination. Although turn shorts do not directly lead to machine failure, they can lead to high bearing vibration, may damage synchronizing systems within brushless motors and may limit output. Off-line tests are available to detect rotor winding shorted turns, however they may be unreliable since the rotor is not spinning for the test and if only a few shorts are present, the shorts may disappear once the rotor is spinning (or vice versa). With funding from the US Electric Power Research Institute, a new type of on-line magnetic flux test has been developed that is suitable for salient pole machines, and in particular the salient pole rotors in 4 (or more) pole hydrogenerators and synchronous compressor motors that are widely used for air separation. The test requires retrofitting a small magnetic flux probe to the stator core

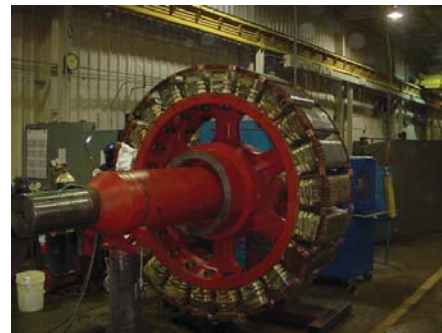
Fig. 1 Rotor from a salient pole synchronous motor

Most of the synchronous motors used in the air separation business have salient pole rotor windings having 4 to 26 poles. Each field pole is an electromagnet, and the rotor winding is made by mounting the poles in pairs on the rotor rim. The poles are then electrically connected to the DC supply (normally up to a few hundred volts) in such a way as to create alternating north and south poles around the rim. Each field pole consists of laminated steel core, which looks rectangular when viewed from the rotor axis. Around the periphery of each pole core are the copper windings. Fig. 1 is a photo of a rotor from a 20-pole salient pole synchronous motor.

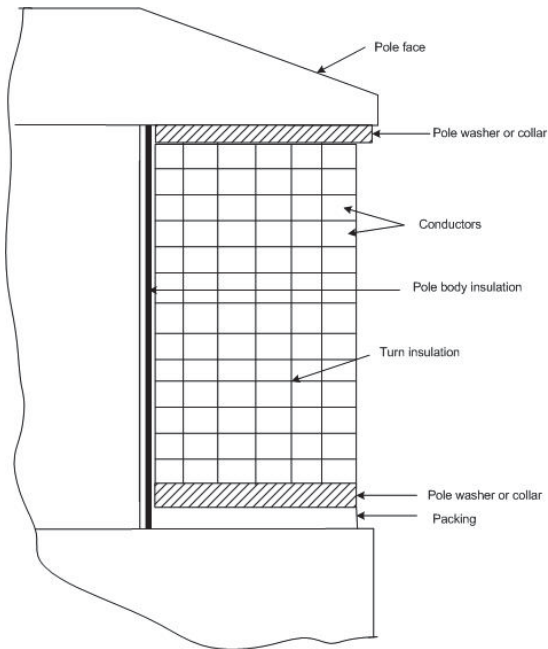
Fig. 2 Multi-layer wire wound design

There are two basic types of salient pole designs [1]. The older type of field pole design, and still the design used on motors less than a 1000 HP or so, is called the multi-layer wire wound type. In this design, magnet wire is wrapped around the pole (Fig. 2). The magnet wire usually has a rectangular cross section, and many hundreds of turns are wound on the pole, several magnet wire layers deep. The turn insulation is the magnet wire insulation. Looking from the axial direction, the laminations are shaped to have a pole tip (which is the part of the rotor pole which is closest to the stator) to support the winding against the centrifugal force. Insulating washers and strips are placed between the magnet wire and the laminations to act as the ground insulation.

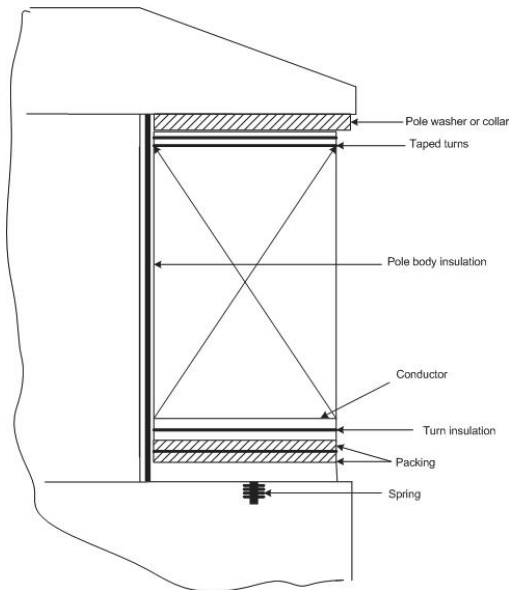
Fig. 3 Copper "strip on edge" salient pole design

For larger machines, the 'strip-on-edge' design is favored since it can be made to better withstand rotational forces. In this case a thin copper strip is formed into a 'picture frame' shape, so that the 'frame' can be slid over the pole laminations (Fig. 3). Laminated insulating separators (made from epoxy glass laminates or Nomex<sup>TM</sup> materials) act as turn insulation to insulate each copper 'frame' from one another. On some copper 'frames', especially those near the pole face, an insulating tape may be applied to the copper strip to increase the creepage distance. The tape and separators form the turn insulation, and the copper 'picture frames' are connected in series to make the coil. As with the multi-layer design, the winding is isolated from the grounded pole body by insulating washers and strips (Fig. 3). Often the entire pole may be dipped in an insulating liquid to bond the various components together.

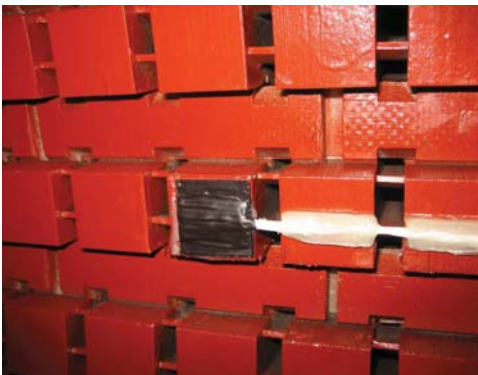
Fig. 4 Flux Probe (black) mounted on a stator core tooth, with connecting lead (white)

Rotor flux monitoring involves measuring the magnetic flux in the generator or motor air-gap to determine if field winding shorts have occurred in the rotor poles. The radial magnetic flux from the rotor is detected by means of a coil or "probe" consisting of several dozen turns that is glued to a stator core tooth (Fig. 4). As each rotor pole sweeps by the flux probe, a voltage is induced in the coil that is proportional to the flux from the pole that is passing the coil. The voltage is measured by electronic instruments. In a salient pole machine, the radial magnetic flux profile across each rotor pole depends on the MW and MVAR loading of the machine. After corrections for variations in the air-gap, any change in the flux profile within a pole at a given load must be due to shorted turns.

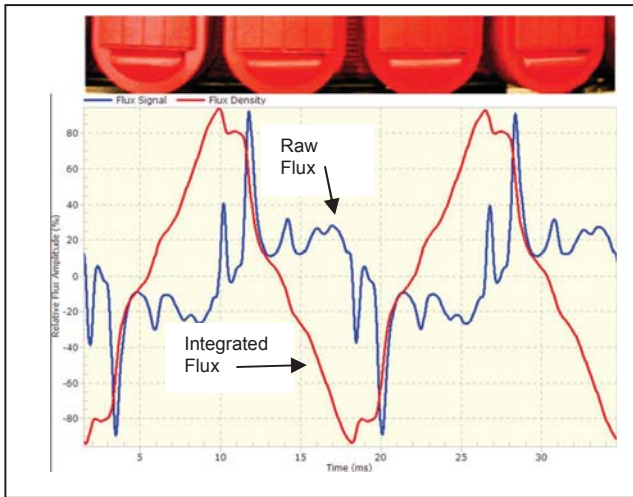
←direction of rotor movement

Fig.5 Shape of the flux signal at 0 MW, 0 MVAR. The vertical scale is the voltage output of the flux probe while the horizontal axis is the circumferential position around the rotor.

The initial experiments with the flux monitoring system were carried out on many dozens of hydrogenerators which generally have a large number of salient poles. An example is shown below. The voltage waveform from a flux probe is shown in Fig. 5. The generator was operated at no load conditions, 0 MW and 0 MVAR, resulting in a symmetrical shape of both the raw signal measured (blue line) and integrated values of raw voltage signal (red line). Since the shape of the signal changes at different loads of the machine (Fig.6), raw data should be integrated for further processing.

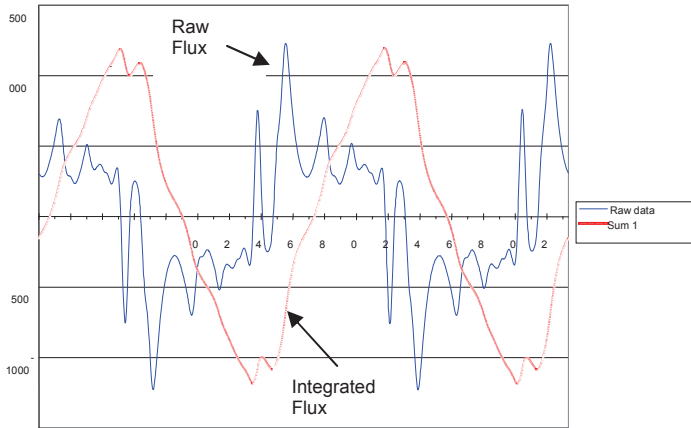
Fig. 6 Shape of the signal at 125 MW, 0 MVAR

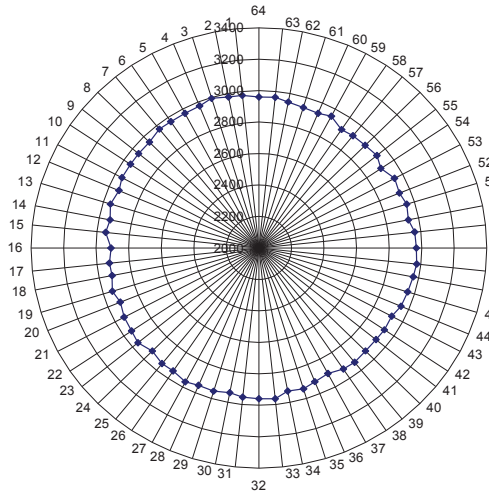
Fig. 7 Polar flux diagram of a hydrogenerator operating at full power. The machine has 64 poles and no known shorts. The radial scale is the accentuated average flux and the circumferential scale is the rotor pole number.

Given that change in the flux profile within a pole at a steady load must be due to shorted turns, comparison of one pole to another can be used as an indication of shorted turns. The transformed flux data can then be shown as a polar plot (Fig. 7). Minor differences between poles and rotor or stator eccentricity will result in a less than perfect circle.

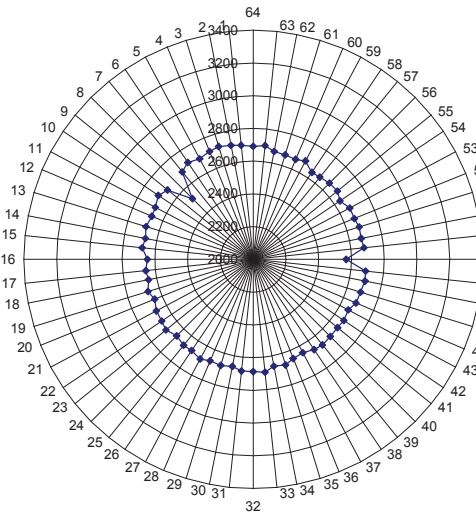
Fig. 8 Polar diagram of 64 pole rotor with shorts detected at poles 8 and 48

Fig. 8 is the result from the same 64 pole rotor with temporarily applied shorts on poles 8 and 48. The poles with shorted turns are clearly determined by the lower flux magnitude at these poles.

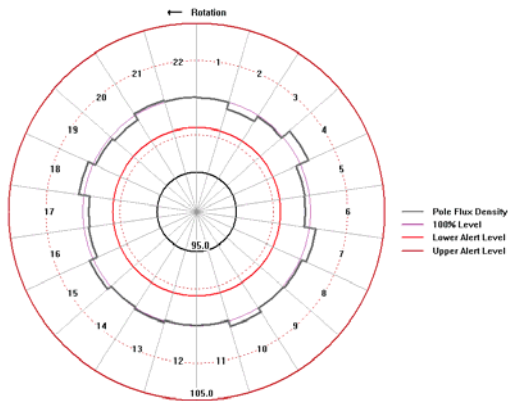
Fig. 9 Flux plot recorded in 2006 from a 22 pole motor

In 2004 flux probes were installed on seven stator cores of salient pole motors used to drive compressors for air separation processes. These motors had from 6 to 22 poles. Figs. 9 and 10 show the resultant flux plot from a 22 pole motor with a strip-on-edge rotor pole design. Figs. 11 and 12 show the flux data from a 6-pole motor. There are minor differences in the magnetic flux from each pole caused by different pole mounting (and thus slightly different air gaps). However, none of the poles has a significant enough reduction in flux to indicate that shorted turns on a pole are indicated. Figures 9 to 12 also indicate the flux measurements

are repeatable over time. These machines do not have increased bearing vibration, which supports the belief that there are no shorted turns. To date, none of the motors monitored shows evidence of shorted turns.

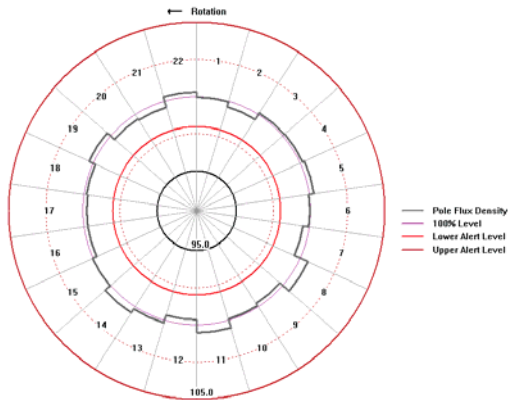
Fig. 10 Flux plot recorded in 2011 from the same motor as Fig. 9

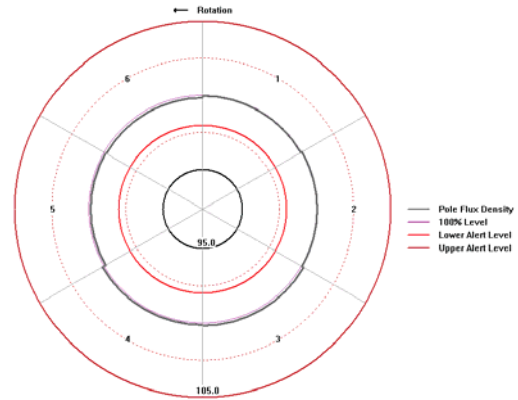
Fig. 11 Polar plot recorded in 2007 of flux from a 6 pole motor.

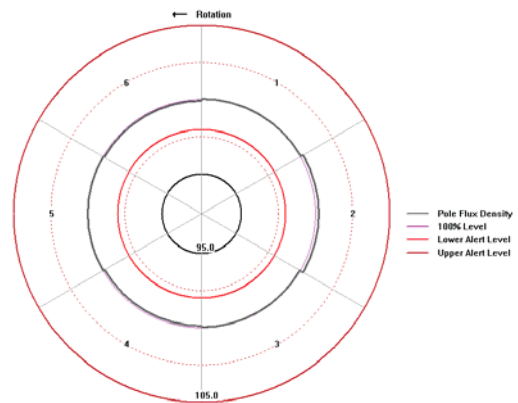
Fig. 12 Polar plot recorded in 2011 of the same motor as Fig. 11
