VIBRATION DIAGNOSTICS AND OVERHAUL PROCEDURES IN HPP JAJCE 1

SUMMARY

Problems related to large vibrations were observed in Jajce 1 Hydro Power Plant on Unit 1. Extensive vibration measurements were conducted with the purpose of providing clear guidelines for the unit overhaul. Vibration was monitored in all relevant operating regimes.

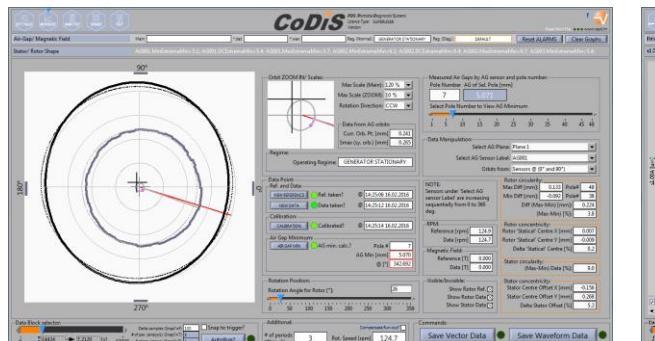
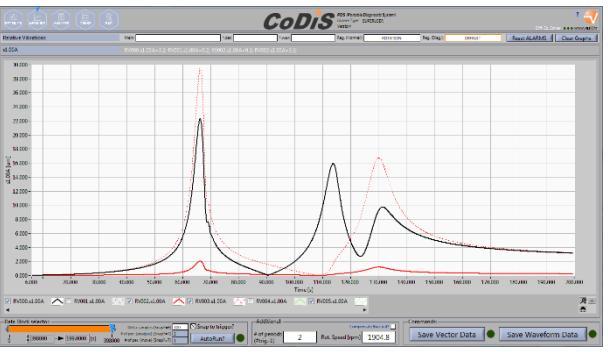
Fig. 1 Example screens from expert modules enabling additional analyses.

Example screens for these are given in Fig. 1

3D shaft Run Out/ Dynamical Rotor Line

Two Plane Balancing Software

Critical Speed and Bearing Stiffness

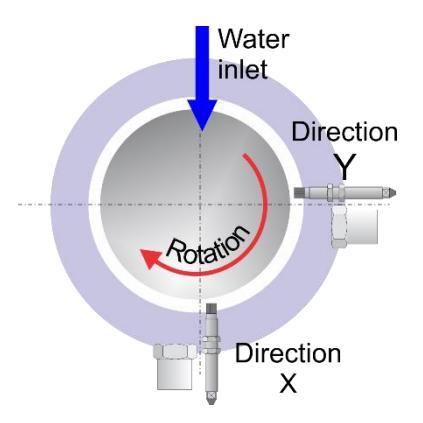
Fig. 2 Measurement layout for relative and absolute vibration sensors. Direction X is at 180° and direction Y at 90° with regards to the water direction (in the rotation direction). Top view.

The directions in which the displacement and acceleration sensors were placed are denoted on Fig. 2.

The bearings are: UGB – Upper Guide Bearing, LGB – Lower Guide Bearing and TGB – Turbine Guide Bearing. The thrust bearing is of the combined type and is integrated with the UGB into one housing. Fig. 3 shows the sensors at TGB level along with the laptop used for the measurements.

For all measurements – the sensors were placed in the X and Y directions as shown on Fig. 2, but in different vertically positioned measurement planes.

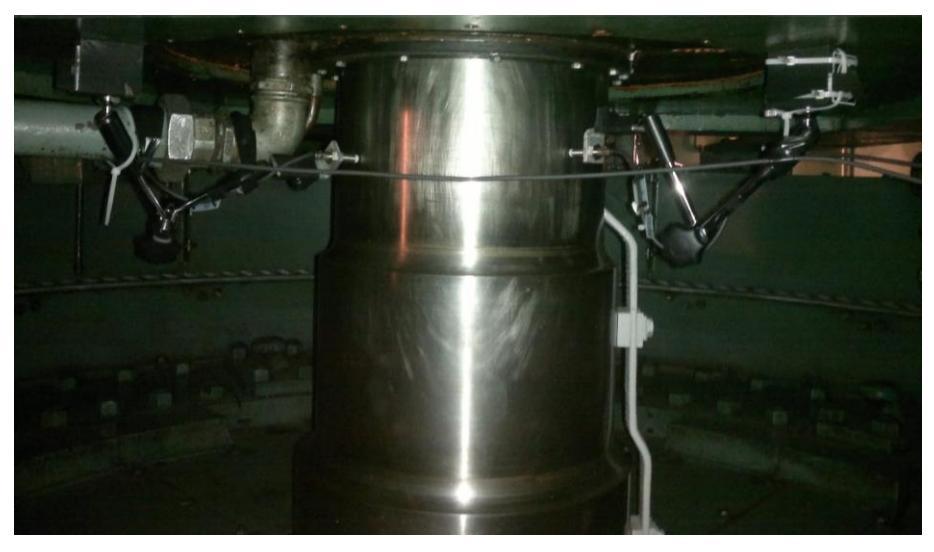
Fig. 4 Sensors under UGB (and under the thrust collar).

Additionally, for the measurements in which the rotor dynamical line was established – the sensors were placed in different planes along the unit's vertical (axial) direction. One example is given on Fig. 4 (for sensors placed under UGB under the thrust collar).

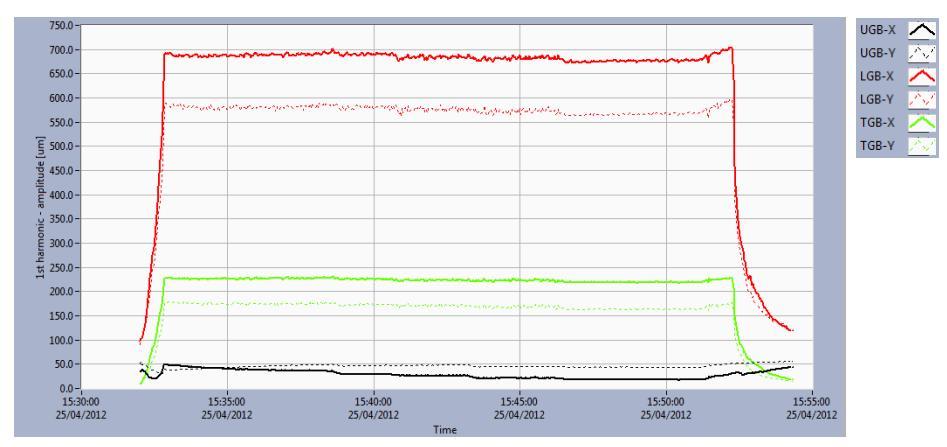
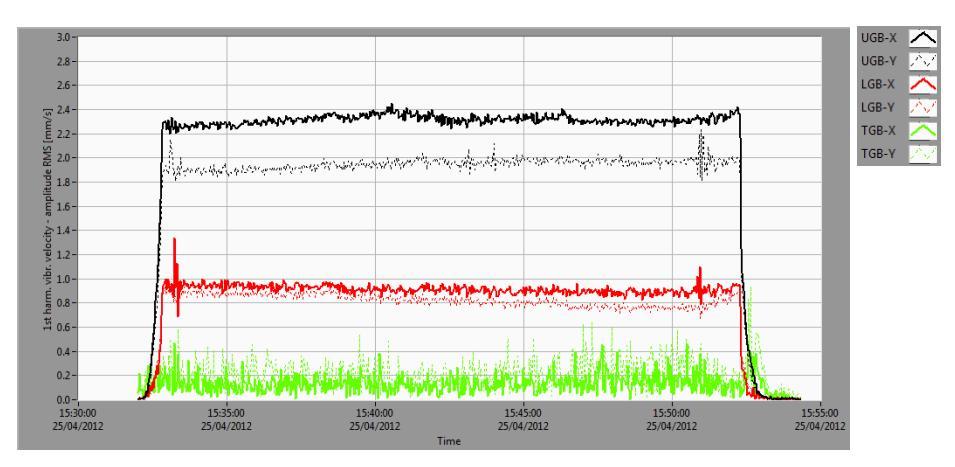
Fig. 5 Upper diagram: Trend of first harmonic peak amplitude for shaft displacement. Lower diagram: Trend of first harmonic rms amplitude for bearing housing vibrations.

For this reason – all of the following analyses refer to this parameter. It is directly comparable (although slightly smaller) to Smax value given by the ISO standards. Fig. 5 shows the trend of first harmonic amplitude peak for relative shaft displacements and first harmonic amplitude rms for absolute housing vibrations.

From Fig. 5 it can be seen that the LGB relative vibrations in both directions X and Y are outside the allowed values recommended by the standards (ISO 7919-5:2005 – see Fig. 6) and also outside the one-sided clearance which is set to ~0.22 mm. For example – the boundary between zones C/D¹ for 300 rpm machines is at 270 μ m and the amplitude peak vibrations on LGB are above 700 μ m! It would be very dangerous to run this machine for a longer time as it could lead to its catastrophic failure.

The shaft displacements relative to the bearing housing at UGB are very small (black lines on Fig. 5 – upper diagram), but at the same time the bearing housing absolute vibrations at UGB are between 1.9 and 2.4 mm/s (these are the first harmonic rms values, that is values at 5 Hz) depending on the direction viewed. This indicates shaft tension in the UGB zone where the forces are transferred through the oil-film to the bearing housing. If the shaft was in the bearing center – for measured displacements – the vibrations on the bearing housing would also be small, especially at the first harmonic. This is not the case here.

Since the displacements on LGB are larger than the bearing clearance and vibrations on bearing housing are relatively small (under 1 mm/s for amplitude rms of the first harmonic of the vibrational velocity) one can conclude that the large forces between the shaft and the LGB segments have 'widened' the LGB clearance due to the fact that the shaft created extra space to vibrate within. Such a situation produces a great stress on the LGB construction. Housing vibrations are not as large since the LGB construction is very stiff and these forces are (through the LGB construction) transferred directly to the foundation.

Such a disproportion between the displacements and absolute vibrations of bearing housing on UGB and LGB suggests there are also problems with the fact that **shaft and bearing are being misaligned**.

Based on these measurements – basic overhaul procedures were proposed to improve the unit's vibrational state. When the unit was stopped before the (first) overhaul, it was found that LGB bearing was damaged and that the one-sided clearances were increased to ~0.5 mm when compared to the nominal values (~0.22 mm). Overhaul was performed in 2012. During this overhaul, the LGB was repaired and set to its nominal (~0.22 mm – one sided) clearance. But, unfortunately – the problem of forces originating from the rotor was not solved by these actions as the state begun to deteriorate (vibrations started to increase). New measurements were performed with the purpose to solve unit's vibrational problems once and for all.

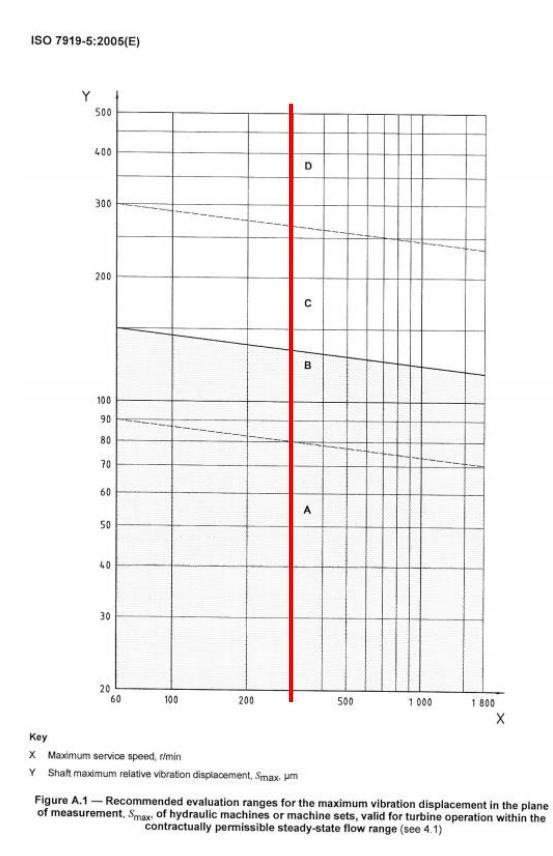
Fig. 6 ISO 7919-5 standard for relative shaft vibrations. Zones of operation based on Smax are shown. Rotational speed for HPP Jajce 1 is indicated.

Note that the 700 µm is even above the diagram visible area (Fig. 6)!

¹ Zone D: Vibration levels in this zone indicate that there is a high probability of damage to the machine. For this reason – immediate action is required to identify the reasons for the high level of vibration.

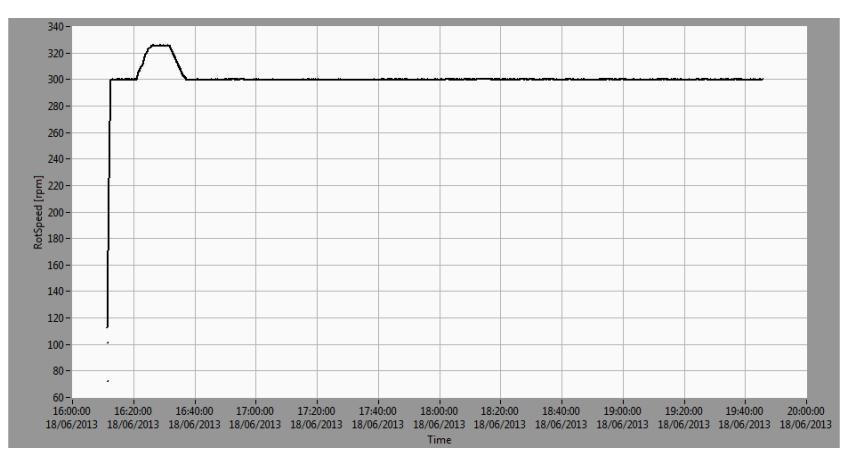
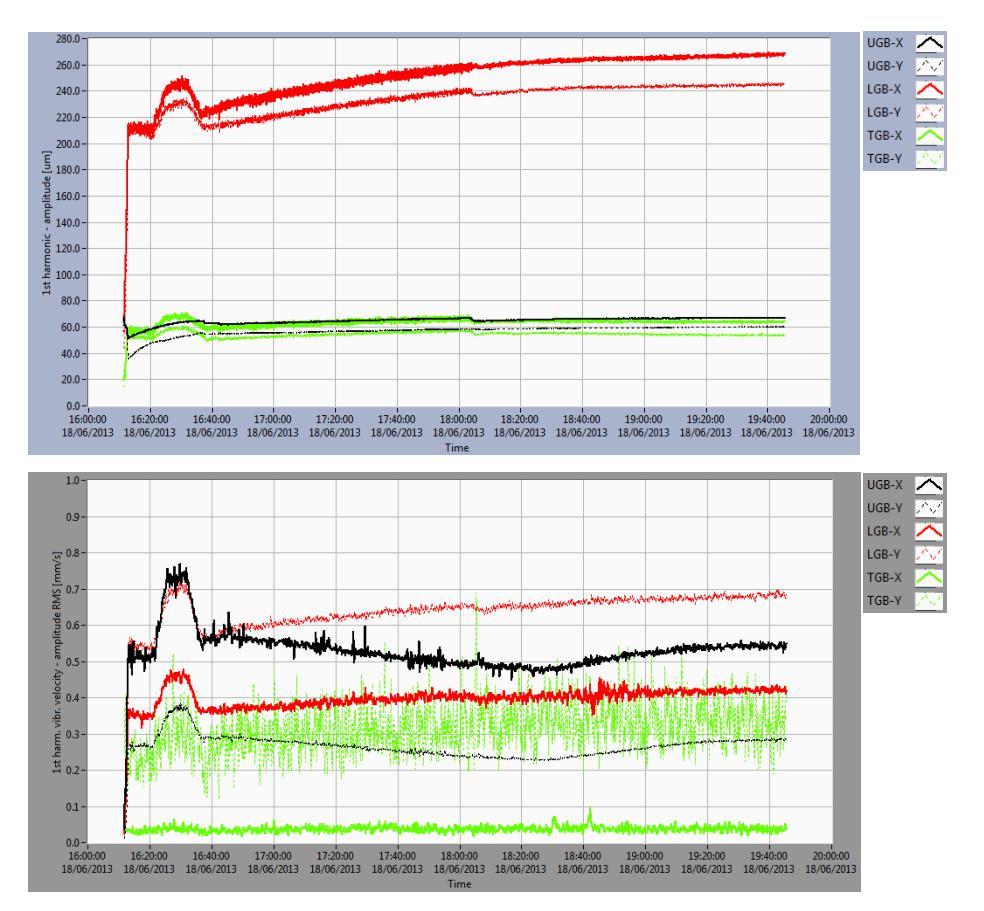
Fig. 7 Rotational speed trend during the measurements (upper diagram). Trend of first harmonic peak amplitude for shaft displacement. UGB-X and UGB-Y at the position above thrust collar, below slip rings (middle diagram). Trend of first harmonic rms amplitude for absolute vibrations (lower diagram).

The measurements lasted a couple of hours from run-up, (automatic) excitation, rotational speed change of excited unit (Fig. 7). After the excited unit rotated a couple of hours – it was synchronized and load increased to maximum (30 MW). The rotation in this regime lasted the next two hours until the temperature stabilized.

What do the results shown on Fig. 7 show?

First of all – it can be seen that the vibration amplitudes change significantly with the regime changes, especially for LGB vibrations, which are at the limit of allowed values even for short-term operation (according to ISO 7919-5 the C/D zone limit is ~270 μ m). At the beggining of the recording, the amplitudes peak of the first harmonic (which are practically identical to Smax) reach ~210 μ m on the LGB. Unit was already automatically excited at this point. After that, for a short time – the rotational speed was increased to ~330 rpm. Vibrations increased to ~250 μ m thus indicating that they vary significantly with the regime changes.

It can also be seen from the diagrams that the vibrations for rotation with excitation and later with load increase continually. After approximately 4 hours they reach \sim 270 µm. It

can be evaluated that they would, after approximately, 2 hours reach 280-290 μ m. Those numbers are unacceptable for the long-term operation. The vibrations on UGB and TGB are a couple of times smaller and do not vary as much with regime changes (except rotational speed change).

The absolute bearing vibrations are below ~0.8 mm/s (first harmonic, rms). For slowspeed machines such as that in HPP Jajce 1 – the absolute vibrations can serve as an indicator of the overall vibrational state but will rarely reach values unallowed by currently valid standards (ISO 10816-5).

One interesting fact can be seen from the diagrams. For similar absolute vibrations measured on bearing housings (0.4-0.6 mm/s) the amplitudes of UGB and LGB relative vibrations are significantly different, that is, the ratio LGB/UGB is ~4. If the nominal clearances for UGB and LGB were set to similar values during overhaul, it is evident that after the overhaul the bearing clearance on UGB is significantly smaller than that on LGB which is why on UGB the relative shaft vibrations with the same values cannot develop with the same values as on LGB. It can be concluded that the shaft is "leaning" to the one side and on this side – the bearing clearance is significantly smaller. Due to this – the oil film stiffness is significantly increased and the vibration amplitudes are smaller. So, similar to the state from April 2012, the **shaft and bearing misalignment** problem remains.

But, during the unit thermal expansion, the relative vibrations increase (Fig. 7 – middle diagram). This is a sure sign that the forces are accumulated inside the generator rotor due to which the vibrations reached the highest values allowed by the bearing clearance.

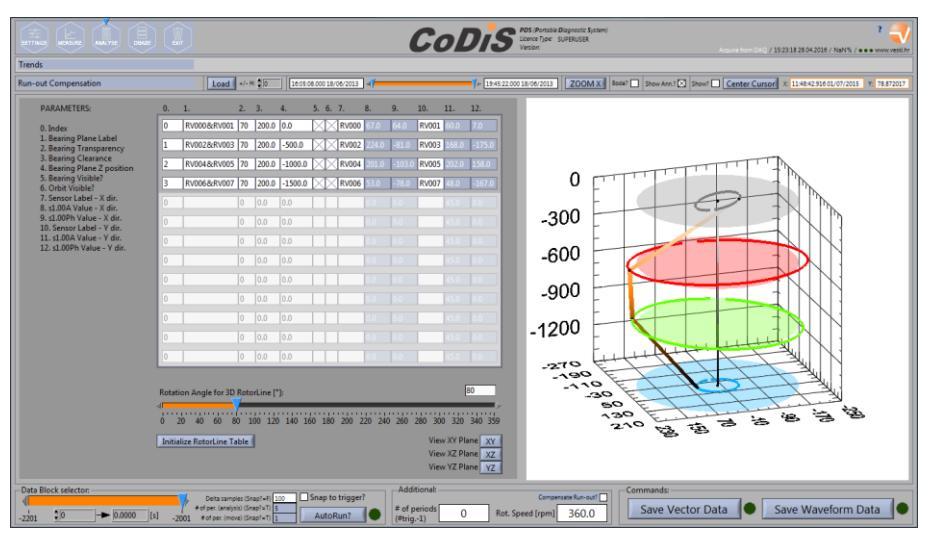
Fig. 8 Rotor dynamical line (under excitation). Top to bottom: position I, position III (as indicated in text), LGB, TGB plane.

Fig. 8, basically, shows the rotor vibration shape at the rotational speed. Vibration amplitudes and phases, based on which the figure was drawn were taken for the nominal speed + excited regime. It should be pointed out that the rotor dynamical line is similar in mechanical rotation but with smaller vibration amplitudes.

Based on these results - the basic properties of dynamical rotor line can be established:

the largest statical (DC) shaft deflection is at the coupling level and is, approximately, 80 µm; at UGB (at bearing segments level) and at TGB – are the positions with smallest statical deflection

- the dynamical shaft deflection up to nominal (and higher) rotational speeds increases in one direction, which is seen from the phase relations
- large shaft vibrations below thrust collar, which are out-of-phase to those above the thrust collar indicate that there is a clearance between the shaft and the collar

In July 2013 an overhaul was performed during which:

- adequate (solid) connection was established between the thrust collar and the shaft (by repairing the thrust collar)
- horizontality of the thrust collar's runner was ensured
- shaft's tension in the UGB zone was relaxed
- unit was balanced (weights in the LGB plane are shown in Fig. 9)

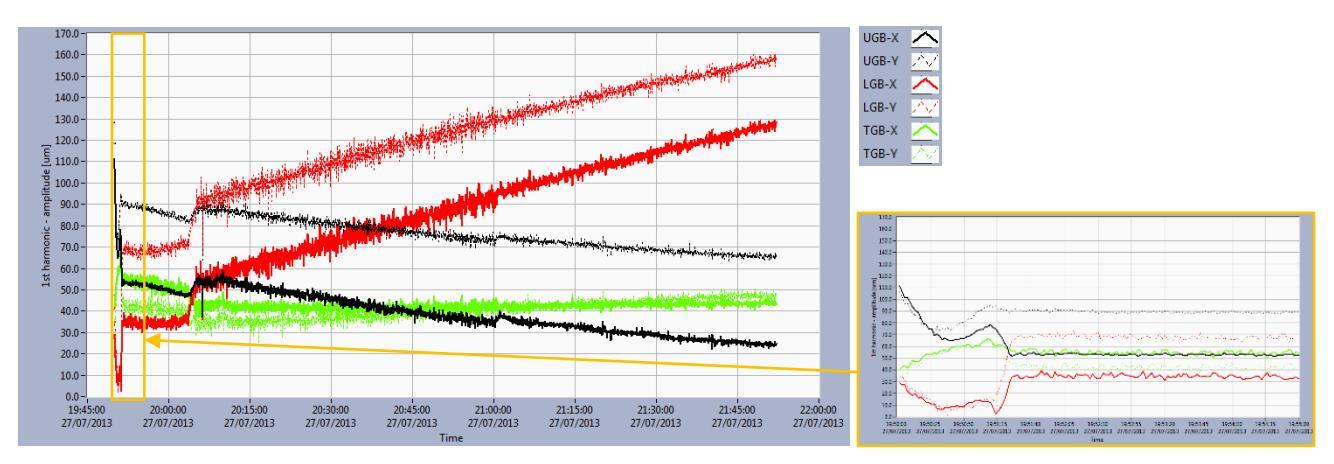
Fig. 10 Trend of first harmonic peak amplitude for shaft displacement. Small figure is zoomed in figure to compare the vibrations in mechanical rotation to that in excited state.

The measurements were peformed with the layout given in chapter 2. After balancing in mechanical rotation, vibrations during excitation and load increase were recorded. The regime was the following: run-up with automatic excitation, rotation with excitation on for ~10 minutes followed by synchronization and load increase up to 20 MW. Rotation for ~1 hour under those conditions followed by load increase to ~29 MW which lasted for ~1 hour. The results for relative shaft vibrations are shown on Fig. 10.

From the zoomed in part of the Fig. 10 it can be seen that the vibrations in mechanical rotation are significantly reduced. For example, on LGB they are 10-15 μ m. After the excitation is turned on, the vibrations in the LGB-X direction increased to 35 μ m and in the LGB-Y direction to 70 μ m. Those are acceptable values and if they remained at these levels at maximum load – the problem with vibrations would have been solved already.

Unfortunately, after synchronization and load increase to 20 MW the vibrations increased to 60 μ m in the LGB-X direction and to 100 μ m in the LGB-Y direction and within the next two hours continuously increased further. After approximately one hour (around 21:00 h) the load was increased to 29 MW which had no influence on the vibration trends. The trend slope indicates that the vibrations would saturate at ~190-200 μ m.

This is unacceptable and, in order to ensure that the unit operates within acceptable vibration limits, it is neccessary to re-distribute the influence of excitation and thermal rotor deformations so that in all regimes the values are around 100 μ m (50% of bearing clearance). This was achieved with adequate balancing weights distribution.

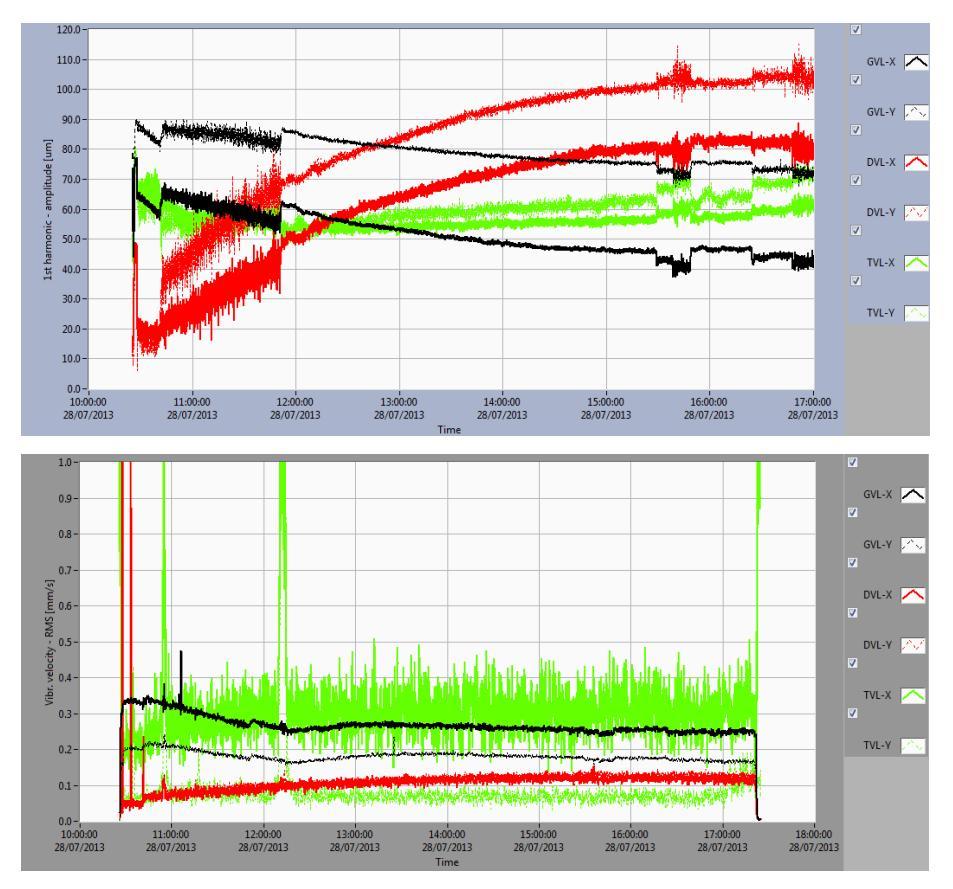
Fig. 11 Trend of first harmonic peak amplitude for shaft displacement (upper diagram). Trend of effective (RMS), that is, overall vibration velocity (lower diagram).

After several iterations vibrations were recorded again and the results are shown on Fig. 11.

It's seen that the vibrations in all regimes are under 100 μ m, at ~50% of bearing clearance (and absolute vibration RMS levels are under ~0.4 mm/s). A relatively large rotor run-out at UGB position is a consequence of the fact that the rotor is deformed, which was present in the same form before the overhaul. But, since the connection between the thrust collar and shaft was not rigid it diminished this deformation at UGB zone. When the connection between thrust collar and shaft was corrected in the overhaul, the run-out manifasted itself fully.

Absolute bearing housing vibrations shows that after the overhaul, forces originating from the shaft and transferring to the stator and foundation were reduced multiple times when compared to the state before the overhaul.
