Experience with PDA Diagnostic Testing on Hydraulic Generators

By J.f. Lyles, G.C. Stone, and M. Kurtz, Ontario Hydro, Canada From IEEE Transactions on Energy Conversion, Vol. 3, No. 4, December 1988 Pages (824–832)

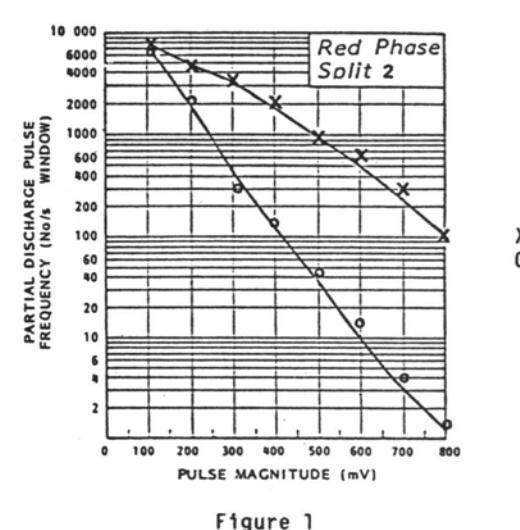
Sir Adam Beck Niagara II GS Unit A

For this condition, the PDA test data gives positive (+VE) pulse predominance as Indicated by the +VE plots of Figure 1.

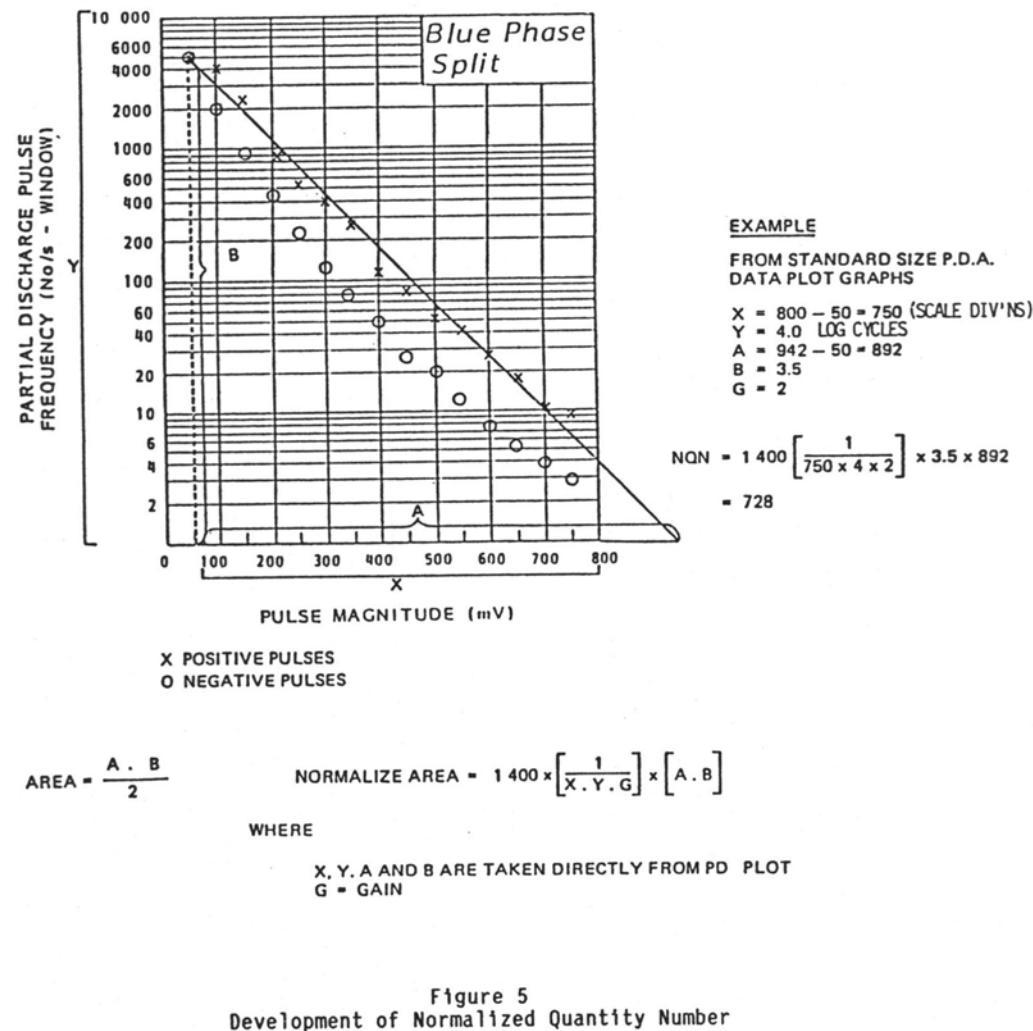
of Normalized Qua (NON)

Figure 5 Illustrates a method of calculating the quantity NQN via Integration of the area under the positive (*VE) PDA data plot. The value NQN can then be related to a probable winding condition for a given Insulation system as described In Charts I and II. The charts also relate maximum coll side force/inch length to corrective action time as per Ontario Hydro's experience for thermoset systems. The probability of success for in situ repair, based on Ontario Hydro's experience is also given.

Figure 6 presents examples of positive (*VE) data NON long-term monitoring plots for two Ontario Hydro multiunit stations, one Incorporating thermoplastic and the other thermoset stator winding Insulation systems of 1954 and 1958 vintage.

David W. Jackson, R. W. Beck and Associates, Waltham, MA. There appear to be some anomalies in the NQN history plots of Fig. 6. Among the thermoplastic insulations. Generator 13 experienced a doubling of NQN from 1983 to 1984. It then declined to half the original value by 1987. No remedial work is indicated. Is there an explanation? Generator 15 was rewedged in 1980 but between mid 1981 and mid 1983 its NQN doubled, and then declined sharply in one year to its original value. Is there a known reason?

In reply to Mr. O.W. Jackson and associates' discussion, we comment as follows. The NQN data presented in Figure 6 was calculated from the original PDA (1981) test instrument. This instrument was found to suffer from a shorter than expected recallbrat1on requirement i.e., it tended to drift over time. This deficiency has been corrected In the PDA-H model. Furthermore, the concept of the NQN value was not conceived until the second quarter of 1986. Thus, the NQN values presented were calculated from PDA data obtained from 1981 through 1986. It is the SAB II PDA Instrument's tendency to drift which Is partially responsible for the noted anomalies. We have also noted in the past that the deterioration function Is not continuous over time but has a step function characteristic as a result of void conditioning due to trapped discharge by-products in the thermoplastic insulation system. This characteristic we feel has also contributed to the SAB II GS data anomalies.

For the R.H. Saunders GS thermoset HQH data plots, we feel that the concrete creep induced station distortion [2] is a cause of the noted anomalies as well as the stator rewedgtng which was performed on the units at the time indicated by the vertical parallel paired lines. Stator rewedging usually produces erratic PDA data for up to 6 months upon a unit's return to service. Such erratic PDA data being the result of stator winding settling. However, 1n this case, due to the release of stresses in the stator core as a result of modifications to each unit's stator sole plates, the stator winding settling 1s being extended over a longer period of time.
