# Creative Solutions For Significant Generator Failure Damage

**GE 9A4  
Shaft ID Damage  
& Repair**

# GE Water Cooled LP Shaft OD Damage & Repair

# GE 324 Main Lead Repairs

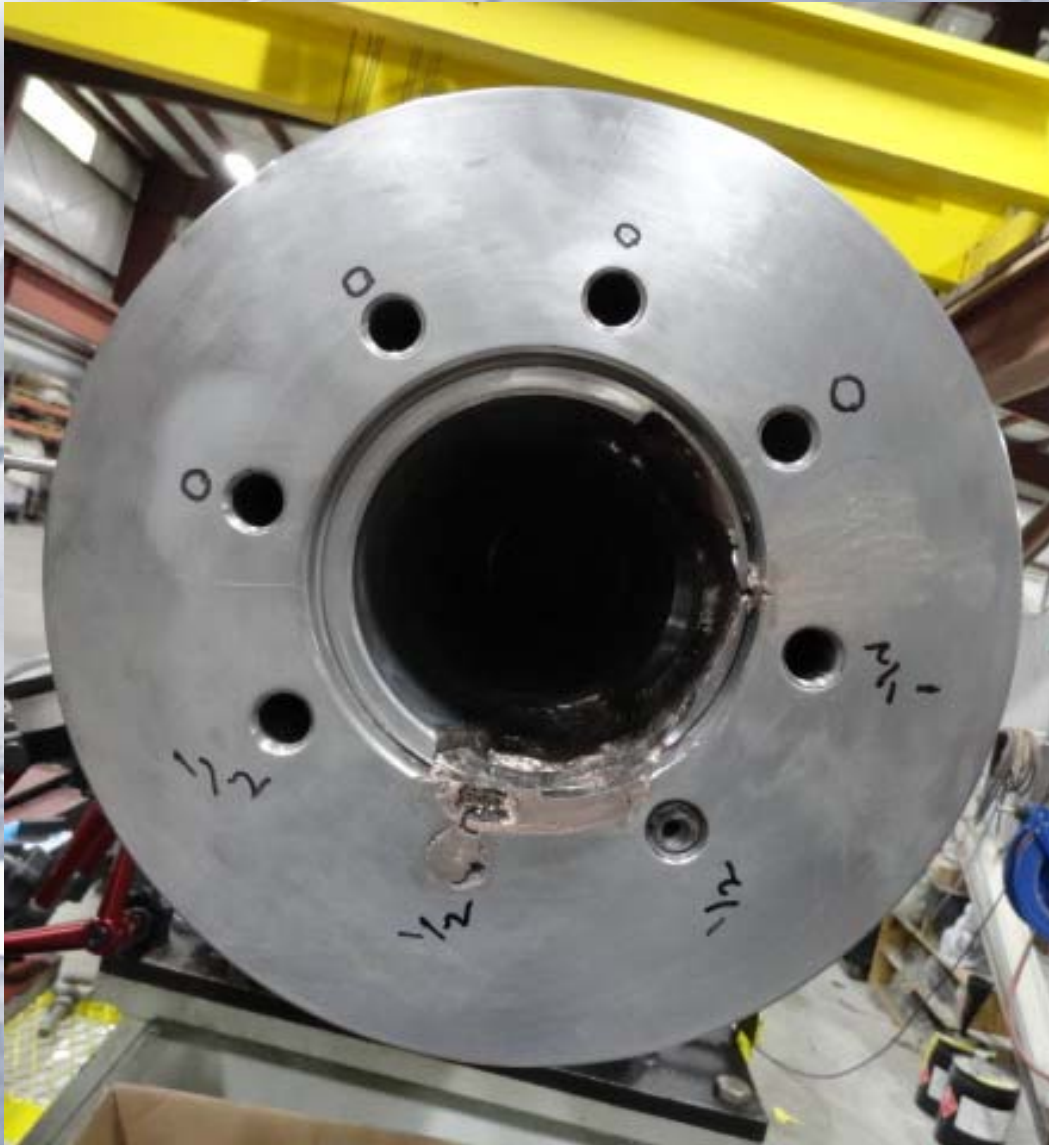
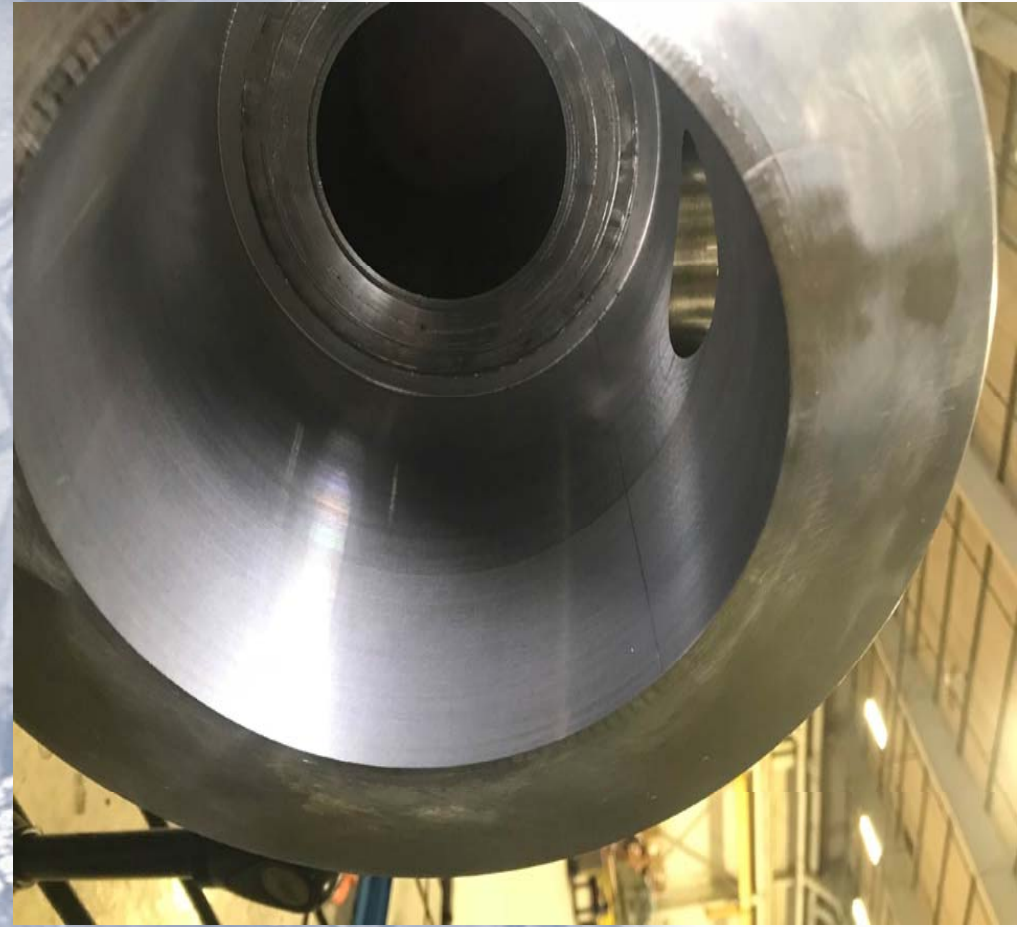
**Before / After**

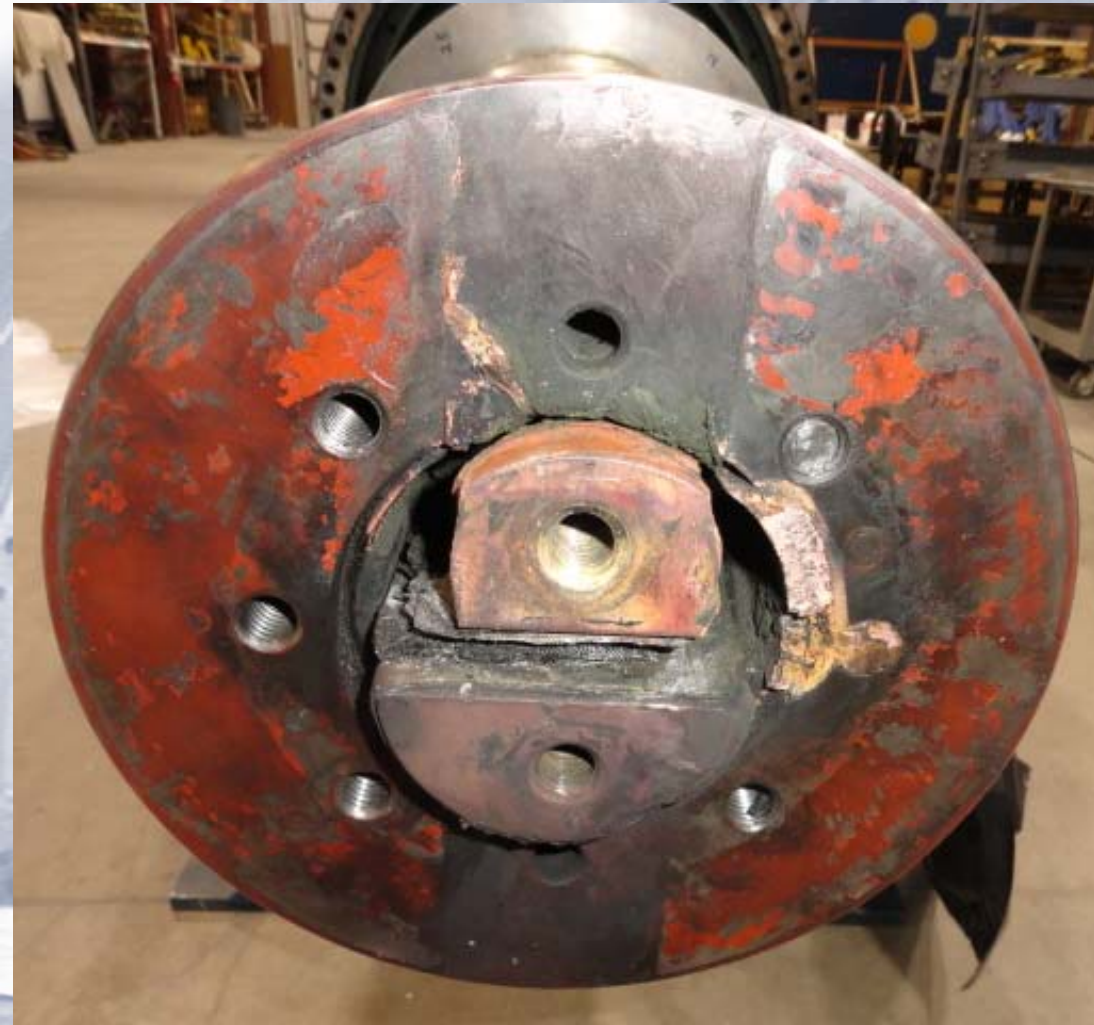
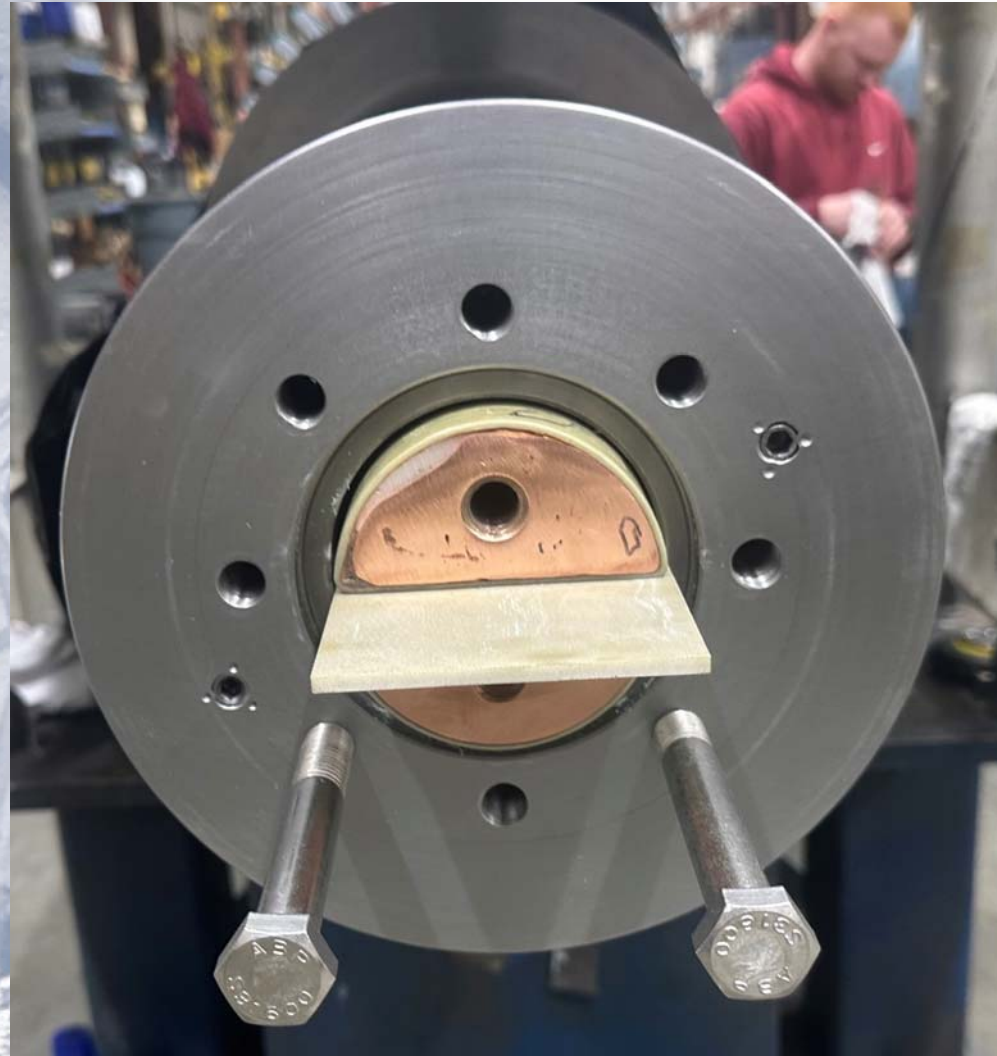
**Before & After**

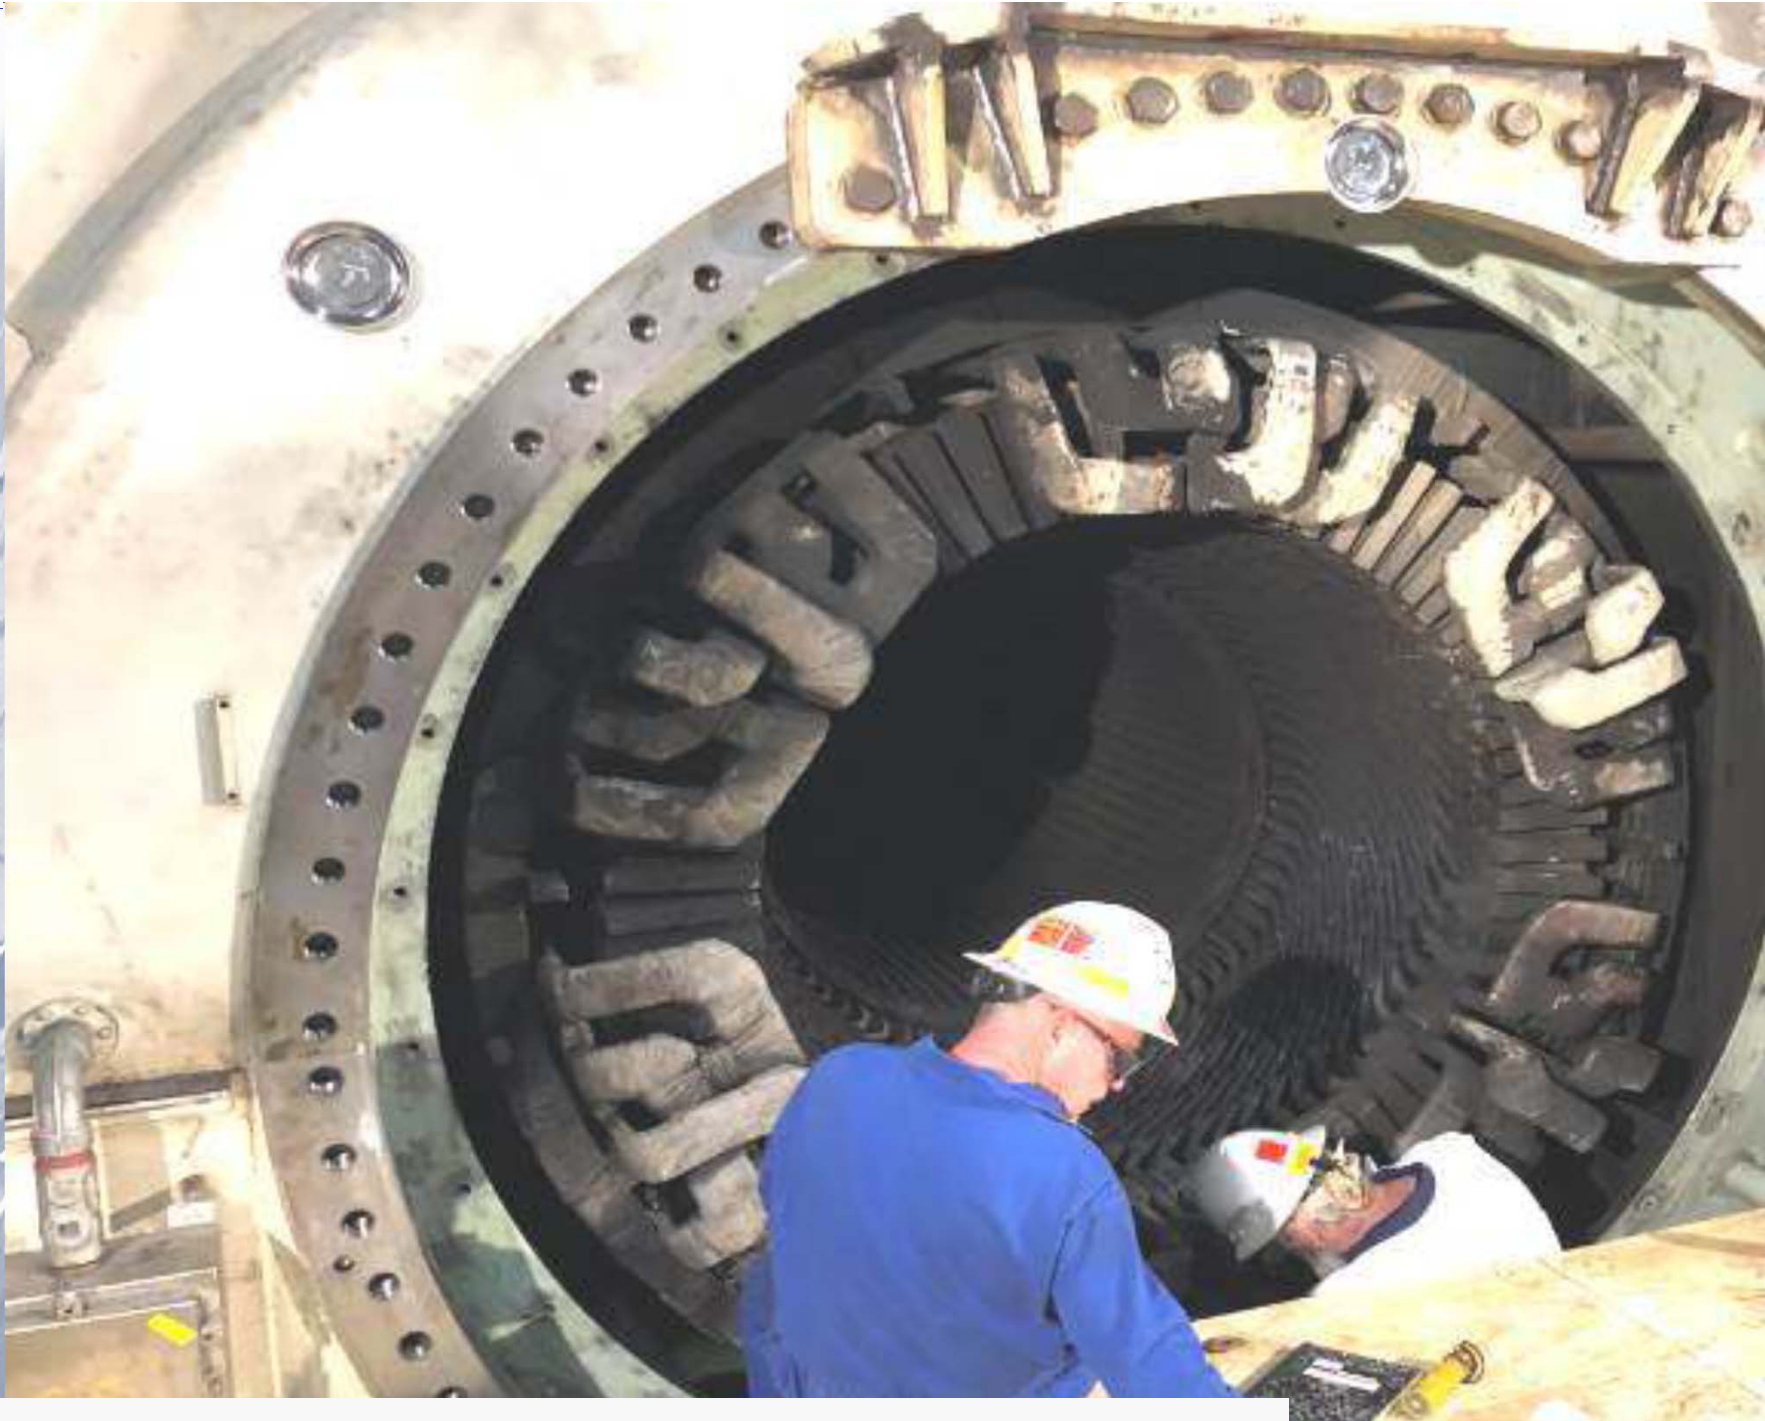
**GE 324 – 3 Circuit Winding Connections**

**NOT 324 basket**
